Sundry Notices and Reports on Wells

5. Lease Number
SF-078509
6. If Indian, All. or
Tribe Name
7. Unit Agreement Name
San Juan 32-9 Unit
8. Well Name & Number
San Juan 32-9 U #23
9. API Well No.
30-045-11014
10. Field and Pool
Blanco Mesaverde
11. County and State
San Juan Co, NM

WORKOVER PROCEDURE - TUBING REPAIR

San Juan 32-9 #23
DPNO 69866
Blanco Mesaverde
SW, Section 5, T31N, R9W
San Juan County, New Mexico

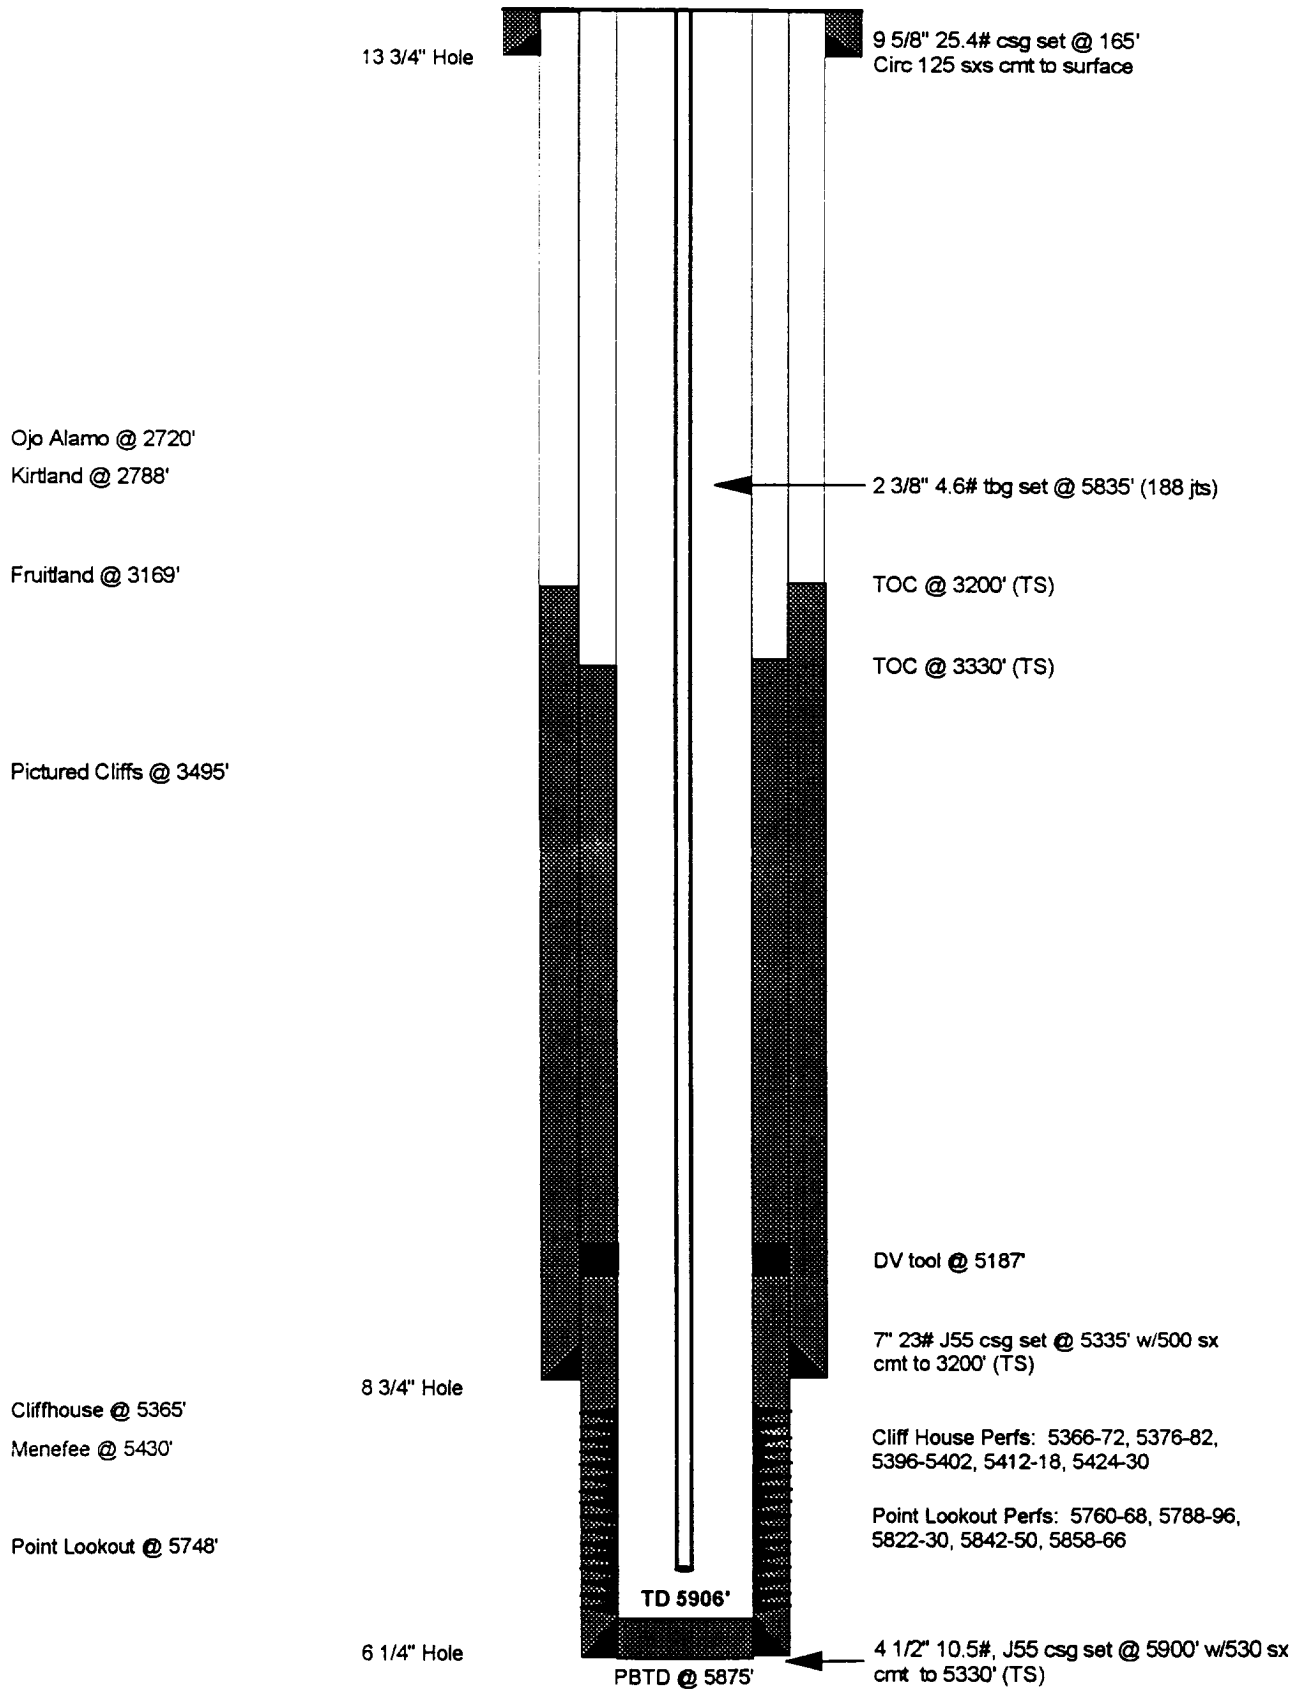
CURRENT

San Juan 32-9 #23

IGNACIO BLANCO MV
DPNO 69866

990' FSL, 990' FWL,
Section 5, T-31-N, R-9-W, SAN JUAN COUNTY, NM

Spud: 5/6/54

Completed : 6/28/54
