UNITED STATES DEPARTMENT OF THE INTERIOR BUREAU OF LAND MANAGEMENT

WORKOVER PROCEDURE -- TUBING REPAIR

SAN JUAN 32-9 UNIT #1 Blanco Mesaverde Sec. 18, T31N, R09W San Juan Co., New Mexico DPNO: 69837

San Juan 32-9 Unit #1

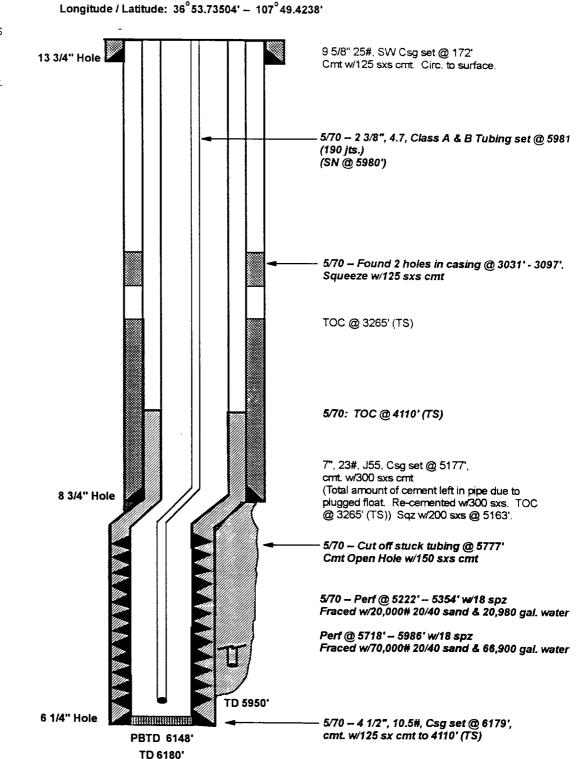
CURRENT -- 12/11/96

5/70: Cut off stuck tubing. Squeeze open hole w/150 sxs cmt. Located holes in 7" casing. Squeezed holes w/125 sxs. Sidetracked w/4 1/2" casing. Cemented, perfed, fraced, and landed tubing.
