Sundry Notices and Reports on Wells

API # (assigned by OCD)
30-045-22684
5. Lease Number
Fee
6. State Oil&Gas Lease #
7. Lease Name/Unit Name
8. Well No.
Betty Hartman #1
9. Pool Name or Wildcat
Basin Dakota
10. Elevation:

Procedure to Locate & Repair Casing Leak

Betty Hartman #1

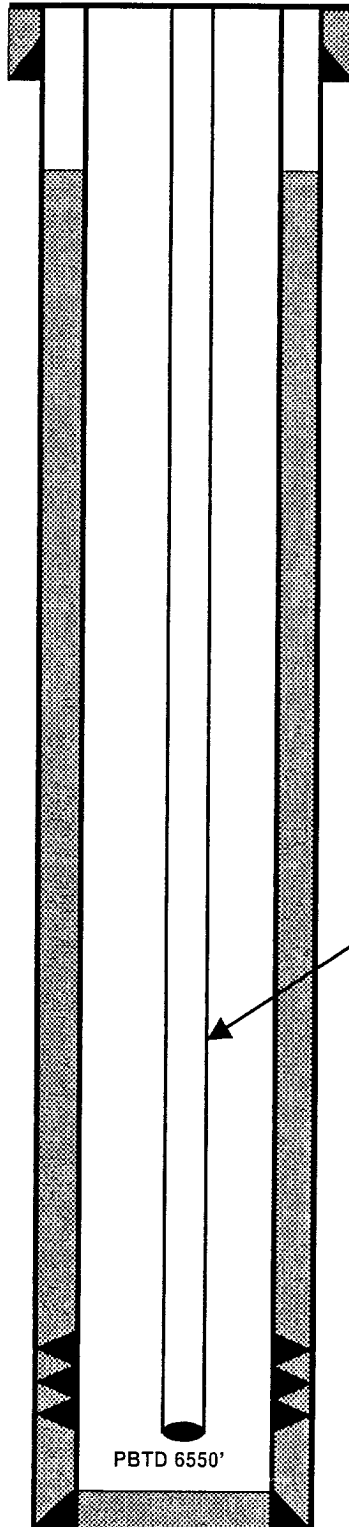
8-5/8" 24# Casing set @ 207'
Cement w/230 sxs (cmt did not circulate –
So backside 250 sxs with 1", then 3 yards pea gravel)

TOC @ 332' (Calc, 75%)

Current - Casing leak. Production stopped. Plunger recovered. Making nothing No packer in well. Close to houses.

No additional information at OCD. Casing may have a DV tool – no reference to it of record.

Objective – repair casing. May leave with packer.
