Sundry Notices and Reports on Wells

WORKOVER PROCEDURE - TUBING REPAIR

Brookhaven Com 1A
DPNO 6586
Blanco Mesaverde
Section 16, T31N, R10W
San Juan County, New Mexico

Brookhaven Com #1A

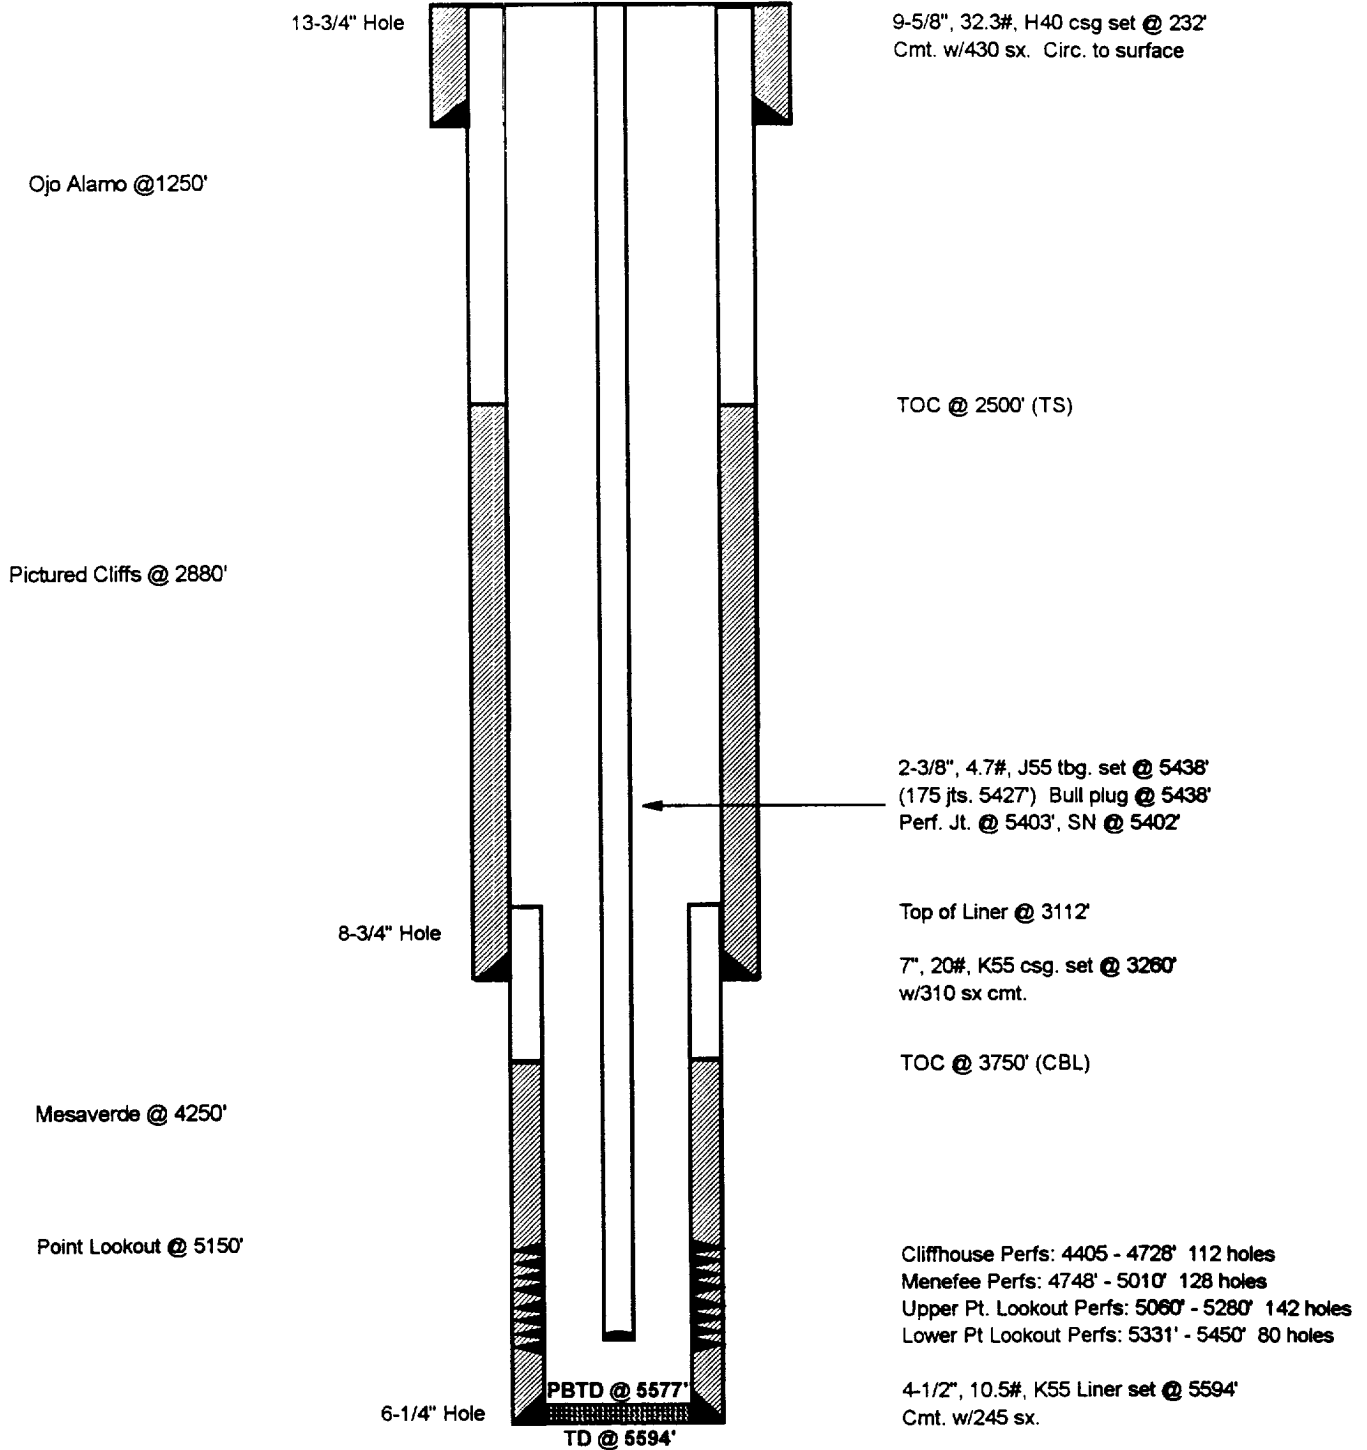
Current 9/27/95

Spud: 1-4-78
 Completed : 2-15-78
 Elev. GL 6110'
 KB 6122"

It is intended to repair the tubing in the subject well according to the attached procedure and wellbore diagram.
