RE: Rule 34 Variance Request –Produced Water Impoundment Construction on Unstable Area

Cave and Karst Resource Inventory Report WaterBridge Parkway Pond Eddy County, New Mexico

July 20, 2022

PW-083B-20220512

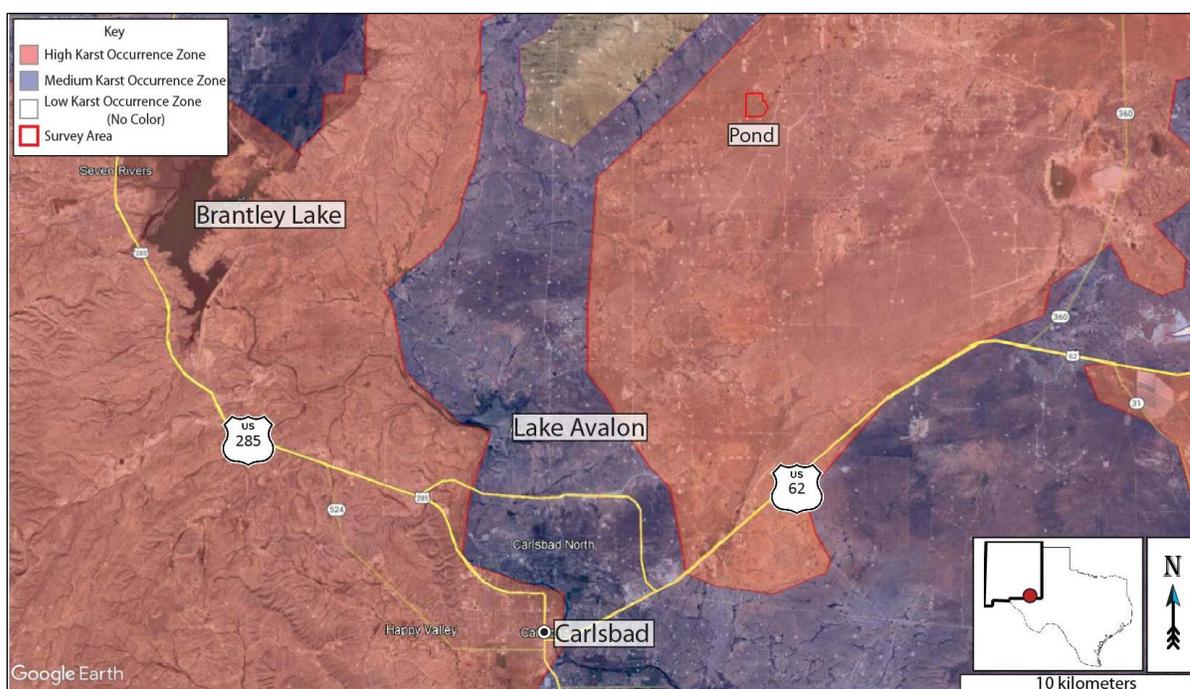
The Bureau of Land Management (BLM) categorizes all areas within the Carlsbad Field Office (CFO) zone of responsibility as having either low, medium, or high cave potential based on geology, occurrence of known caves, density of karst features, and potential impacts to freshwater aquifers^[1]. These designations are also recognized by the New Mexico State Land Office (NMSLO). This project occurs within a **HIGH** karst occurrence zone (**HKOZ, Figure 1**).

Figure 1: Karst occurrence overview. Background image: Google Earth. Image date: December 21, 2019. Datum: WGS-84.

A high karst occurrence zone is defined as an area in known soluble rock types that contains a high frequency of significant caves and karst features such as sinkholes, bedrock fractures that provide rapid recharge of karst aquifers, and springs that provide riparian habitat^[2].

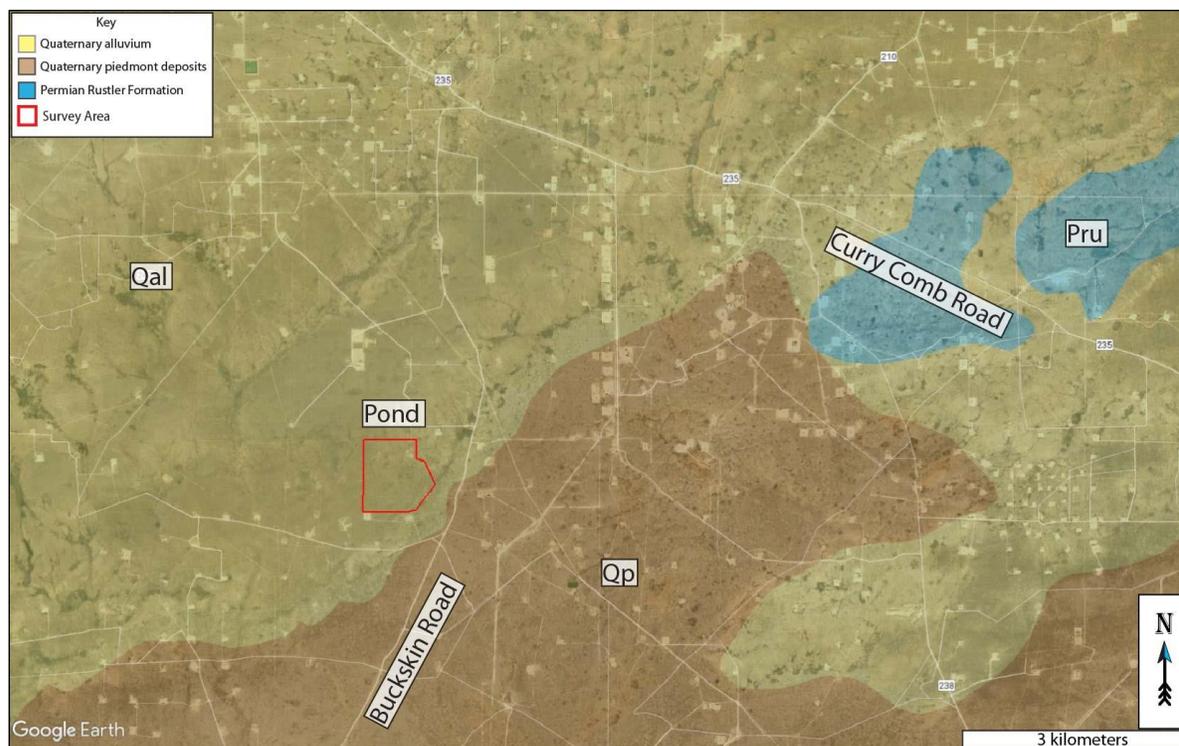
The area surveyed for the WBP project is located in a region locally known as Burton Flats at an elevation of 1,012 meters (3,319 feet), \pm 12 meters (39 feet), and is underlain by the Permian Rustler (Pru) and Salado (Psl) Formations. The area is mantled by thin gypsiferous soils and Quaternary aeolian sands (Qal) and alluvial sands and gravels (Qp)^[7] between 0 and 6 meters in depth (**Figure 3**).

The Salado contains a layer of extremely soluble halite which can readily dissolve to create caves, sinkholes and other karst features; however, due to its extremely soluble nature, only non-soluble silt and sand remain from the dissolution of this layer at the surface^[8]. The Rustler Formation may be subject to collapse if a void has developed beneath it in the Salado Formation^[9].

This area is heavily karstified and has numerous sinkholes, swallets, caves, and other karst features within the survey area. Extreme caution is recommended during any surface activities including surface inspection, brush clearing, and trenching. The survey area is covered by the easily accessible Geologic Map of New Mexico (2003) at 1:500,000 scale^[5].

Figure 3: Geology overview. Map credit: The Digital Geologic Map of New Mexico in ARC/INFO Format^[10], and Google Earth. Image date: December 21, 2019. Datum: WGS-84.

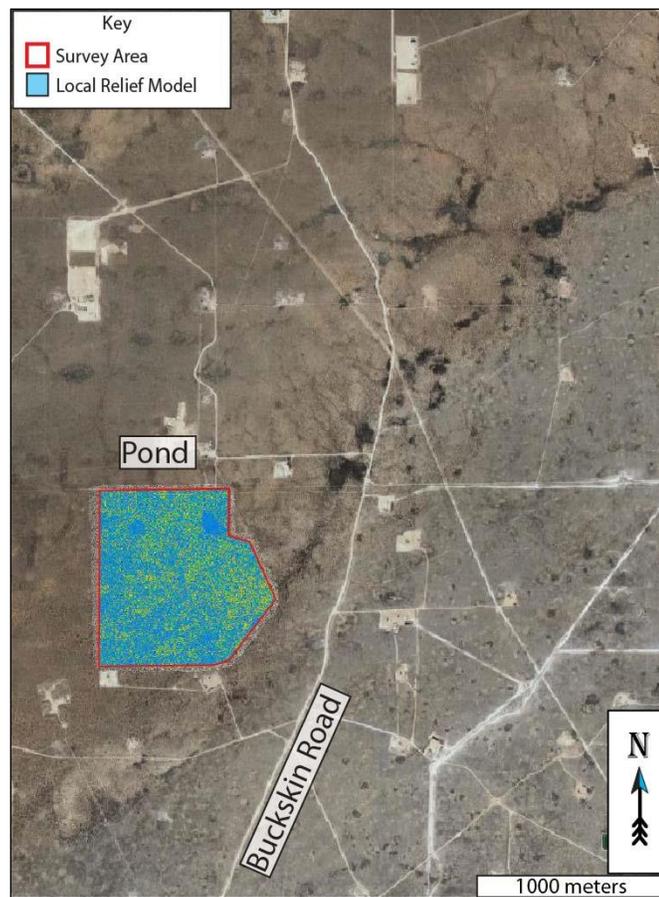
Figure 4: Survey overview. Background image credit: Google Earth. Image date: December 21, 2019. Datum: WGS-84.

No surface karst features were located during this survey.

The lack of surface karst features does not mean the area is not karstified and the survey area may still contain buried karst features. Caution should be exercised while clearing brush and during any excavation, trenching, or construction operations. Employing a karst monitor on-site during these operations should be considered.

The lack of surface karst features does not mean the area is not karstified and the survey area may still contain buried karst features. Caution should be exercised while clearing brush and during any excavation, trenching, or construction operations. Employing a karst monitor on-site during these operations should be considered.

This area may be prone to rapid karst formation in the underlying stratigraphy and warrants careful planning and engineering to mitigate karst-forming processes that could be accelerated by poor design considerations. Proper engineering of petroleum-related facilities following karst guidelines should be implemented during both excavation and construction. Mitigation measures for any karst features revealed during excavation shall be approved by the Bureau of Land Management – Carlsbad Field Office and follow the Natural Resources Conservation Service Conservation Practice Standard for Karst Sinkhole Treatment, Code 527, or the Bureau of Land Management Cave and Karst Management Handbook, H-8380-1.
