Re: Oilfield Water Logistics Fulfer Produced Water Recycling Facility C-147 Extension

On behalf of Oilfield Water Logistics, ENVIROTECH ENGINEERING & CONSULTING, INC. respectfully submits the enclosed C-147 form and summary of monthly inspections and leak detection for the Fulfer Containment and Recycling Facility. For original site plans and submittals, please refer to the facility's original registration application, OCD Registration number 1RF-023, received October 10th, 2017. In accordance with NMAC 19.15.34.10 RECYCLING CONTAINMENTS, Oilfield Water Logistics wishes to seek a one-year extension to the facility.

Updated C-147 Form
Summary of Monthly Inspections and Leak Detection Reports

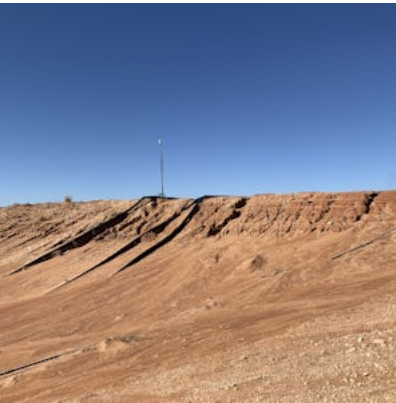
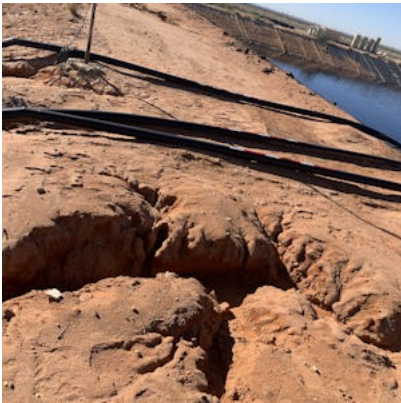
GENERAL DETAILS	
	<div>NOTES</div> <div>Outer sides of pond need dirt work. Signs of erosion</div>
<div>

</div>	
Date	November 6th 2024
Area	New Mexico
Recycle Facility	FULFER_RECYCLE_FACILITY
WEEKLY INSPECTION	
Read and record the fluid height of staff gauges	12ft 9in
Does the pond surface show visible oil?	No
Visually inspect containments liner	Liner appears to be in good condition . Dirt on the side of ponds has clear erosion. Needs to get some dirt work done.

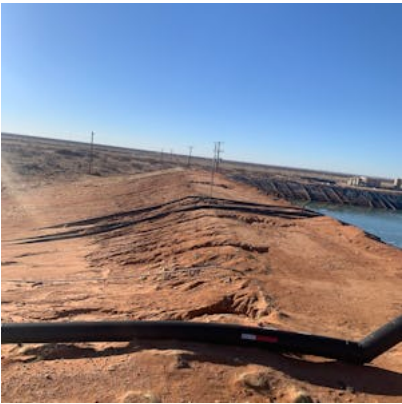
NOTES
Erosion on soil around pond

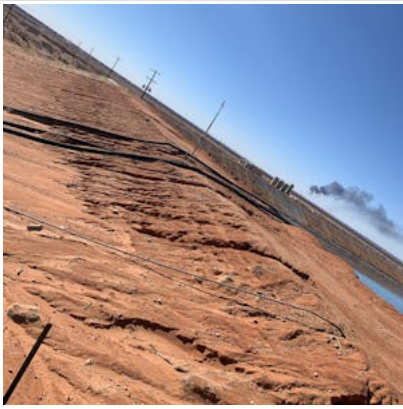
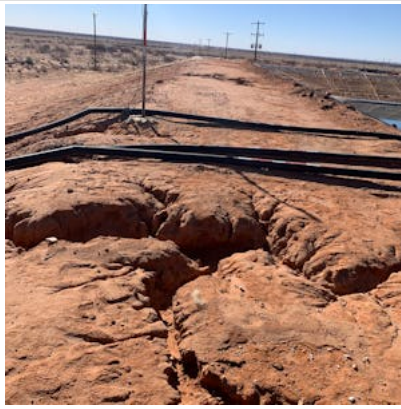
Soil around pond has real bad erosion.

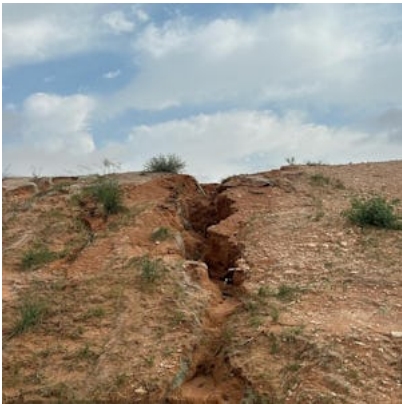
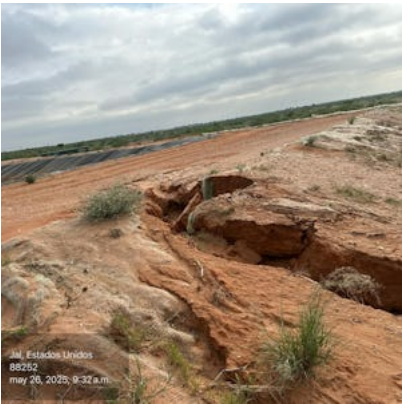
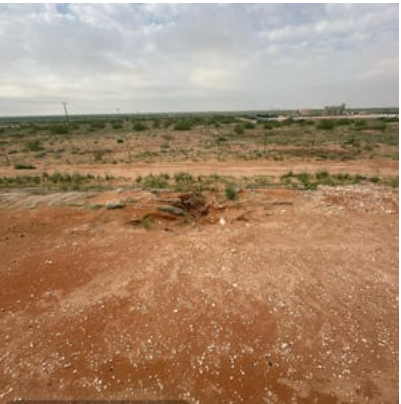
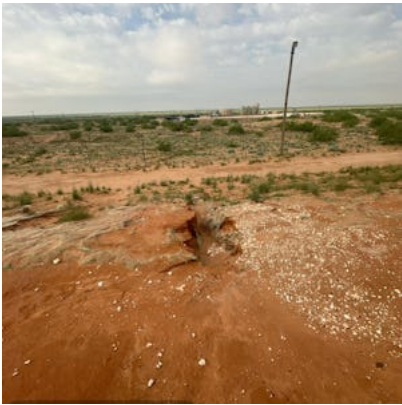
Item There's several wash outs around the pond from heavy rains.

Responsible Persons **FOLLOW-UPS**
Assigned to Nathan Ford on 5/26/25, Due 6/5/25
