## Recycling Facility and/or Recycling Containment

# OPERATIONS & MAINTENANCE REPORT

Zia Hills Recycling Facility Lea Co, NM

**Re:** Conoco Phillips OGRID #217817  
Zia Hills Recycling Facility  
Permit #1RF-454  
Section 30, T26-S, R32-E,  
Lea County, New Mexico

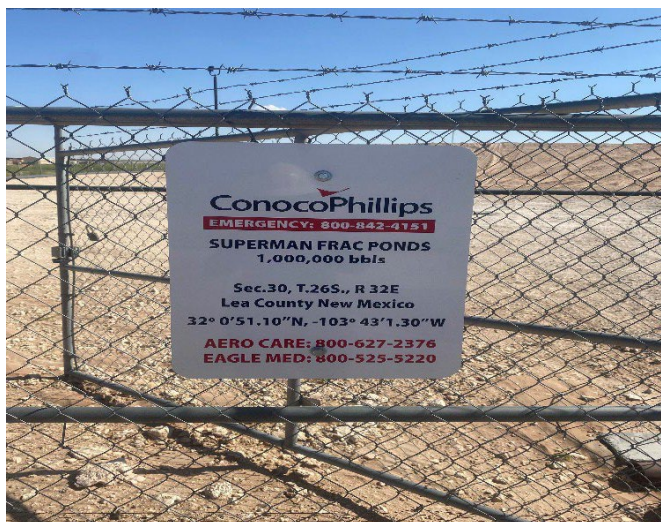
Entrance to facility

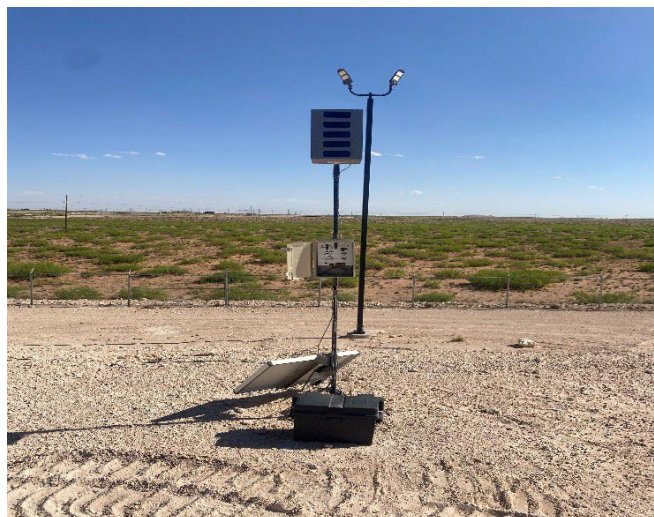
Bird call at south end  
of facility

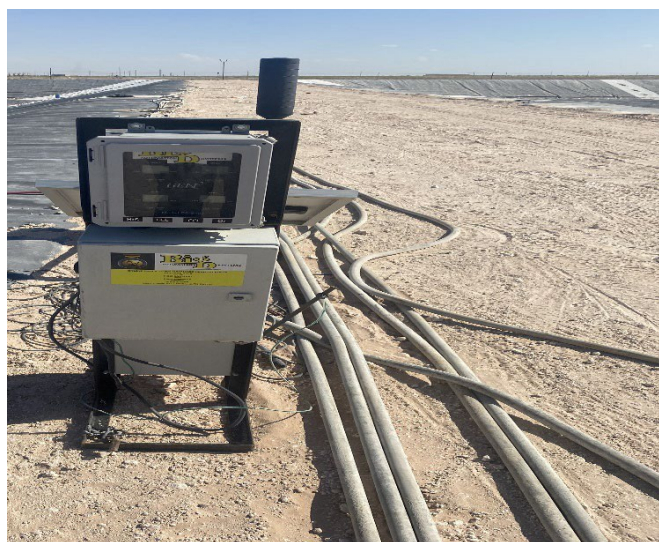
Conoco Phillips Zia Hills Recycling Facility has a depth gauges installed on the east and west interior slopes for manual observation as well as a pressure transducer that transmits the water level electronically to the pond's PLC. Pictures from the on-site observation of the recycled water impoundment can be found in Appendix A.

Automation for water & gas levels

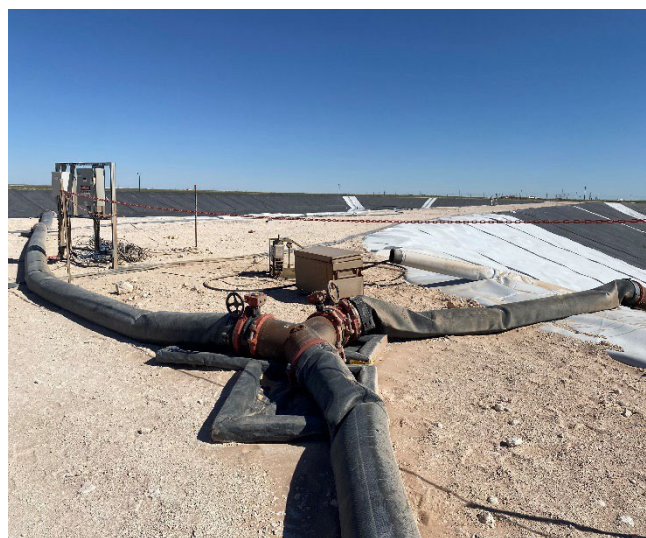
Water inlets

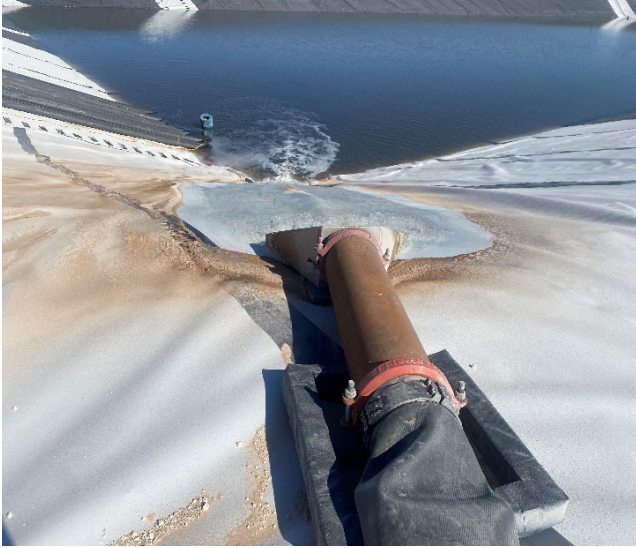
HDPE poly is utilized for outlet piping for the impoundment. Layflat is utilized for inlets. The piping that was able to be visually assessed during the on-site observation appears to be in good condition. Pictures from the on-site observation of the recycled water impoundment can be found in Appendix A.

East impoundment inlet

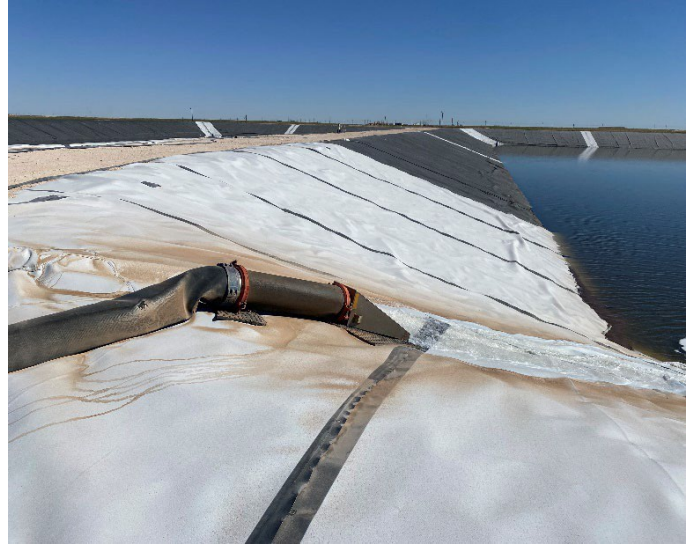
West impoundment inlet

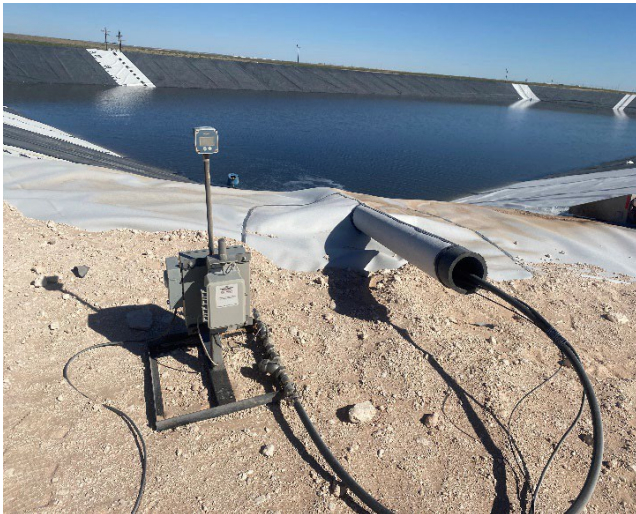
East impoundment leak detection pump

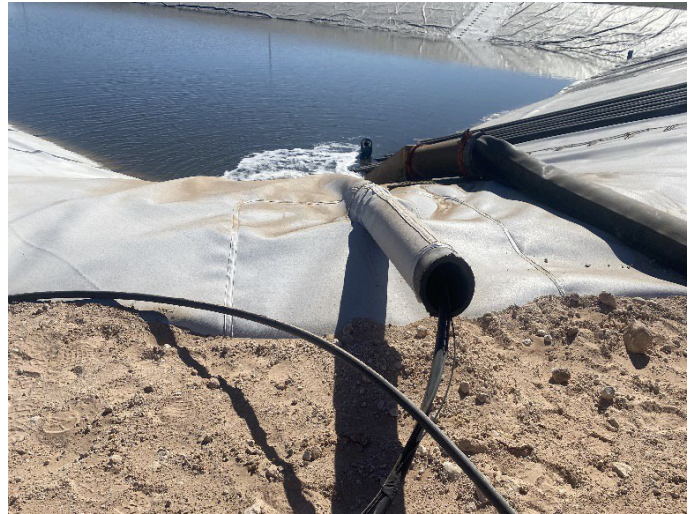
West impoundment leak detection pump

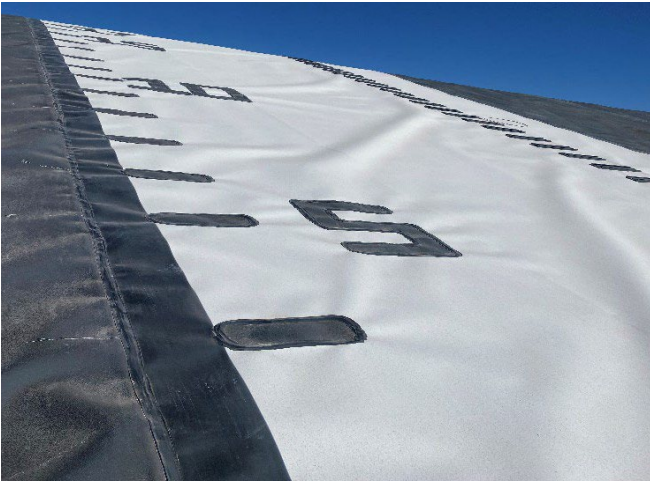
East impoundment depth gauge

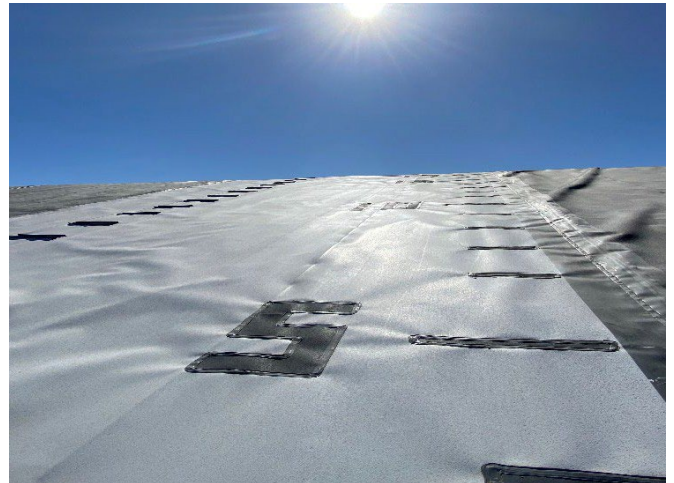
West impoundment depth gauge

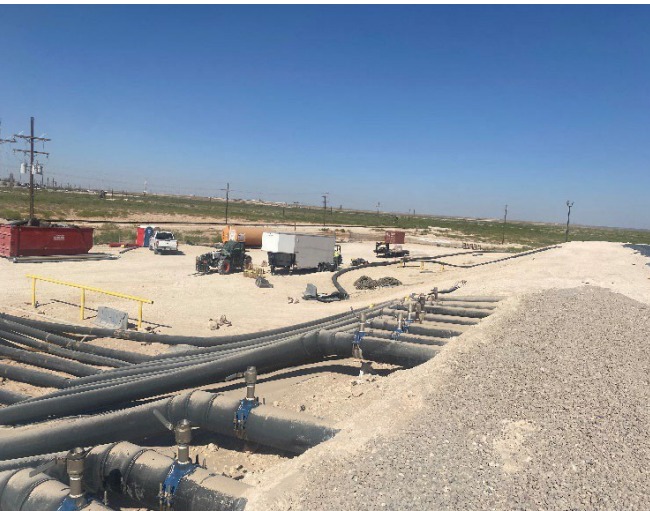
East exterior outlet piping

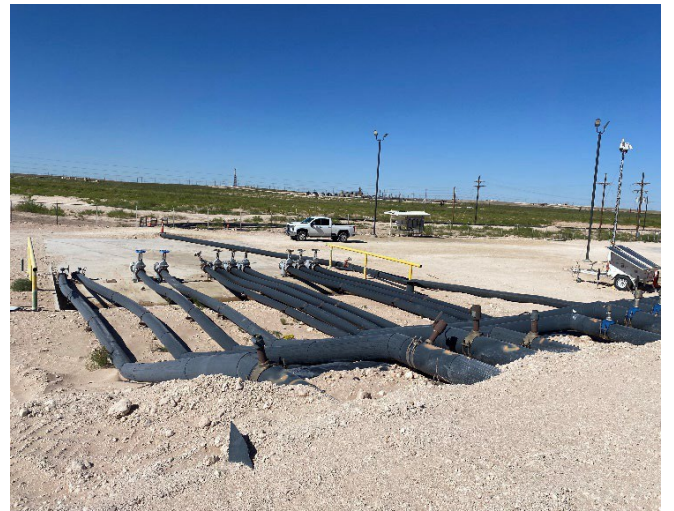
West exterior outlet piping

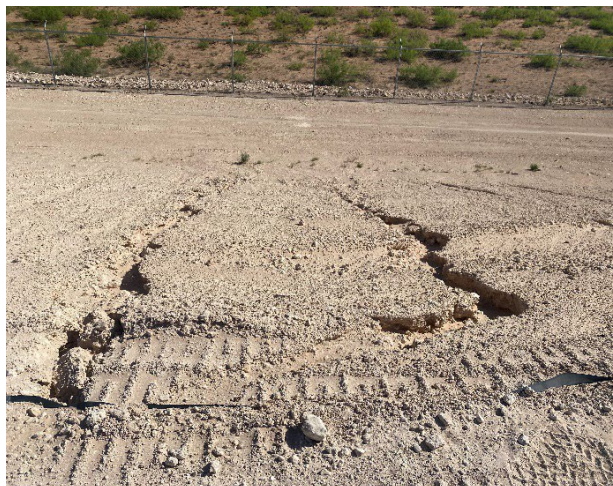
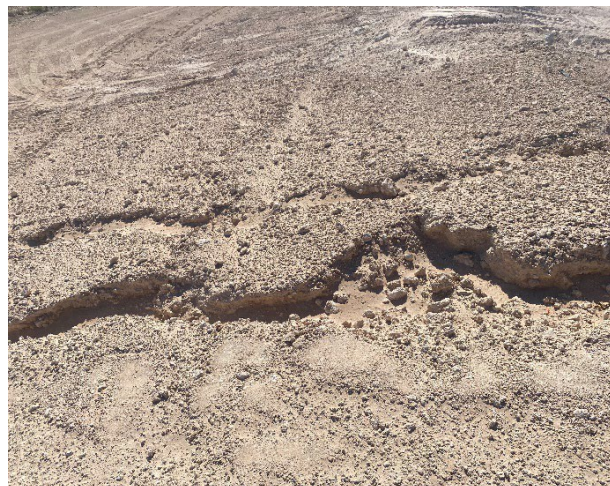
Moderate exterior rill erosion prior to preventative maintenance

No erosion exists due to recent preventative maintenance activities. The facility originally had exterior erosion control installed and has since been removed. Pictures from the on-site observation of the recycled water impoundment can be found in Appendix A.

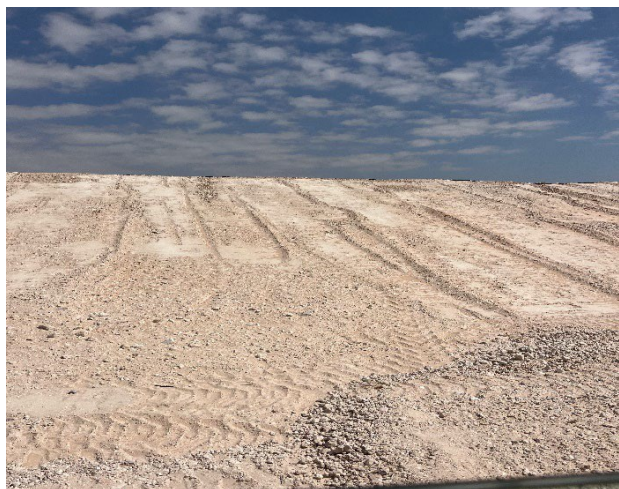
Exterior slopes after preventative maintenance

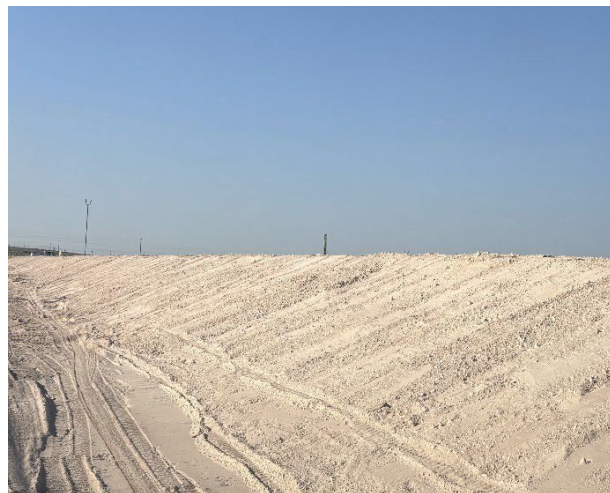
Repaired exterior slopes
