Subject: **Remedial Activities and Closure Report**
 Lime Rock Resources
 West Red Lake Water Station No.1

2 RP-1675

West Red Lake Water Station #1
Lime Rock Resources
Eddy County, New Mexico
Figure 1 - Site Plan

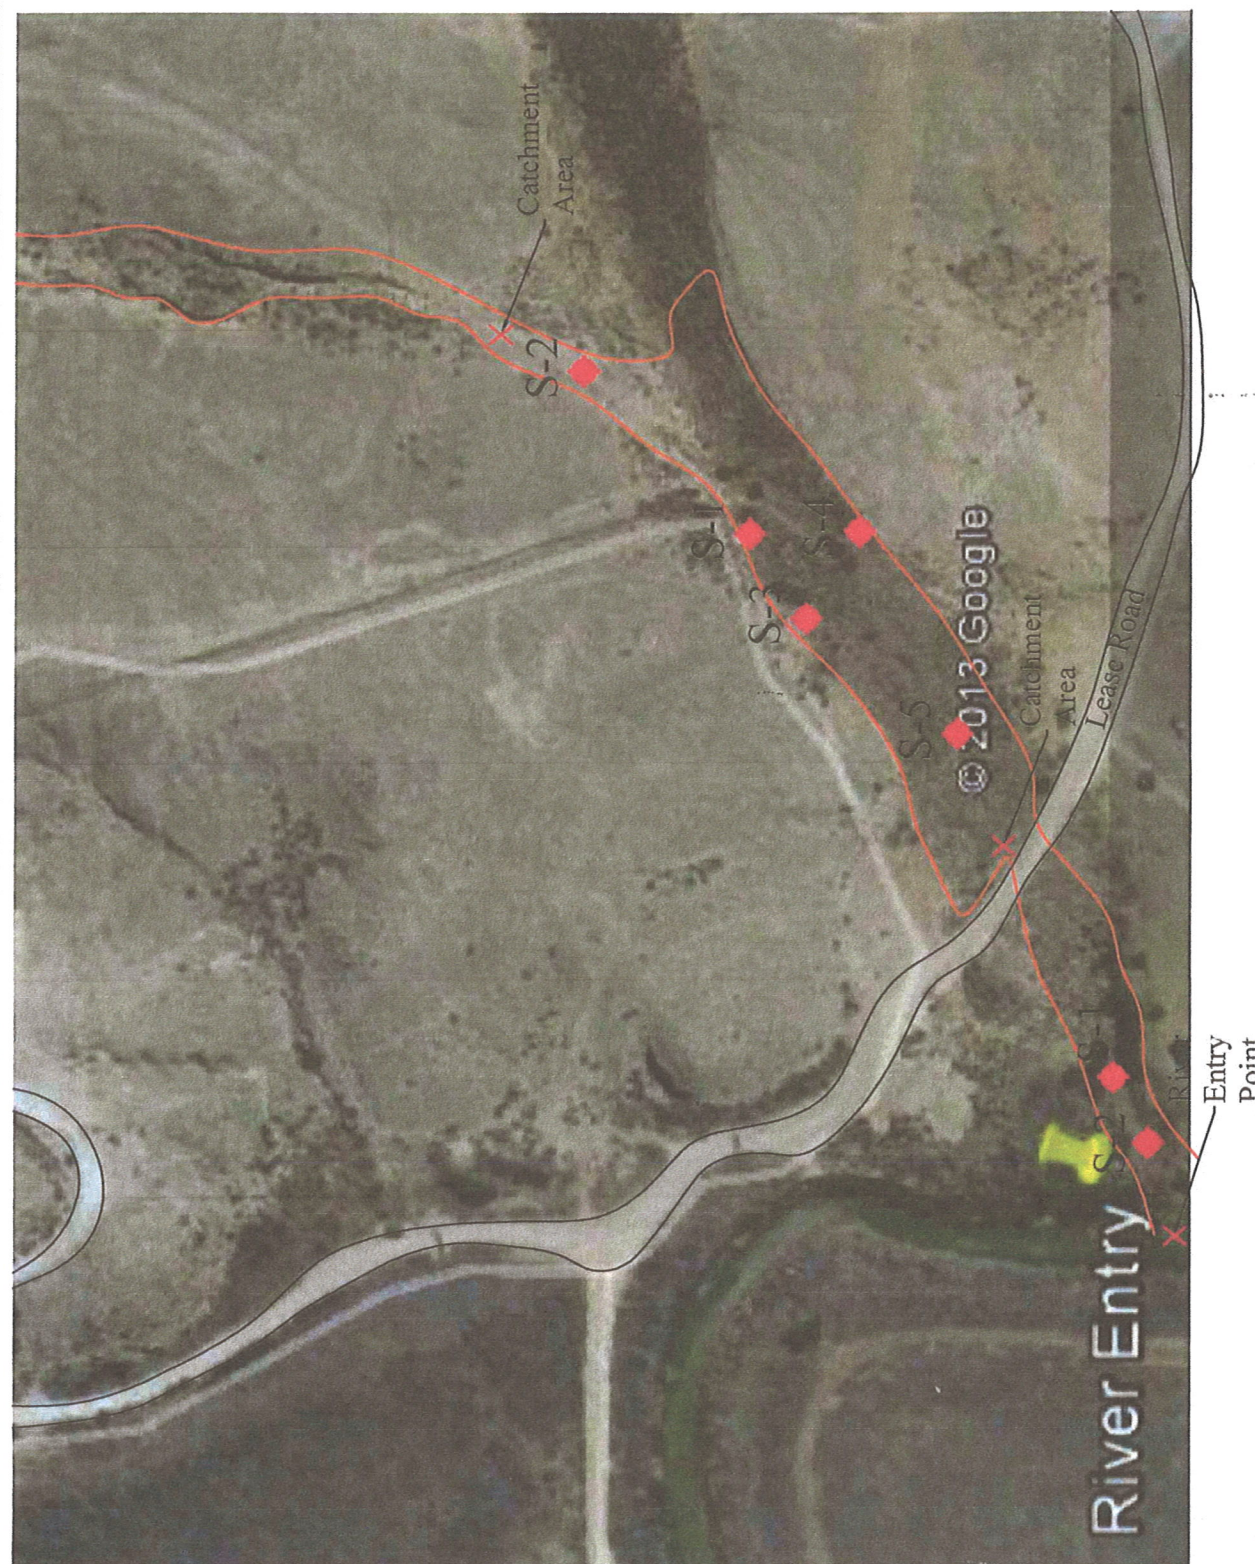
West Red Lake Water Station #1
Lime Rock Resources
Eddy County, New Mexico
Figure 1 - Site Plan

- The impacted soil in the vicinity of the tank battery (source) was initially excavated to a depth of 0.5-feet below ground surface (bgs). Grab soil samples were collected at sample locations S-3, S-4, and S-5. The lab data reported for sample location S-5 was above NMOCD Recommended Remedial Action Levels (RRAL). The impacted area was then excavated further to a depth of 1.5-feet bgs. Additional grab soil samples were taken at sample locations S-5 (1.5'), S-6 (1.5'), and S-7 (1.5') ([See site maps of sample locations](#)).

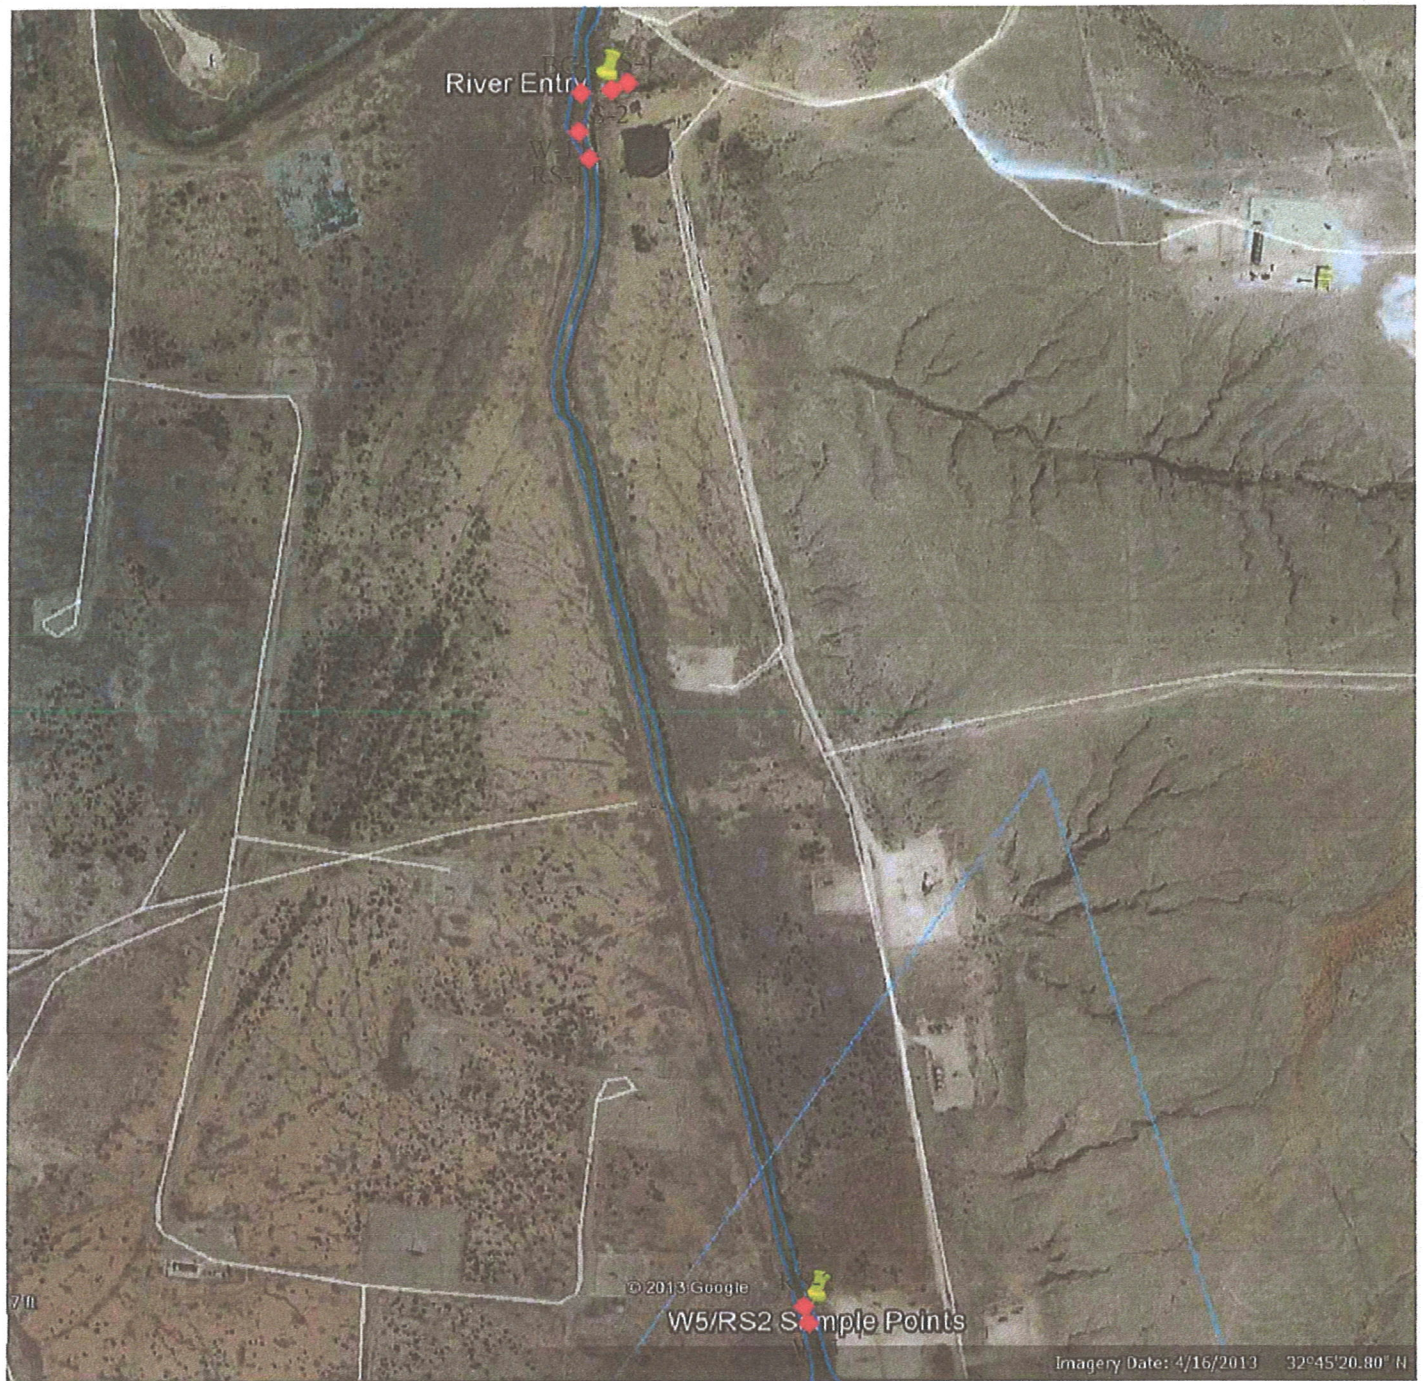
Figure 1 - Site Plan

- The lower portion of the draw was excavated to a depth of 2 to 3-feet deep within the impacted flow paths. Grab soil samples were taken at sample locations S-1 (2'), S-1 (3'), S-2 (2'), S-3 (2'), S-4 (2'), S-5 (2'), and S-5 (3').

- The impacted soil area at the river entry point was excavated to a depth of 3-feet deep. Grab soil samples were taken at sample locations S-1 (3') and S-2 (3').

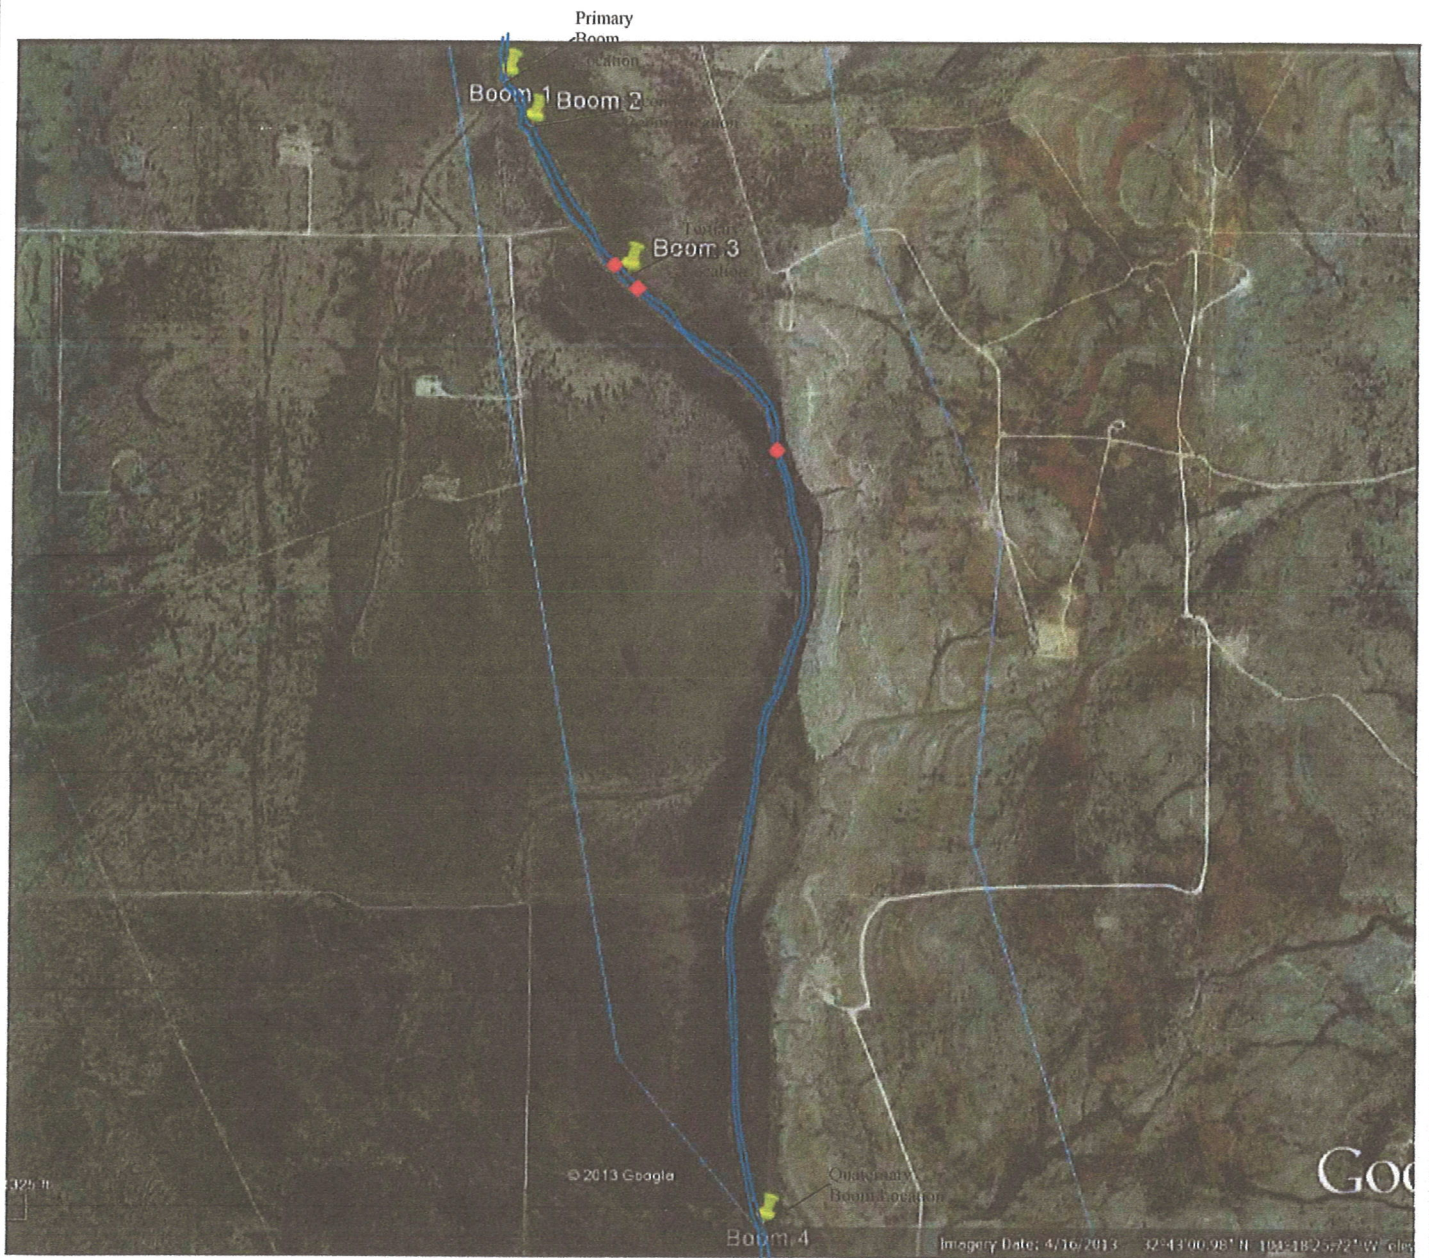
West Red Lake Water Station #1
 Lime Rock Resources
 Eddy County, New Mexico
 Figure 1 - Site Plan

- Oil sorbent booms were placed in the river to retard the flow of the free product so that the lost fluids could be recovered using oil skimmers and vacuum trucks. The booms were placed in a total of (5) locations. ([See site map of boom locations](#)).

- At the river entry point of the release, water samples were collected at W-1 and BG-1 (background, upgradient water sample). A sample of the iron sulfide material collecting in the slow-water eddys along the bottom of the river was obtained at RS-1 (river sediment samples) ([See site map of sample locations](#)).

- Additional surface water samples were taken approximately 20-feet upstream and downstream of the 4th boom location at sample locations W-2 and W-3. A water sample was also obtained approximately 1/2 mile downstream of the 4th boom location at sample location W-4. ([See site map of sample locations](#)).

- Approximately 0.7 miles downstream from the entry point of the release, surface water and river sediment samples were taken in a deep area of the river. These sample points are identified as RS-2 and W-5. ([See site map of sample locations](#)).
