Incident ID	nAPP2211527047
District RP	
Facility ID	
Application ID

Release Notification

Site Name: Dagger Lake Zeus Pond	Site Type: Produced Water Recycle
Date Release Discovered: 4-9-22	API# (if applicable)

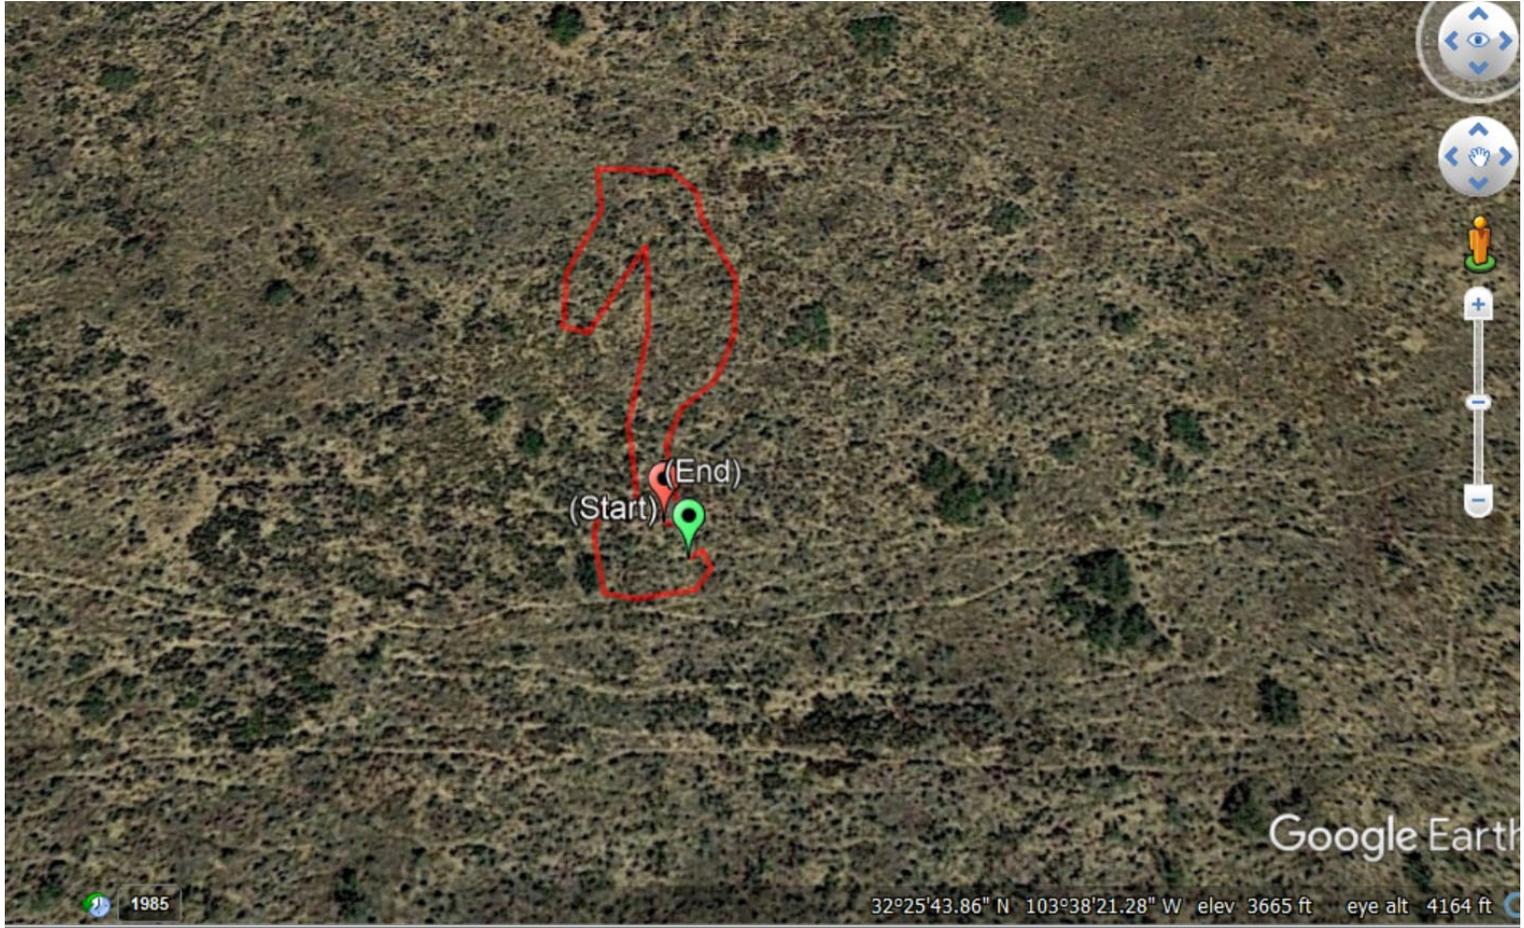
Cause of Release: Layflat hose was being pigged backed to brackish water pond after frac and was open ended at the pond. It was secured to a pump but was removed from the anchor point and left free. The line then shifted and put the effluent water to the ground.

Area	Shape	Length in feet	Width in feet	Diameter (for circular)	Standing Depth in inches	Depth in Soil in inches	Standing Volume	In Soil Volume	Total Volume
1	Rectangle	730.00	10.00		0.000	0.625	0.00	10.16	10.16
