Re: Status Report – 4th Quarter 2020
San Juan 28-7 Unit 183M
Rio Arriba County, New Mexico
OCD Incident No. NCS1901627746

On behalf of Hilcorp Energy Company (Hilcorp), Timberwolf Environmental, LLC (Timberwolf) presents this report to document remedial activities conducted during the fourth quarter of 2020 (4Q20) at the San Juan 28-7 Unit 183M (Site). Due to multiple SVE system vacuum pump failures during 3Q20 and 4Q20 limited remediation activities were conducted during 4Q20.

Timberwolf Project No. HEC-190007

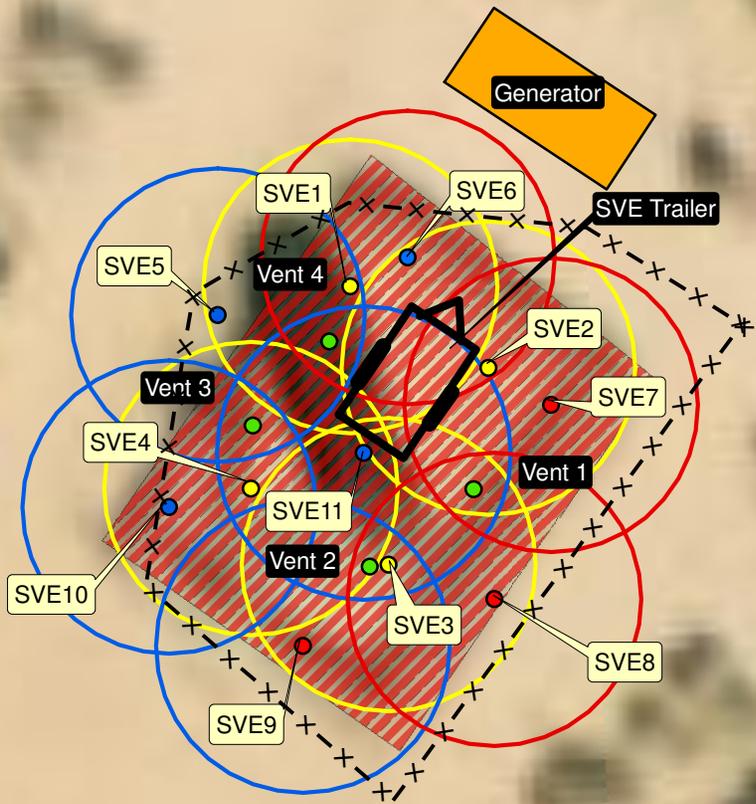
Figure 4
SVE System Overview

The SVE system creates a treatment field of approximately 0.15 acres and treats soil to a depth of approximately 30 ft bgs for a total volume of approximately 7,021 cubic yards of soil. The SVE wells, measured radius of influence of 25 ft, and leg configurations are shown in Figure 4.

Treatment Area= 6,320 ft²
Assuming a 25 ft radius of influence
