LINER INSPECTION AND CLOSURE REPORT **REPORTABLE RELEASE**

Spur Energy Partners
Tarpan 33 Fee #4H
Incident ID: NAPP2129837754
API #30-015-41662
Eddy County, NM

Paragon Environmental LLC
1601 N. TURNER ST. STE.500
Hobbs, NM 88240
575-964-7814

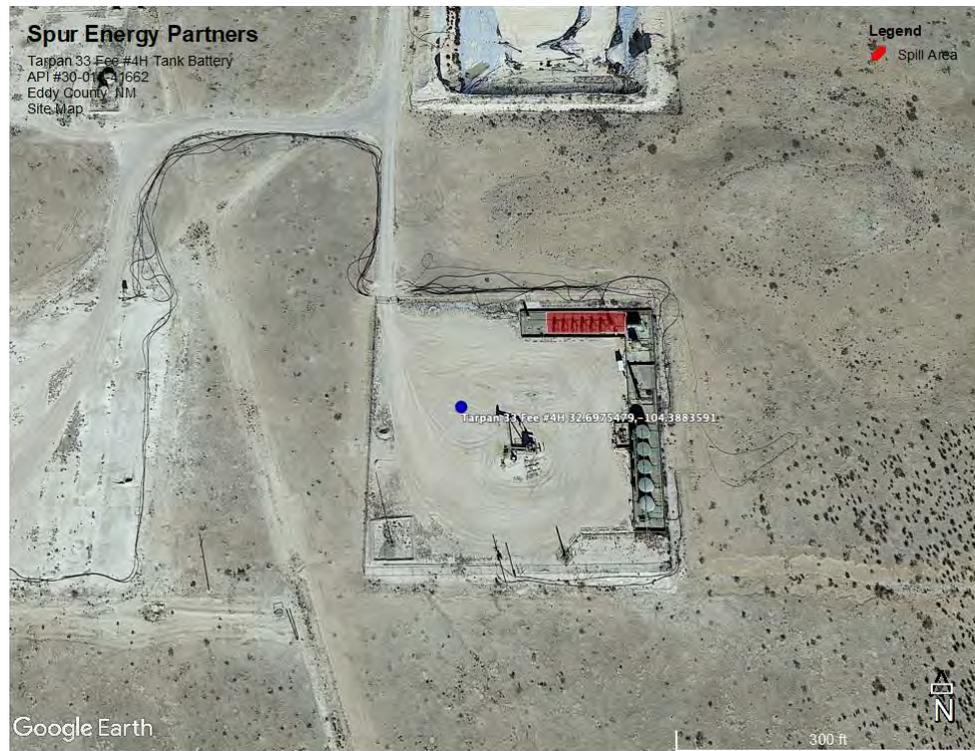
On July 13, 2022, Paragon went to the Tarpan and conducted an initial assessment. There was obvious staining on the liner from the spill. There were no signs outside the containment showing no signs that the liner had been breached. Therefore, no samples were taken. See the site map below showing the affected area.

On July 20, 2022, Paragon returned to the site with equipment and personnel to conduct cleanup activities. We initially sprayed the affected area with surface cleaner. We then power washed and squeegeed the runoff to where the vacuum truck could capture the fluids.

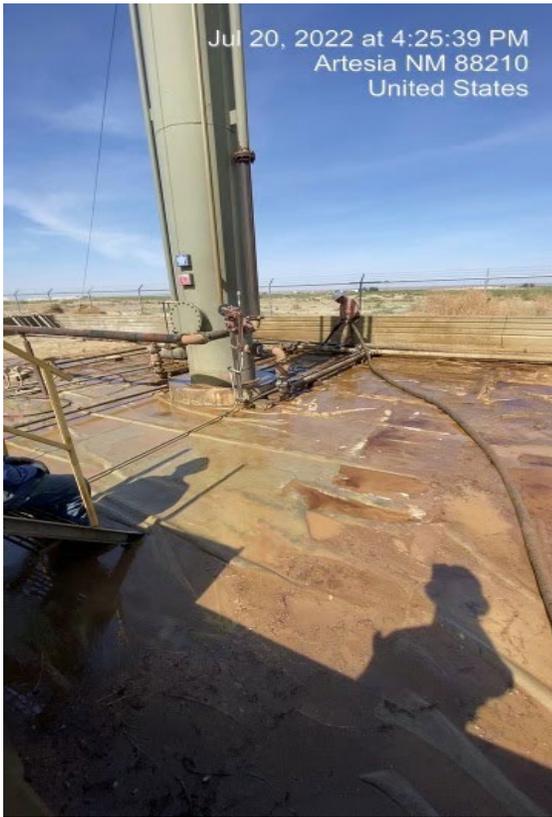
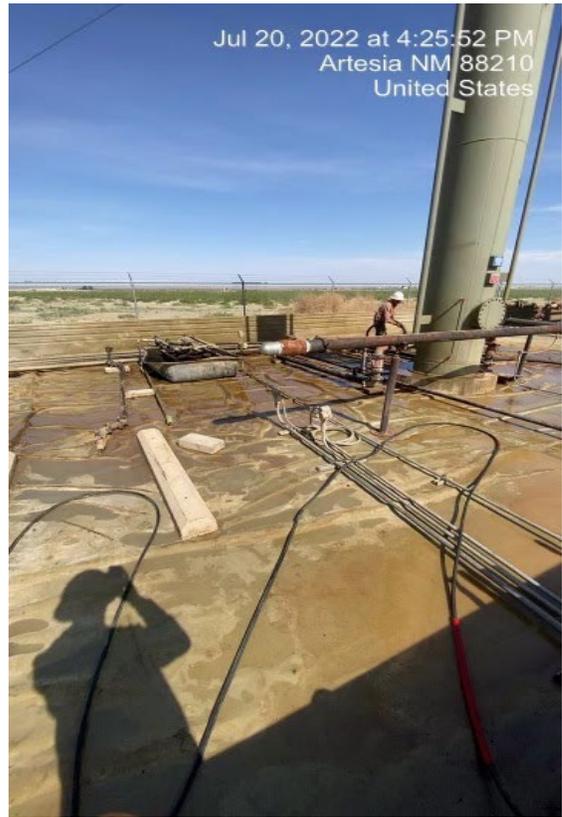
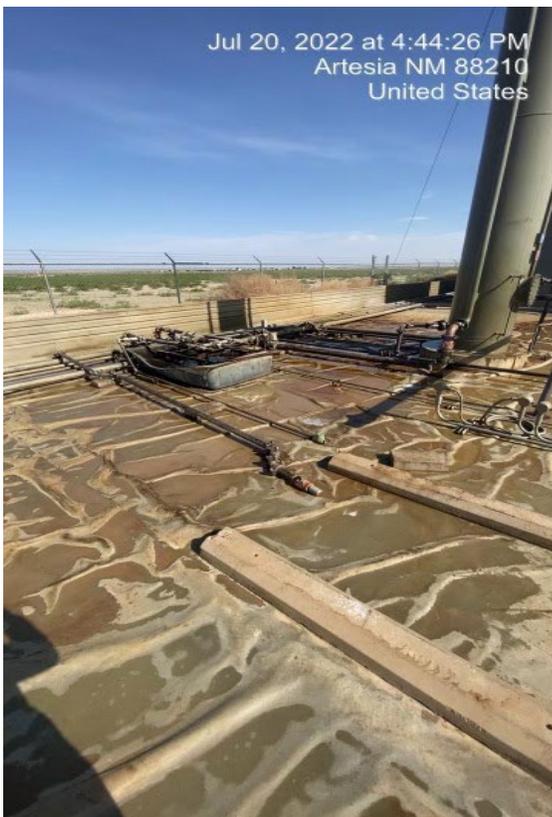
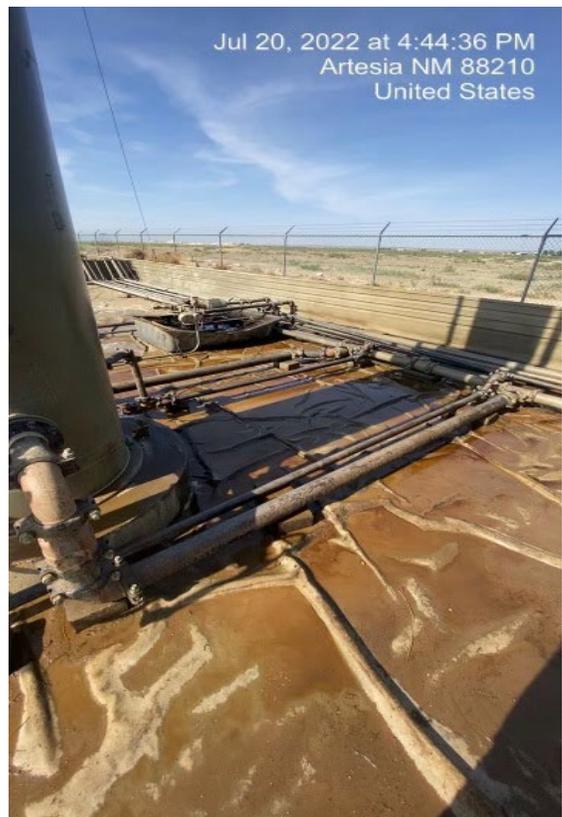
Completed

On August 3, 2022, Paragon returned to the site to conduct a liner inspection. A 48-hour notification was sent out to the NMOCD on August 6, 2022. The liner inspection concluded that the liner was all intact and in good condition. The integrity of the liner appears to have the ability to contain spills. See Appendix D for the email notification and liner report.
