Remediation and Closure Report

Cotton Draw Unit #122H
Eddy County, NM
API# 30-015-38453
2RP-4169

Subject: **Remediation and Closure Request**
Cotton Draw Unit #122H
API# 30-015-38453
2RP-4169

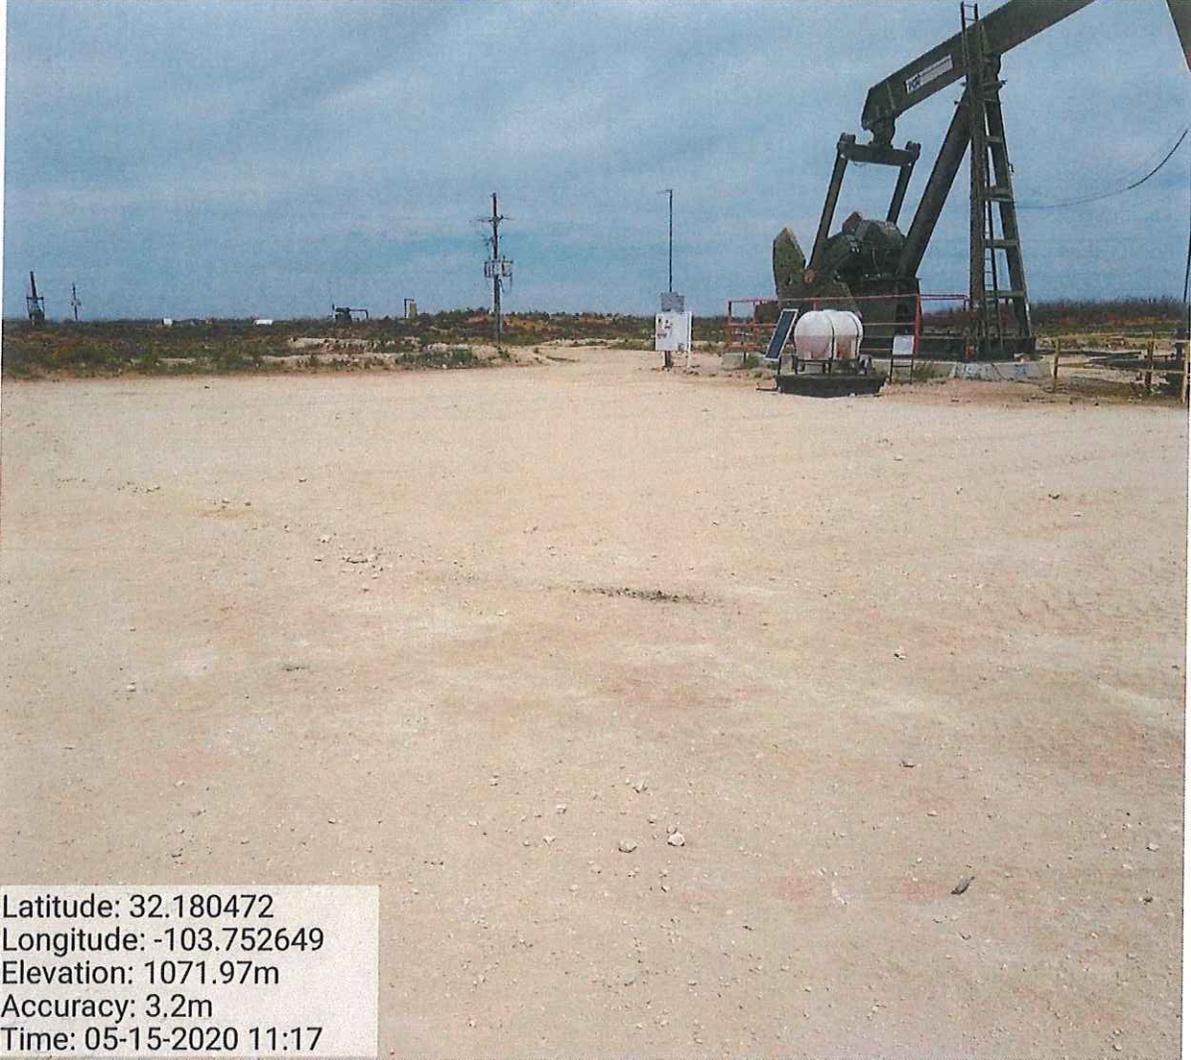
Completed

- The impacted soil in the vicinity of S-1 was excavated to a depth of 2-feet deep. Sidewall samples were collected and the results were below closure criteria
- The impacted soil in the vicinity of S-2 was managed as follows: The material from 0-2.5-feet BGS was excavated and stockpiled. The impacted material from 2.5-6-feet was excavated and transported to disposal. The stockpiled material and sidewalls were sampled, and results were below closure criteria. The stockpiled material was used as part of the backfill material.
- The impacted area in the vicinity of S-3 was excavated to a depth of 1-foot BGS. Sidewall sample results were below the closure criteria.
- The excavated soil was transported to Lea Land, LLC, a NMOCD approved soil waste disposal facility.
- The excavated area was backfilled with clean caliche, machine compacted, and contoured to match the surrounding location.
