April 29, 2020

Subject: Liner Inspection and Closure Report

Cotton Draw Unit #252H Lea County, New Mexico

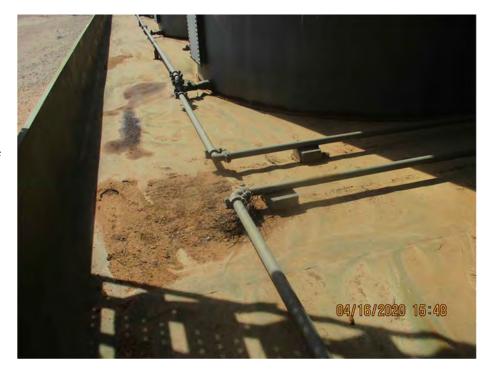
View of the liner on the southern side of the tanks. Staining visible on the liner. Rust visible on the base of the tanks.

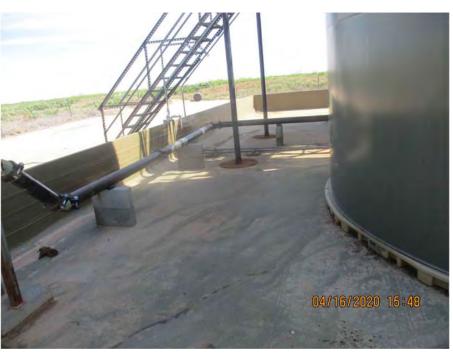
View of the liner on the west side of the containment. Facing south. Rust visible on the base of stair supports.

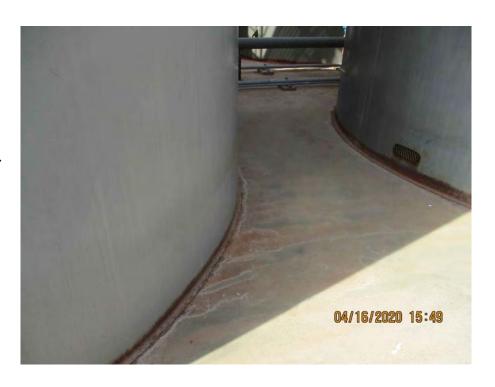
View between tanks.
Visible rust on the base of the tank.
Staining visible on the liner.

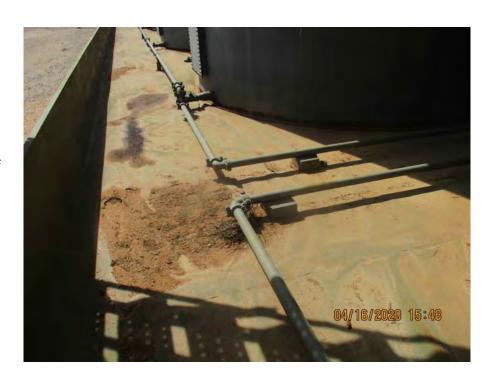
View of the liner on the southern side of the tanks. Visible rust on the base of the tank. Staining visible on the liner.

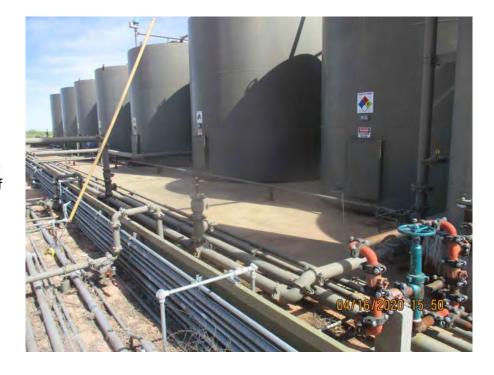
View of the liner on the northern side of the tanks.
