November 17, 2020

Vertex Project #: 20E-00141-064

**Spill Closure Report:** Rio Blanco 33 Fed 1  
Unit N, Section 33, Township 22 South, Range 34 East  
County: Lea  
Incident Tracking Number: NJXK1619637333

**Prepared For:** Devon Energy Production Company  
6488 Seven Rivers Highway  
Artesia, New Mexico 88210

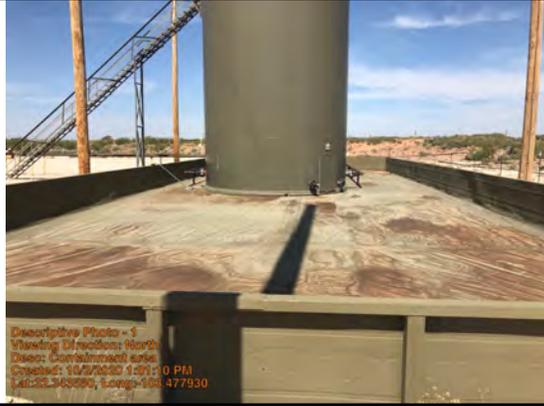
Descriptive Photo - 1  
Viewing Direction: North  
Desc: Containment area  
Created: 10/2/2020 1:01:10 PM  
Lat:32.343884, Long:-103.477895

Containment area

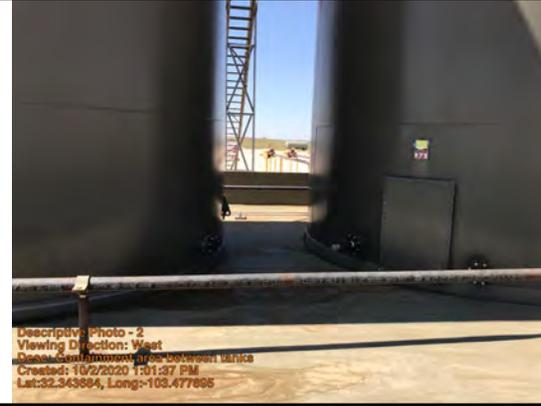
Descriptive Photo - 2  
Viewing Direction: West  
Desc: Containment area between tanks  
Created: 10/2/2020 1:01:37 PM  
Lat:32.343884, Long:-103.477895

Containment area between tanks
