Release Notification

Satchmo Com #1

Site Characterization and Remediation Plan

30-045-34429

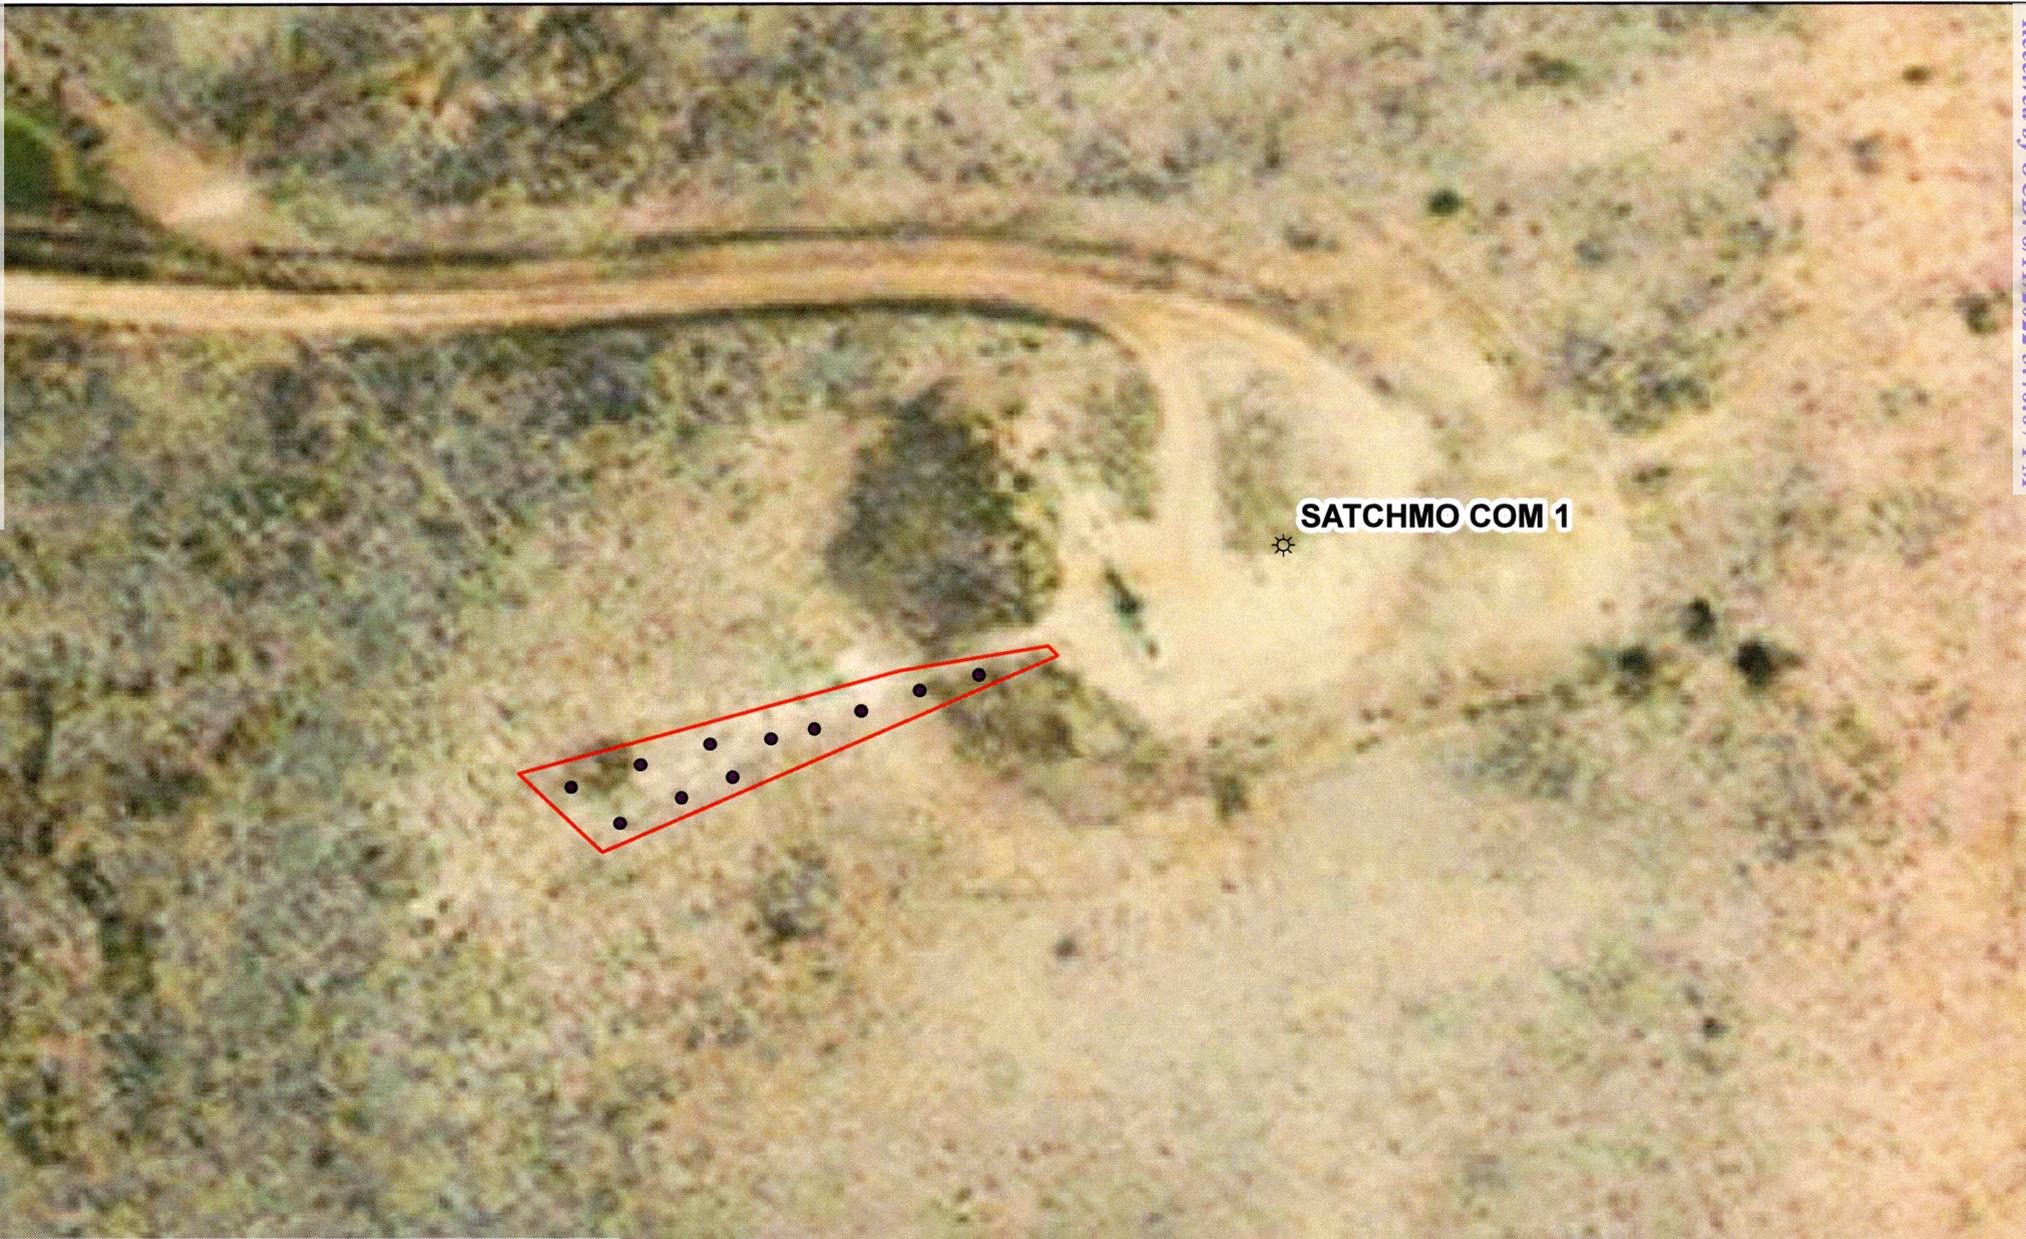
In this case Dugan requests permission to sample every 500 square feet with 5 point composite samples. The spill is approximately 4500 square feet. We propose gathering 9 samples. A map is included showing the proposed locations.
