**RE:** Liner Inspection and Closure Report

Fiji 17 CTB 1 API No. N/A

NMOCD Reference No. NAPP2305351774

### Fiji 17 CTB 1 Liner Inspection NAPP2305351774

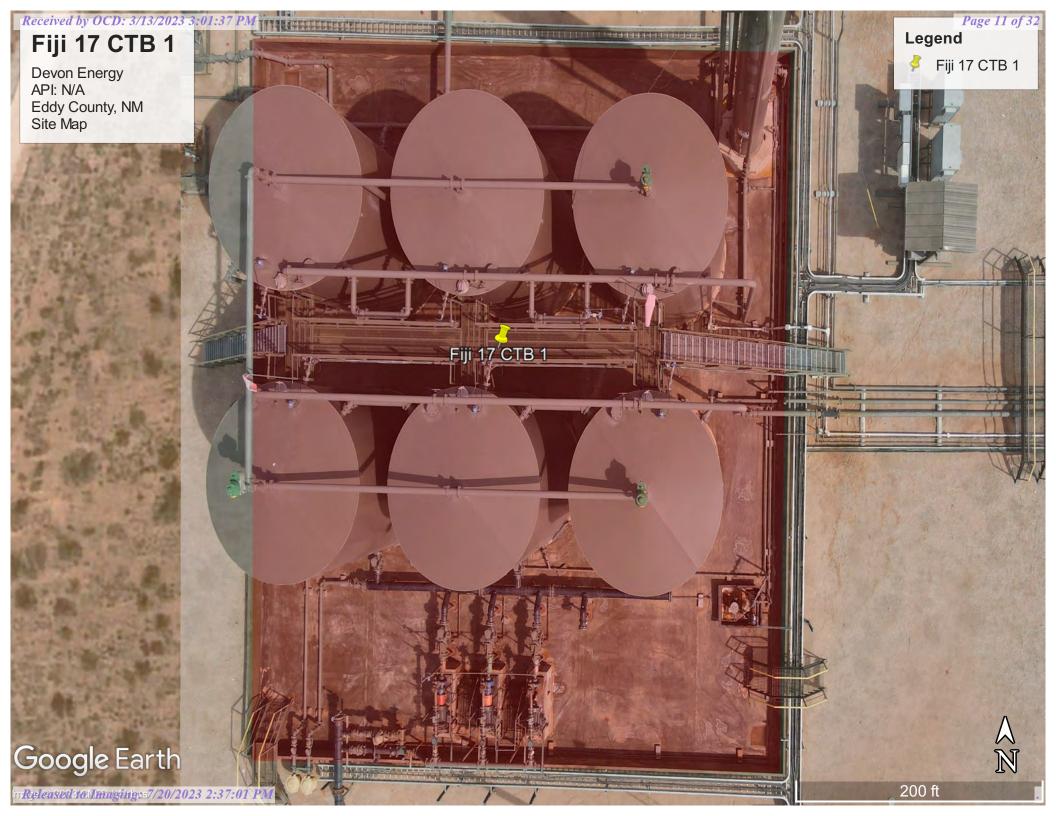
4-Site Map

A Site Map can be found in Figure 4.

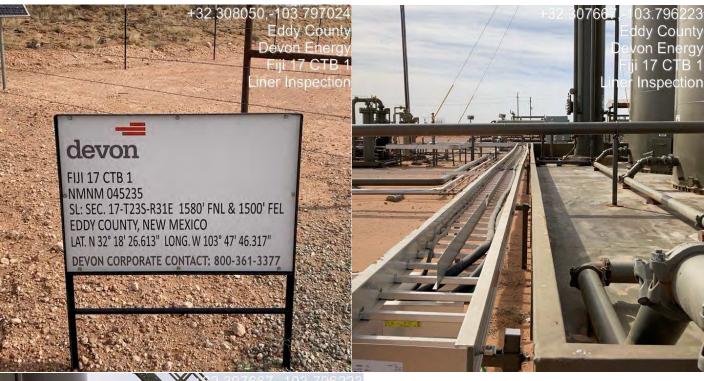
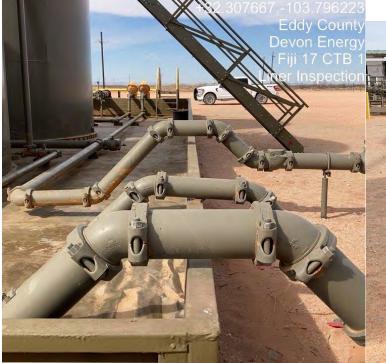
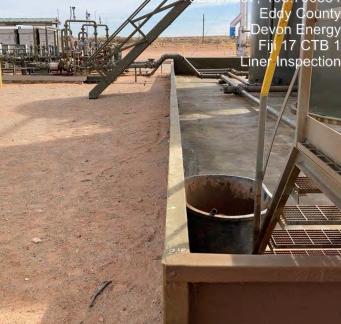
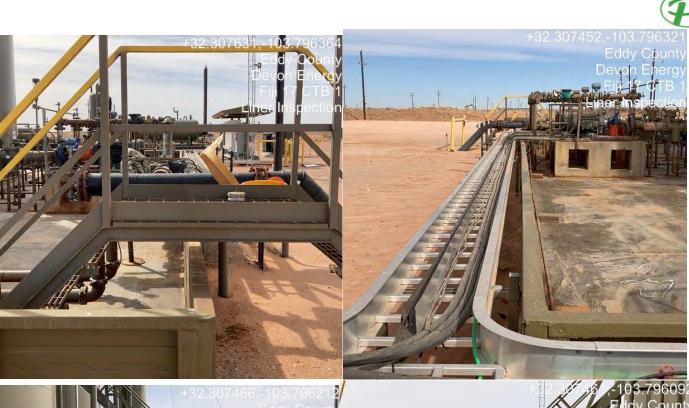
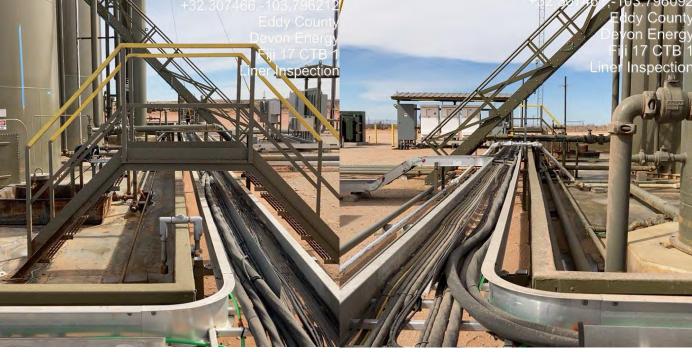
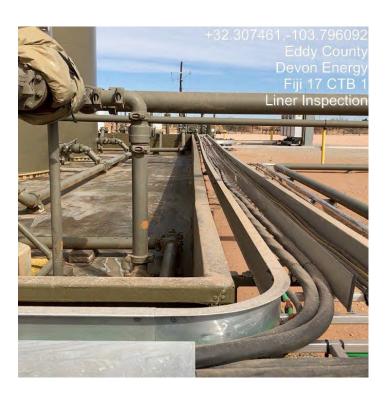
#### **Liner Inspection**

On March 2, 2023, after sending the 48-hour notification email, Pima Environmental conducted a liner inspection at this location. We concluded that this liner and containment maintained its integrity and was able to retain the fluids. The Liner Inspection Form and Photographic Documentation can be found in Appendix C.
