**RE: Liner Inspection and Closure Report**  
**Kool Aid State Tank Battery**  
**API No. N/A**  
**GPS: Latitude 32.82520 Longitude -104.12910**  
**UL- B, Section 24, Township 17S, Range 28E**  
**NMOCD Reference No. NAPP2304837015**

# Kool Aid State Tank Battery

**SITE PHOTOGRAPHS  
SPUR ENERGY PARTNERS  
KOOL AID STATE TANK BATTERY**

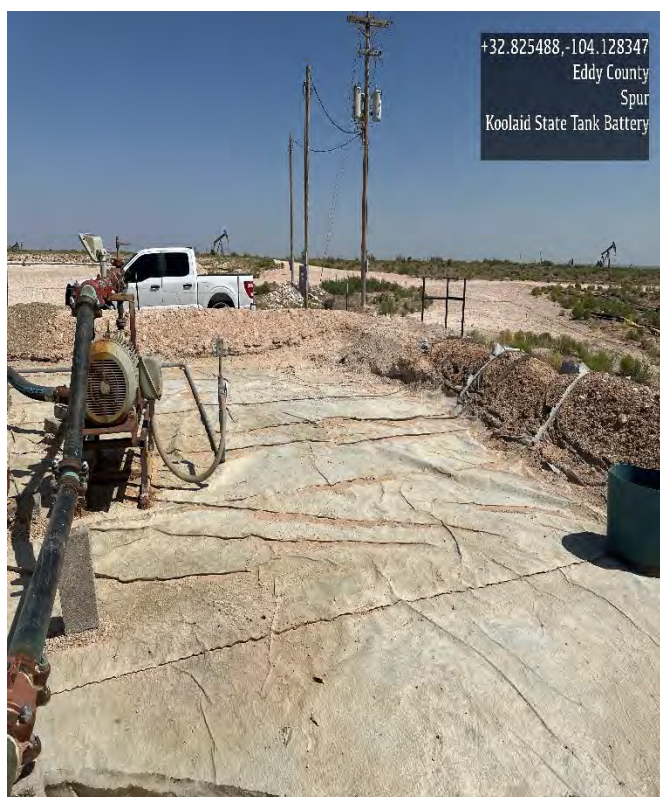
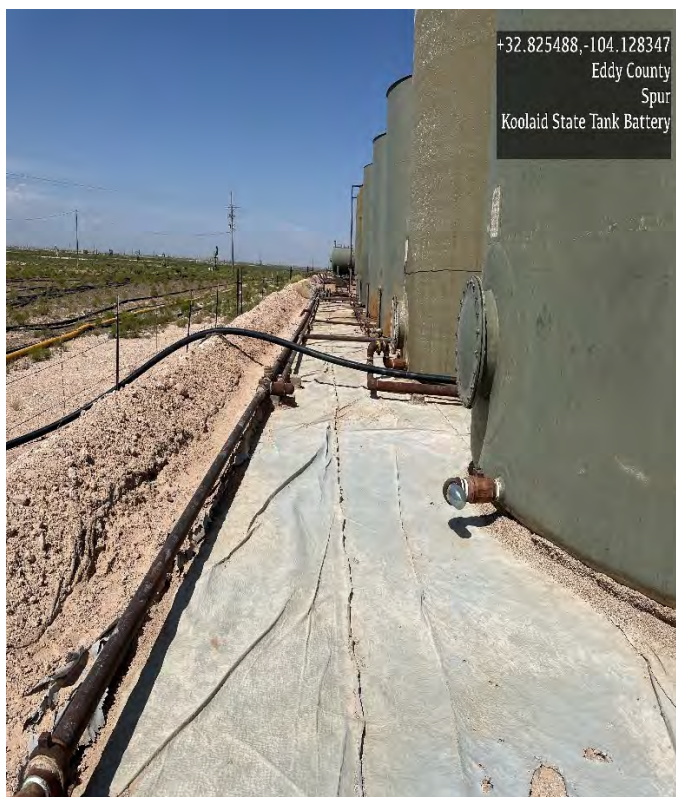
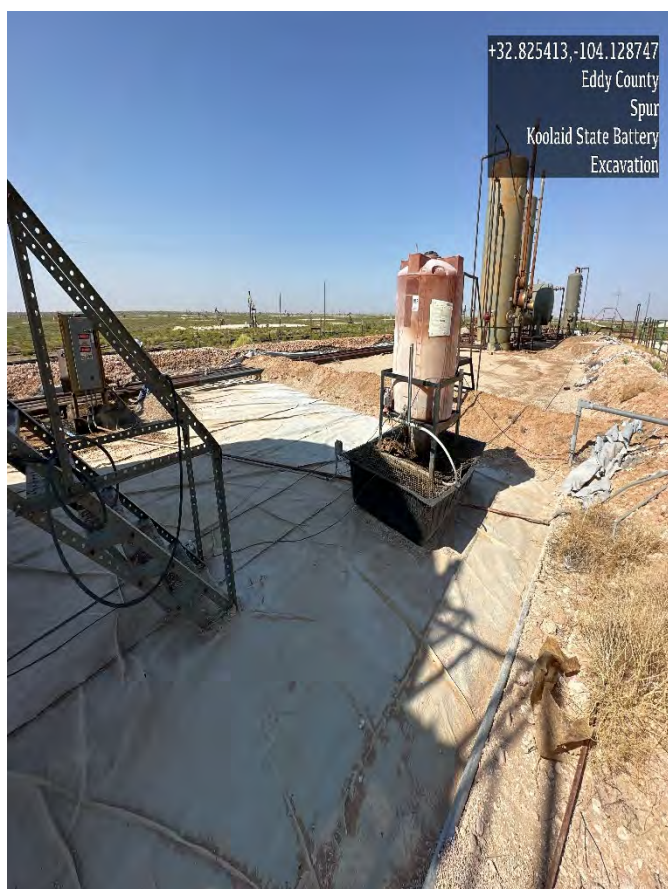
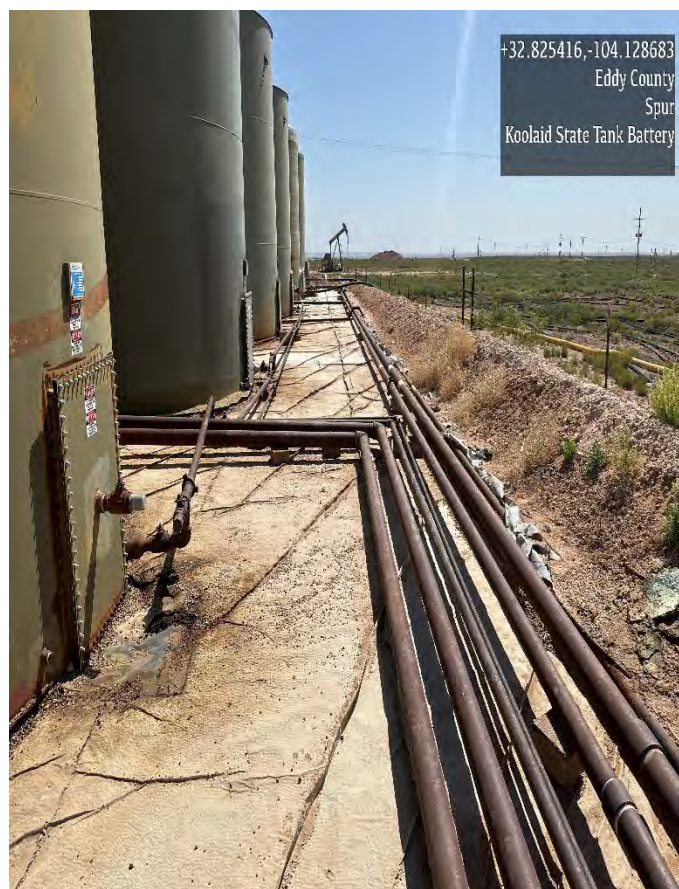
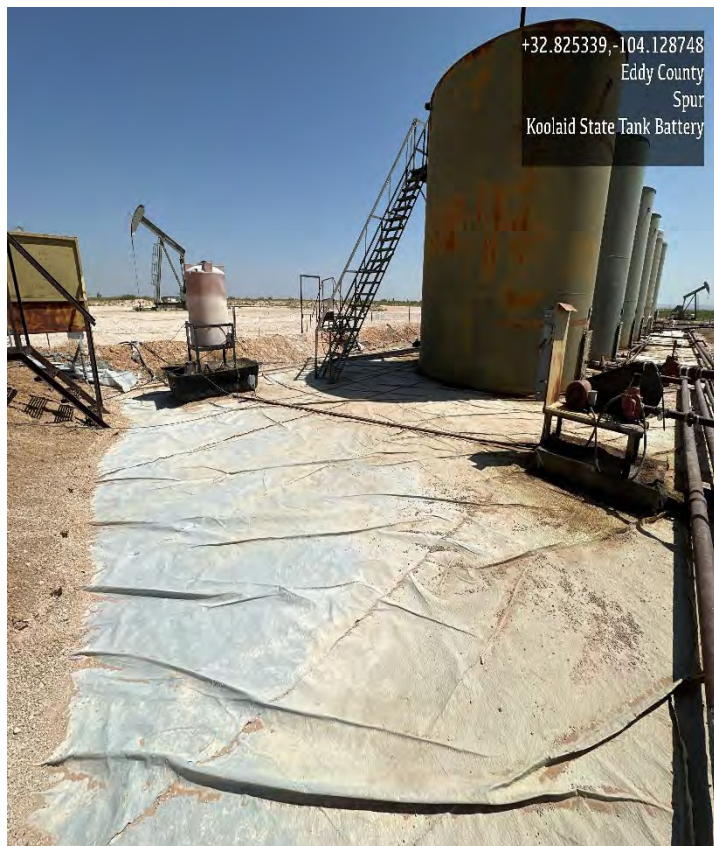
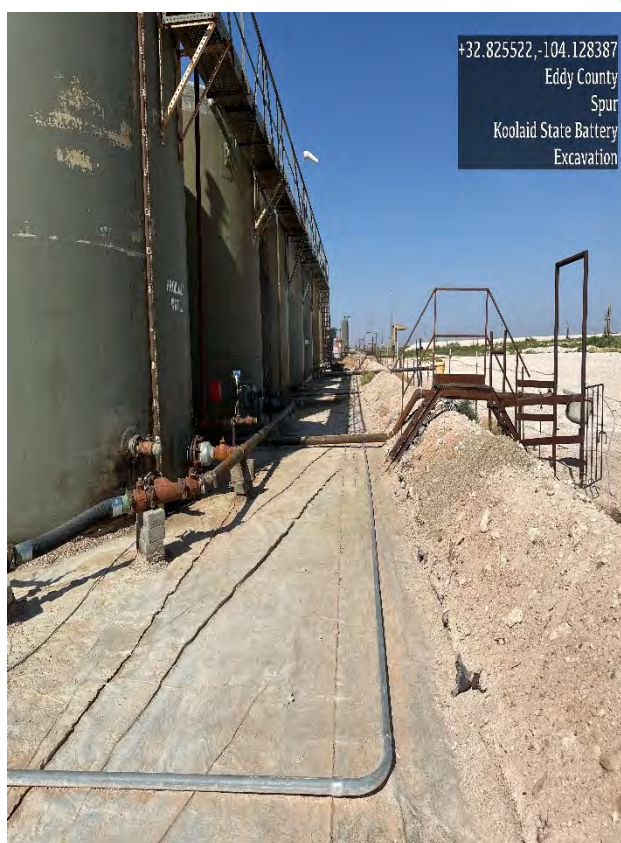
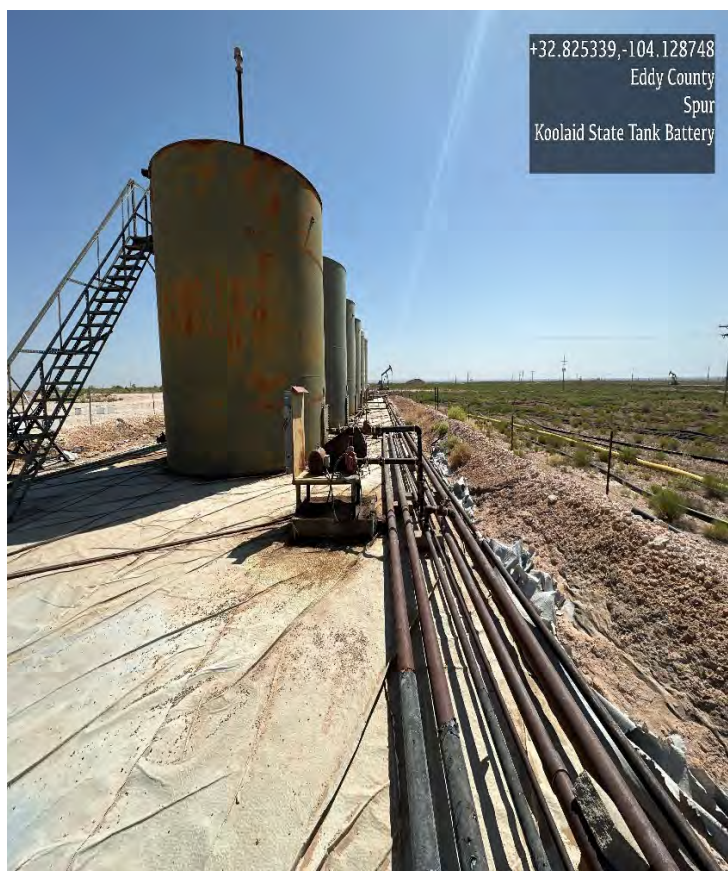
Graver Removal and Liner Inspection (8/9/2023)

On August 9, 2023, after sending the 48-hour notification via email, Pima Environmental conducted a liner inspection at this location. We concluded that this liner and containment maintained its integrity and was able to retain the fluids. The liner inspection form and photographic documentation can be found in Appendix C.
