March 20, 2024

RE: Liner Inspection and Closure Report

Rio Blanco 4 33 Fed Com 1H

NMOCD Reference No. NCH1836147495

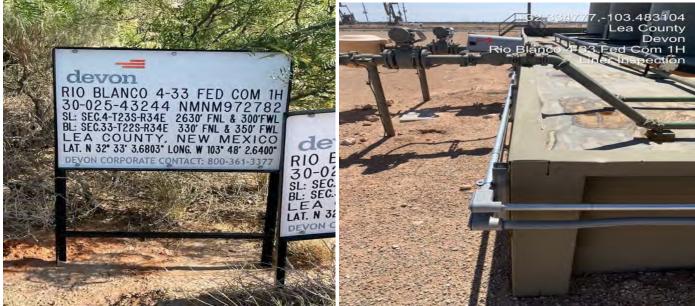
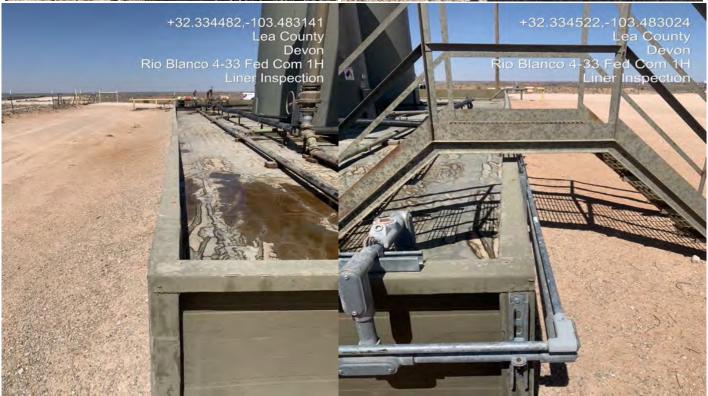
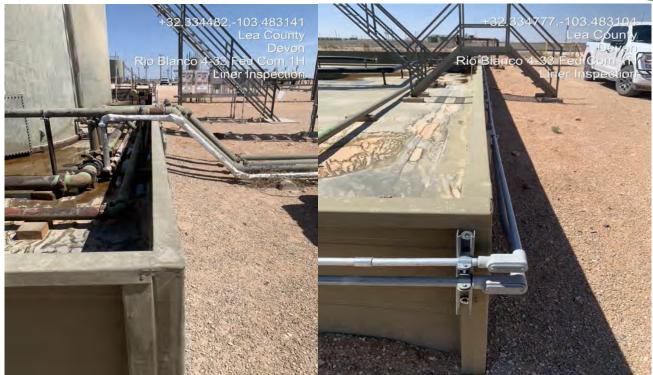
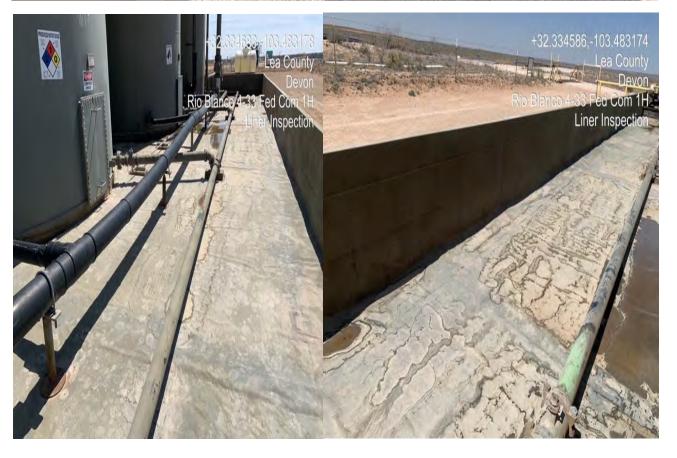
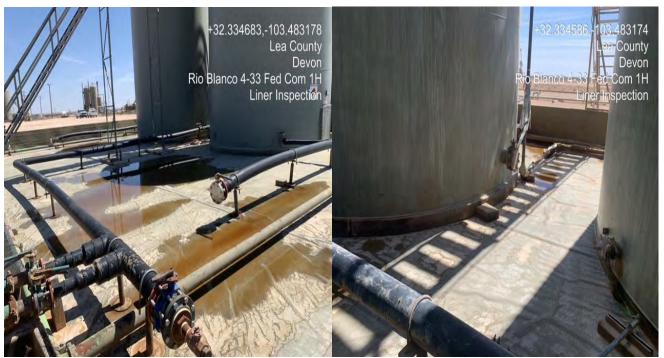
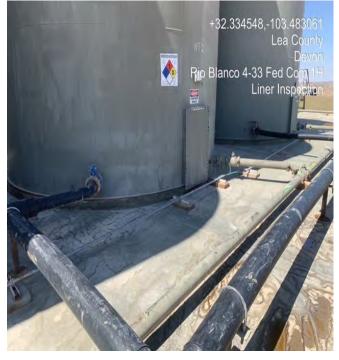
LINER INSPECTION

On March 15, 2024, after submitting the 48-hour notification application ID:322695 to the OCD, Pima Environmental conducted a liner inspection at this location. Pima concluded that this liner and containment maintained its integrity and was able to retain the fluids. The liner inspection form and photographic documentation can be found in Appendix C.

• The Liner inspection photographs have been retaken displaying the secondary containment liner integrity.

• The new Liner Inspection photographs include photo documentation inside the containment where surface equipment is inside the secondary containment.
