Re: Updated Remediation Work Plan

Moore LS 6B
Incident Number: nAPP2206056316
San Juan County, New Mexico
Hilcorp Energy Company

Ensolum, LLC (Ensolum), on behalf of Hilcorp Energy Company (Hilcorp), presents this *Updated Remediation Work Plan* for the Moore LS 6B natural gas production well (Site). The Site is located on private land in Section 25, Township 32 North, Range 12 West in San Juan County, New Mexico (Figure 1).

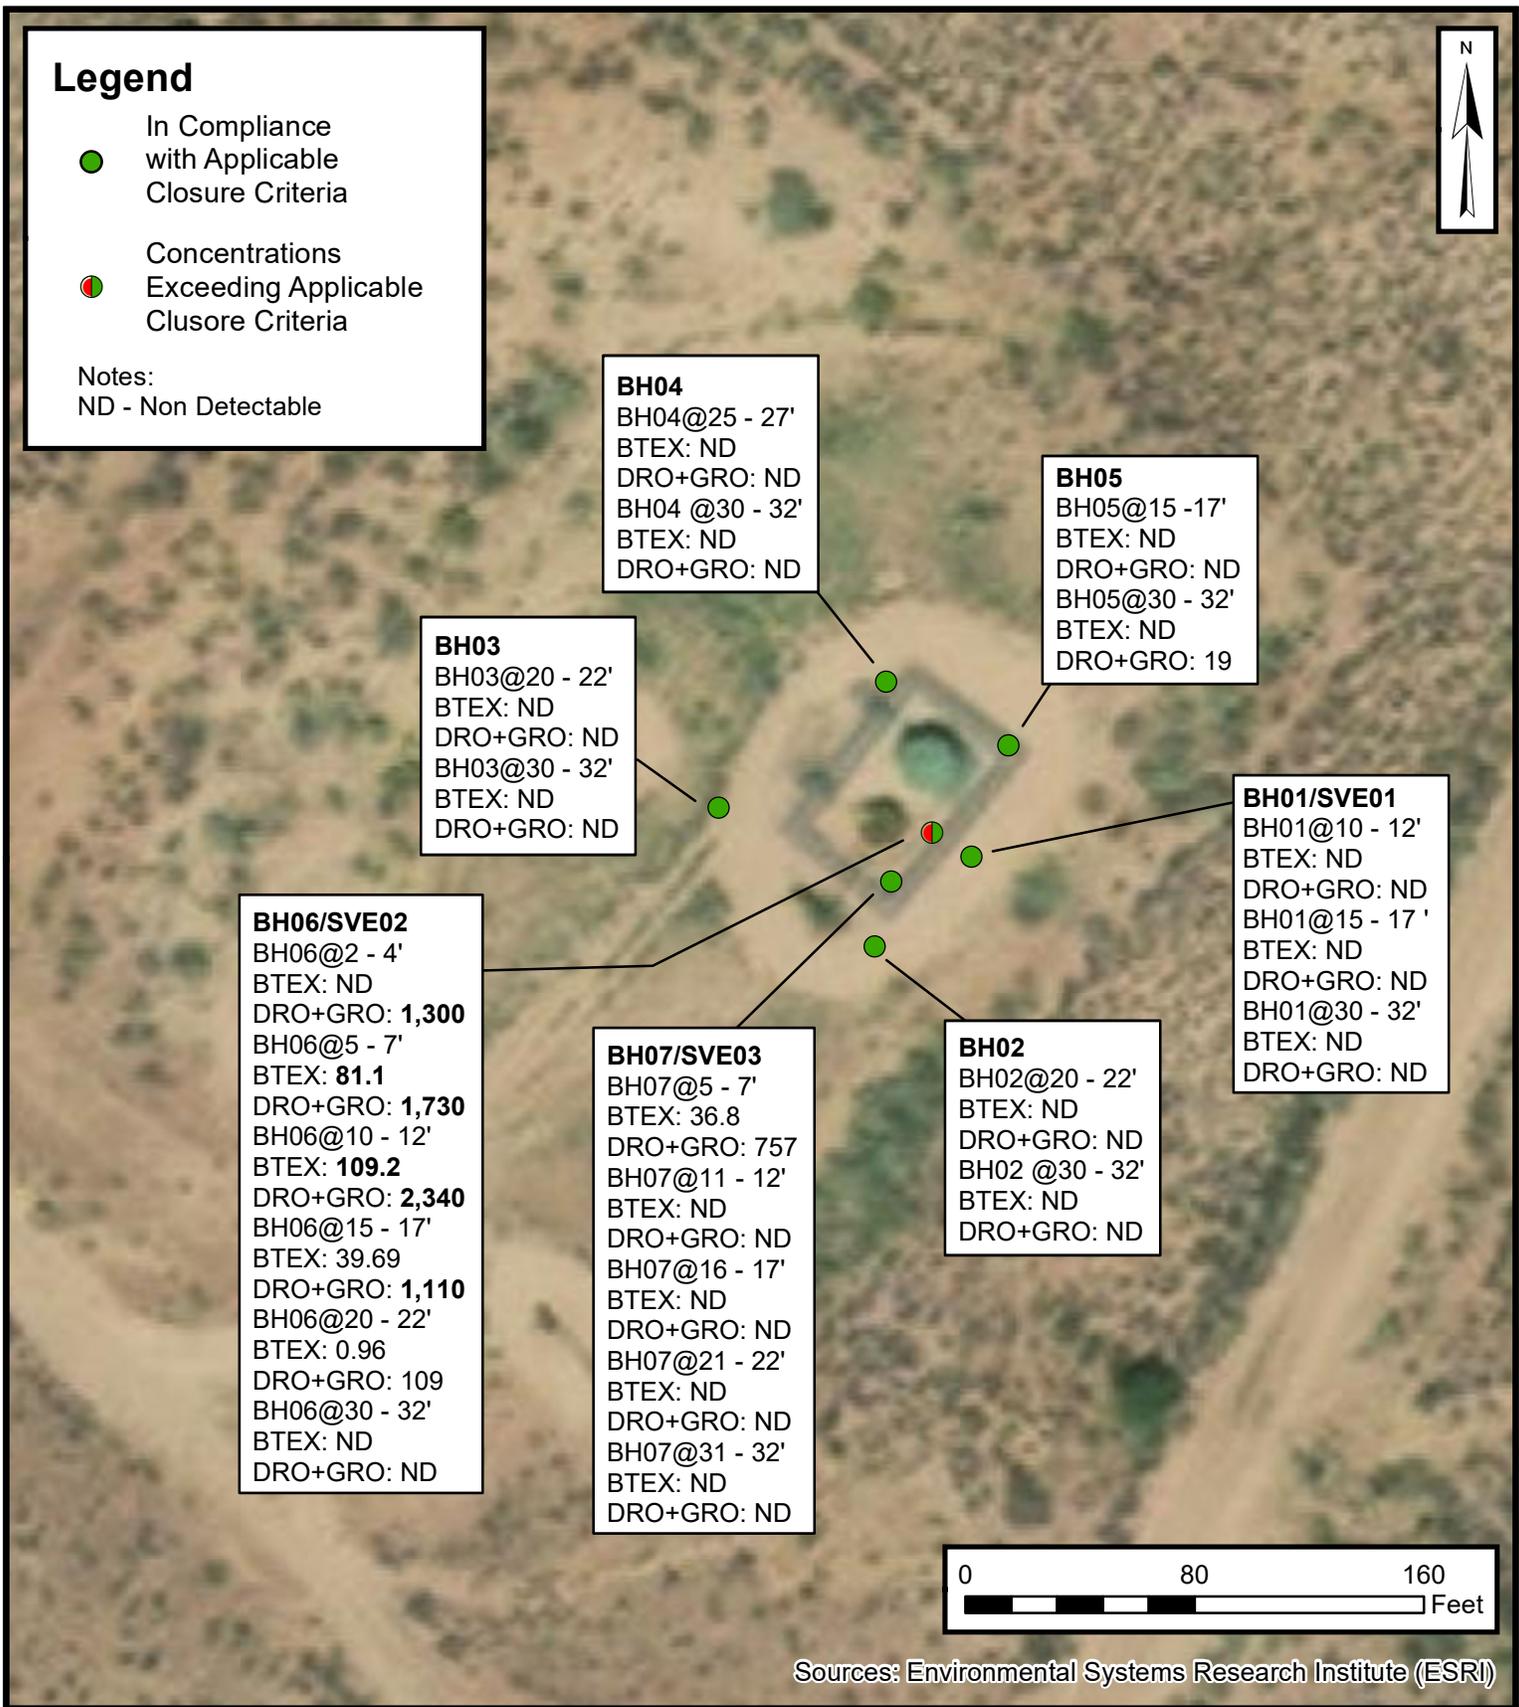
FIGURE
2

On February 14, 2022, Hilcorp discovered two bullet holes in the 268-barrel (bbl) condensate aboveground storage tank located within a bermed secondary containment at the Site (Figure 2). Based on tank-gauging data and the volume of fluid remaining in the tank, approximately 42 bbls of condensate were released from the tank and remained within the limits of the earthen secondary containment berm on the production pad. No fluids were recovered from the release. The initial footprint of visibly impacted soil was approximately 40 feet by 25 feet in lateral extent. Hilcorp provided verbal notification to the New Mexico Oil Conservation Division (NMOCD) on February 15, 2022, and submitted the initial C-141 on March 1, 2022.

Rather than pursue an enhanced SVE design, Hilcorp proposes to excavate impacted soil to below the established Table I Closure Criteria. Based on the delineation soil sample analytical results (presented on Figure 2) and the area of the release extent, an estimated 500 cubic yards of impacted soil will be excavated from the well pad and transported for disposal at a permitted landfarm. Once field screening results indicate impacted soil has been removed, confirmation samples will be collected at least every 200 square feet from the floor and sidewalls of the excavation. The samples will be analyzed for TPH and BTEX only since delineation soil sample results excluded chloride as a contaminant of concern. Once sampling results indicate that concentrations of TPH and BTEX are in compliance with Table I Closure Criteria, a closure report will be submitted to NMOCD requesting site closure. Hilcorp will complete the Site excavation, confirmation soil sampling, and preparation of a Closure Report within 90 days of NMOCD approval of this *Updated Remediation Work Plan*.
