Pima Environmental Services 5614 N. Lovington Highway Hobbs, NM 88240 575-964-7740

Re: Liner Inspection, Site Assessment and Closure Report

Shetland 11 CTB 1 API No. N/A

NMOCD Ref. No. NAPP2320752842

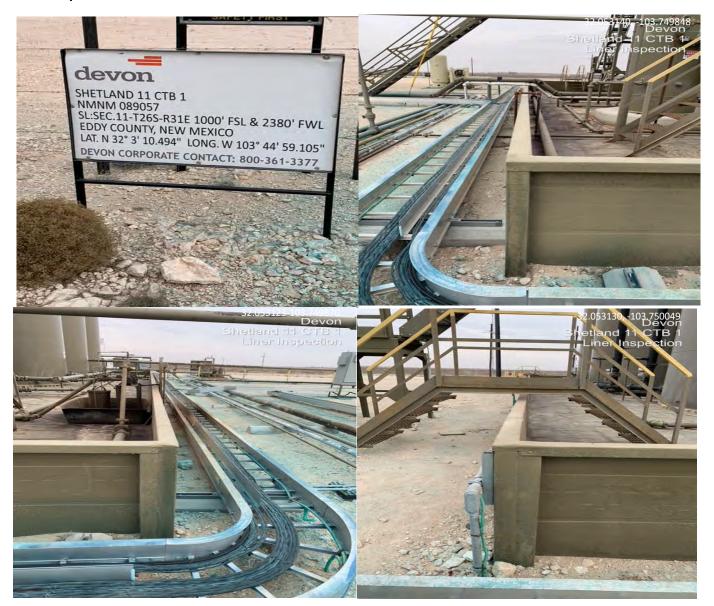
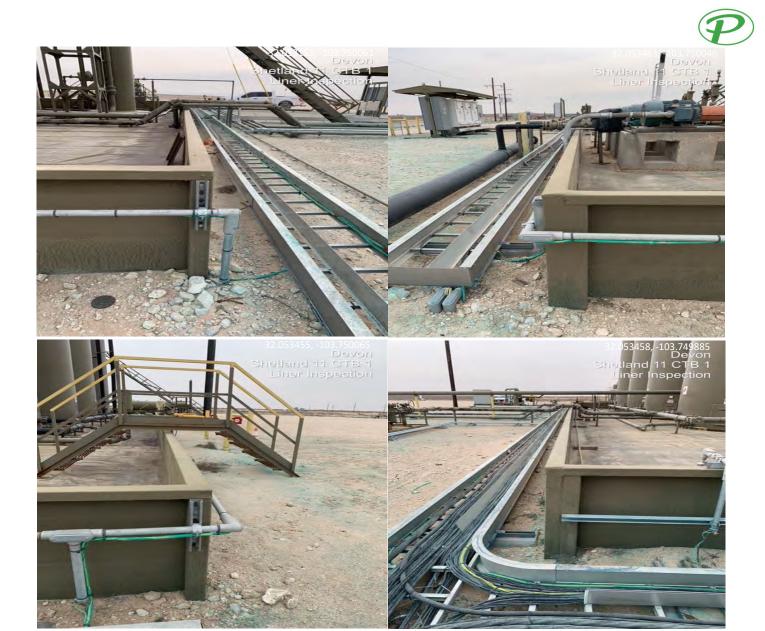
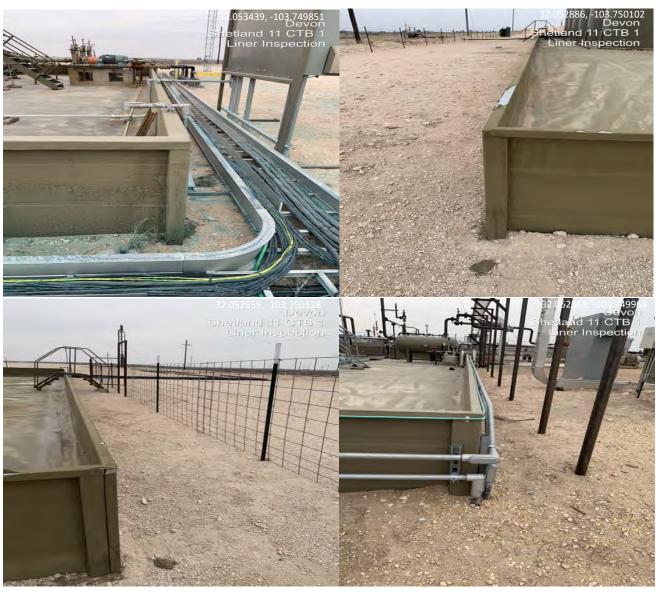
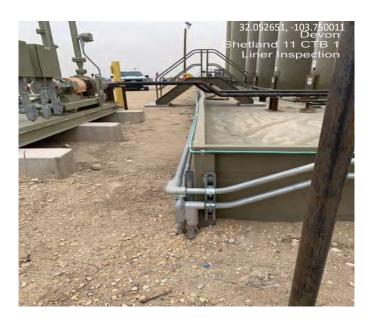
On February 29, 2024, after submitting the 48-hour notification application ID:318178 to the OCD, Pima Environmental conducted a liner inspection at this location. We concluded that this liner and containment maintained its integrity and was able to retain the fluids. The liner inspection form and photographic documentation can be found in Appendix C.
