**RE: Liner Inspection and Closure Report**  
**Clydesdale 1 Fee 1 Battery**  
**API No. N/A**  
**GPS: Latitude 32.69619 Longitude -104.430336**  
**UL- A, Section 01, Township 19S, Range 25E**  
**Eddy County, NM**  
**NMOCD Reference No. NAPP2221627025**

Spur Energy Partners (Spur) has contracted Pima Environmental Services, LLC (Pima) to perform a liner inspection and prepare this closure report for the release of produced water that happened at the Clydesdale 1 Fee 1 Battery (Clydesdale). On August 4, 2022, the initial C-141 was formally submitted. The corresponding release received the designation Incident ID NAPP2221627025 from the New Mexico Oil Conservation Division (NMOCD).

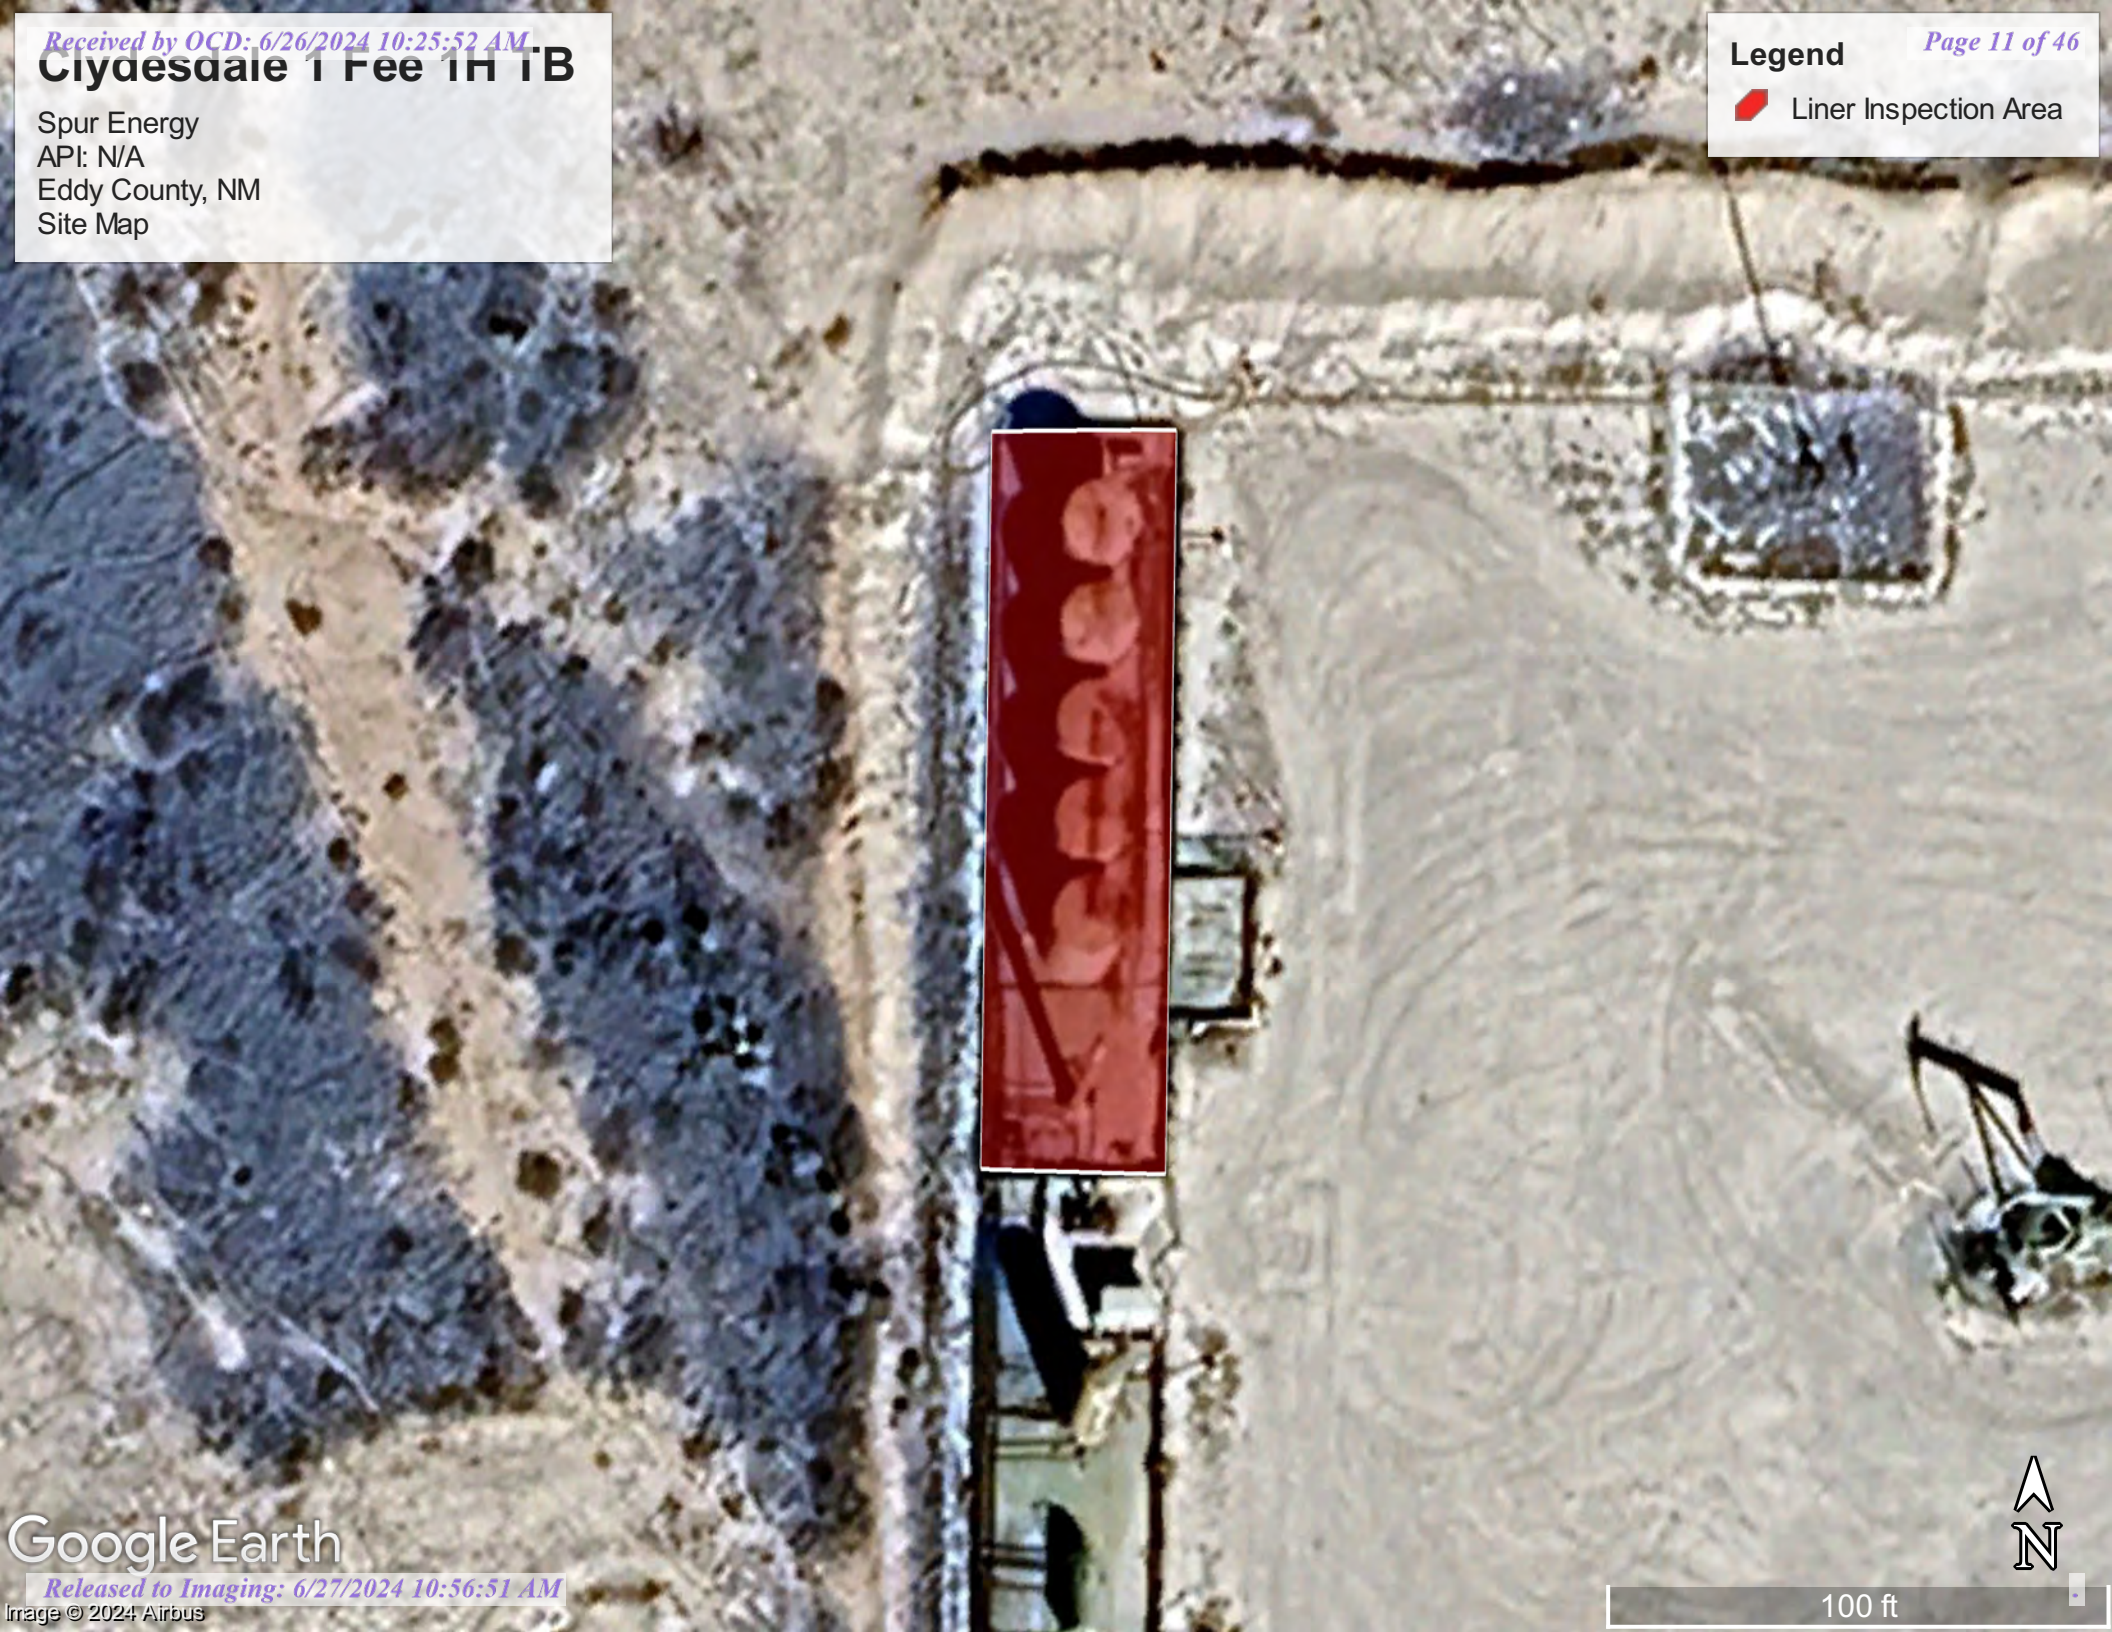
Spur Energy  
API: N/A  
Eddy County, NM  
Site Map

Liner Inspection Area

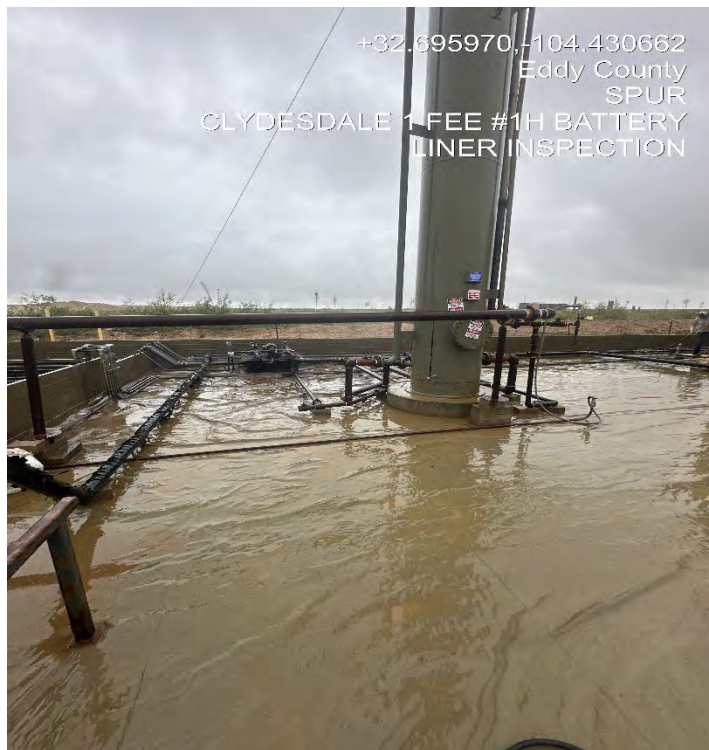
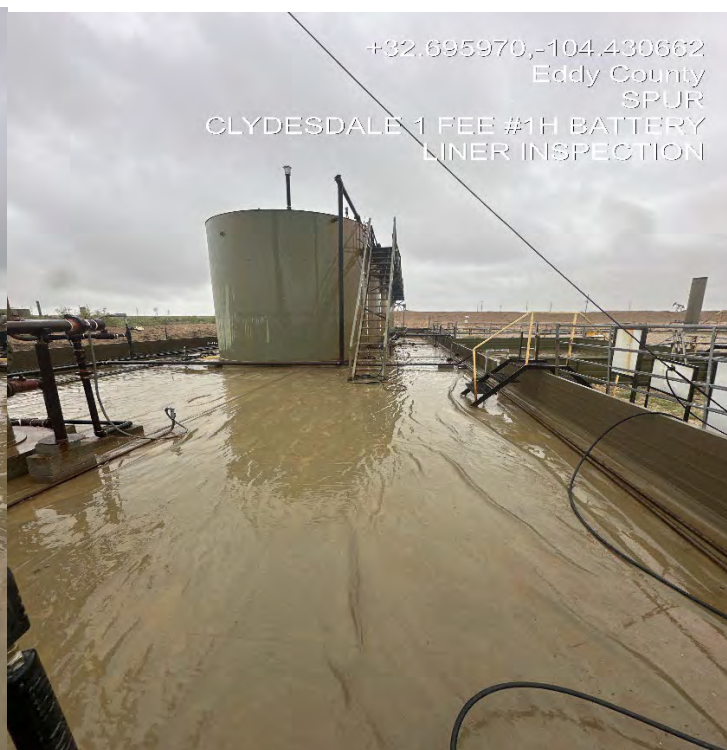
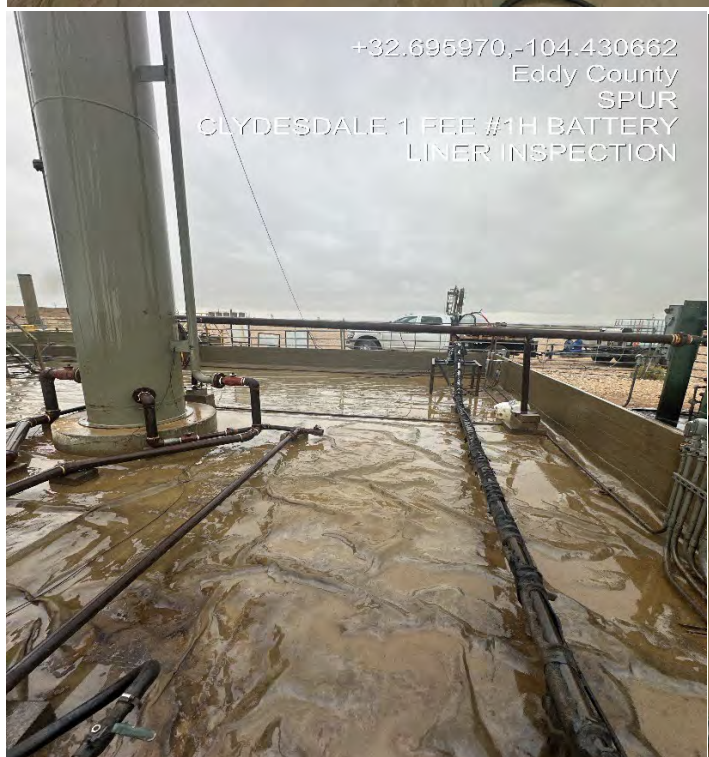
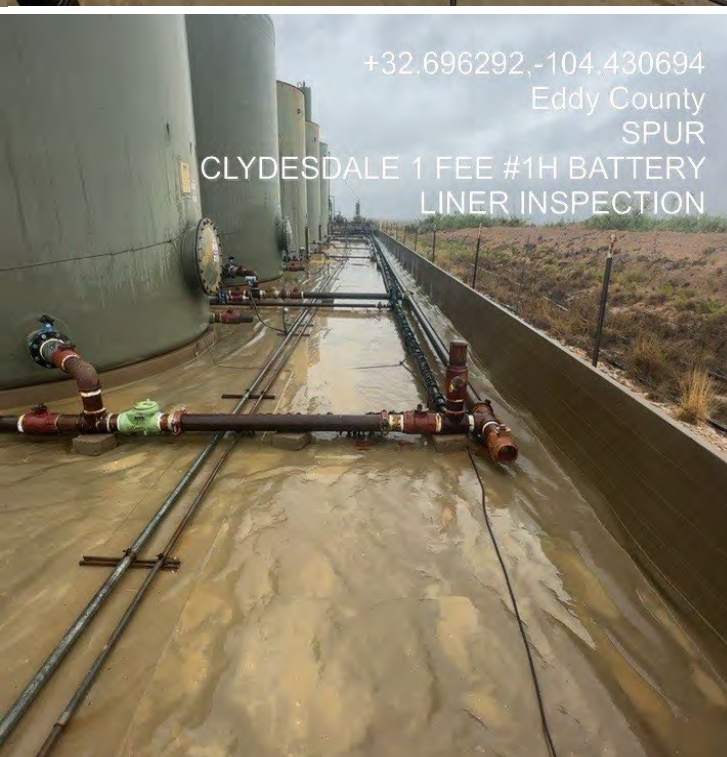
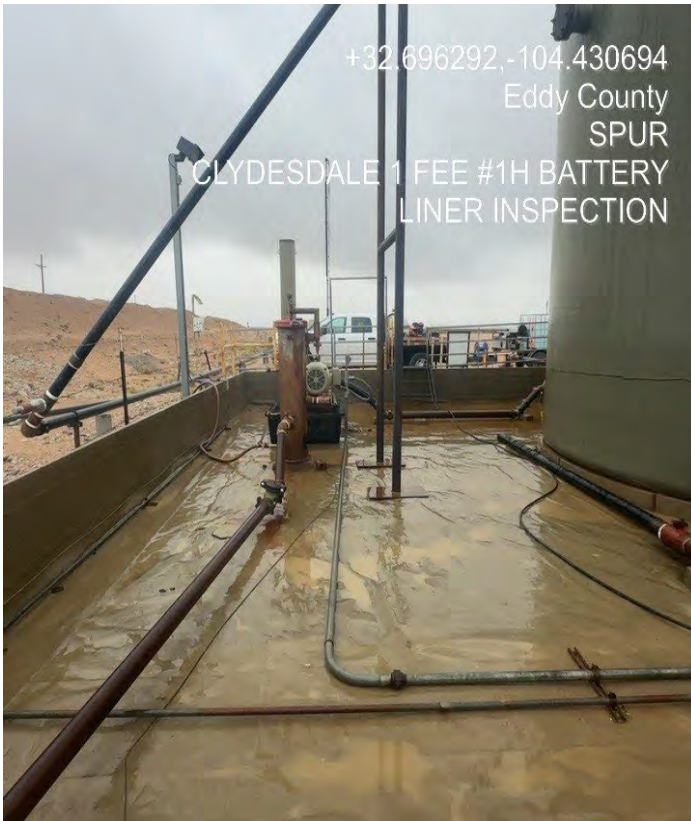
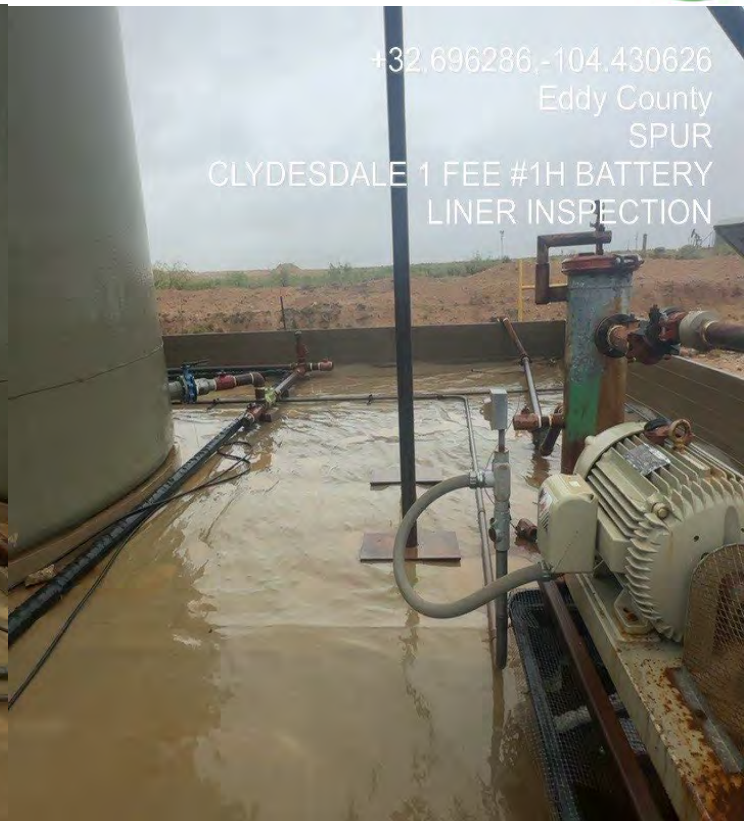
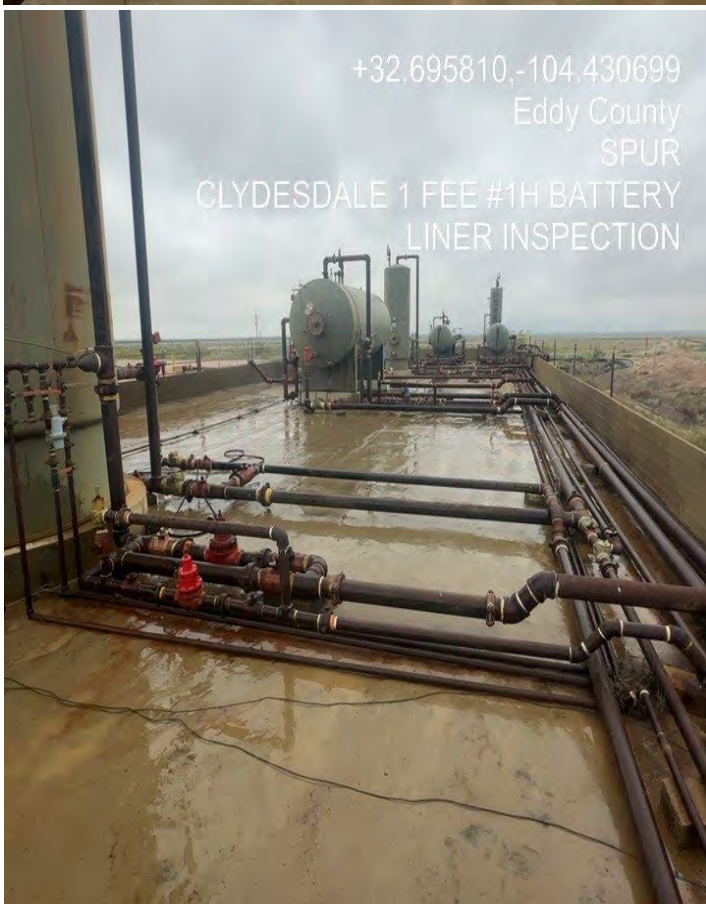
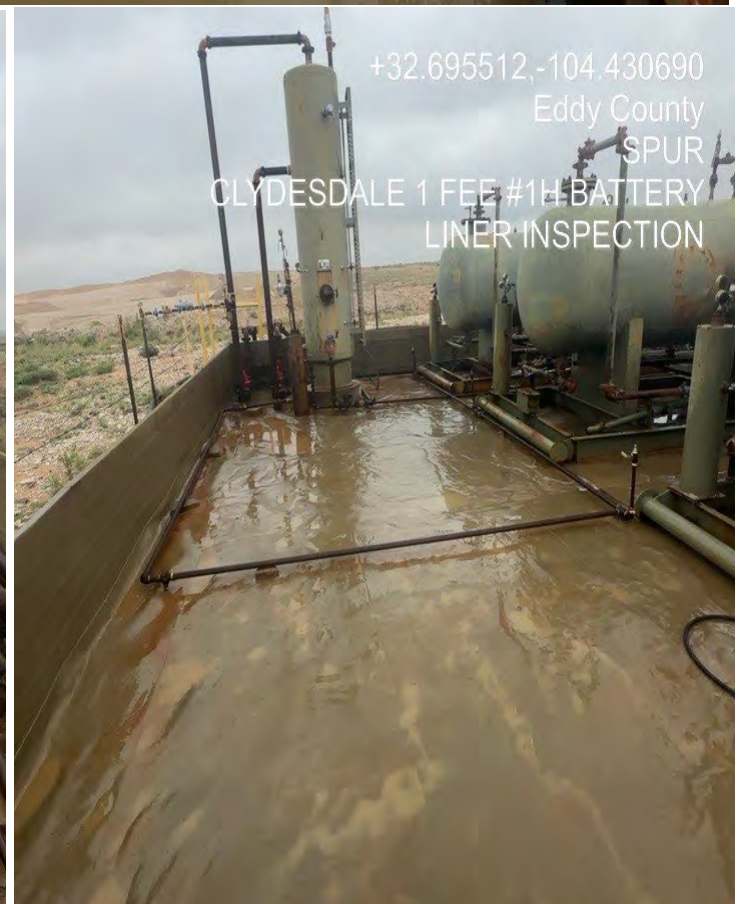
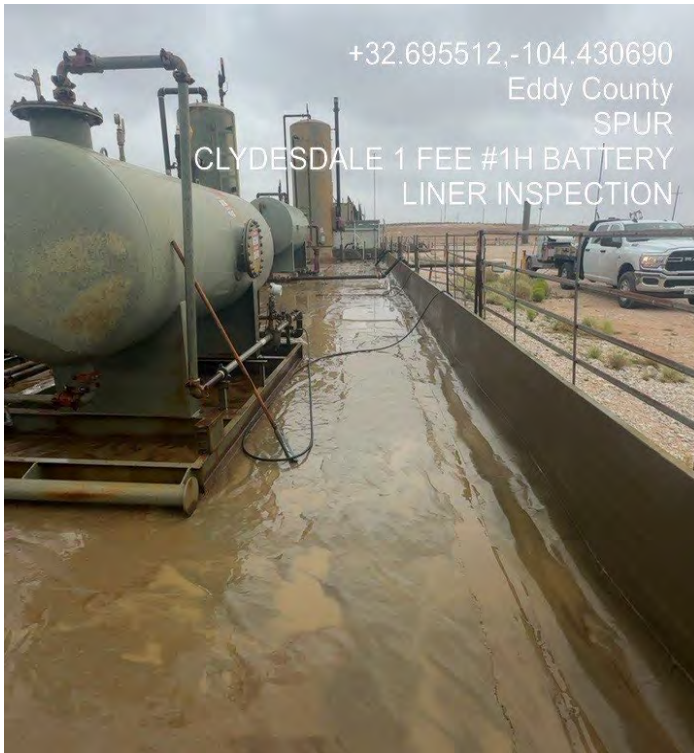
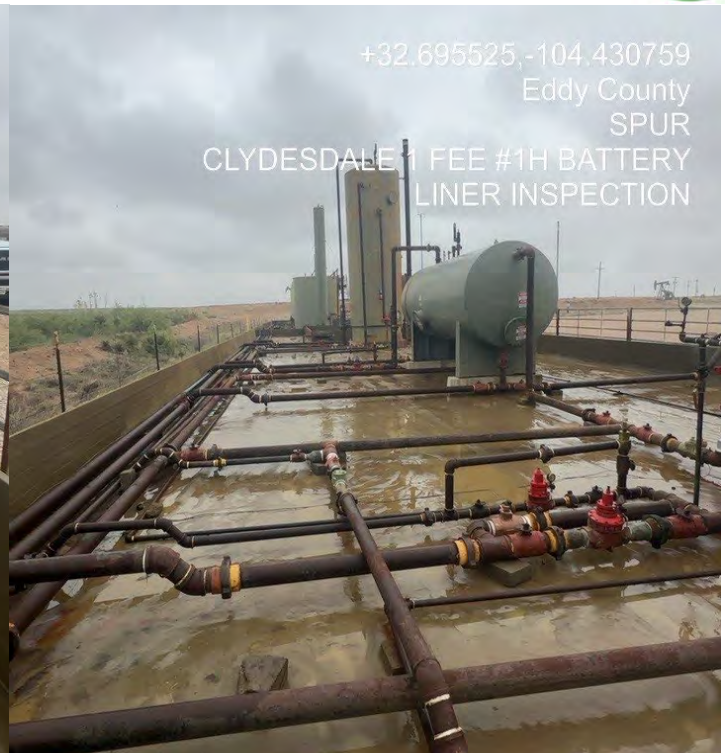
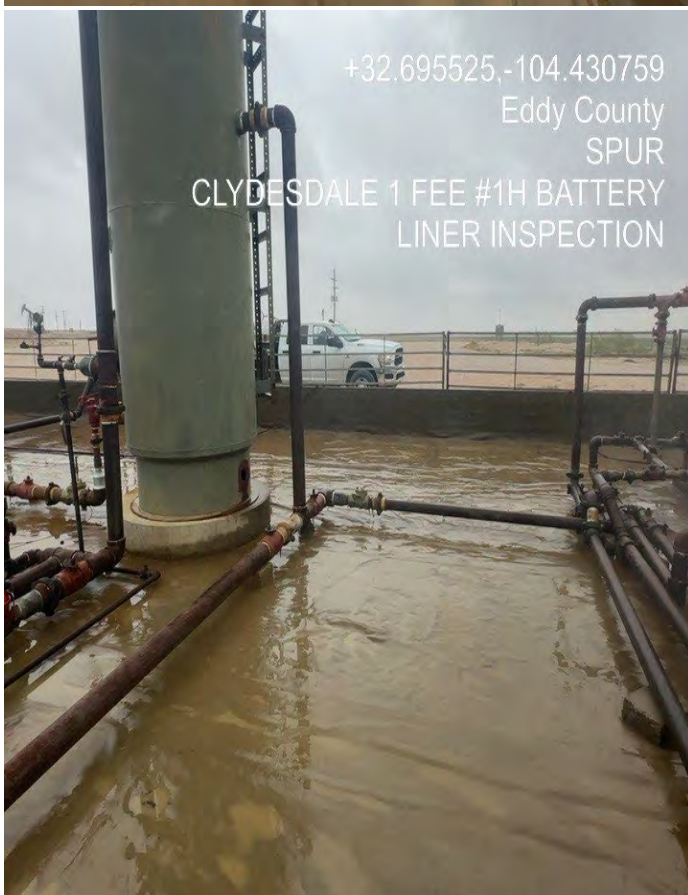
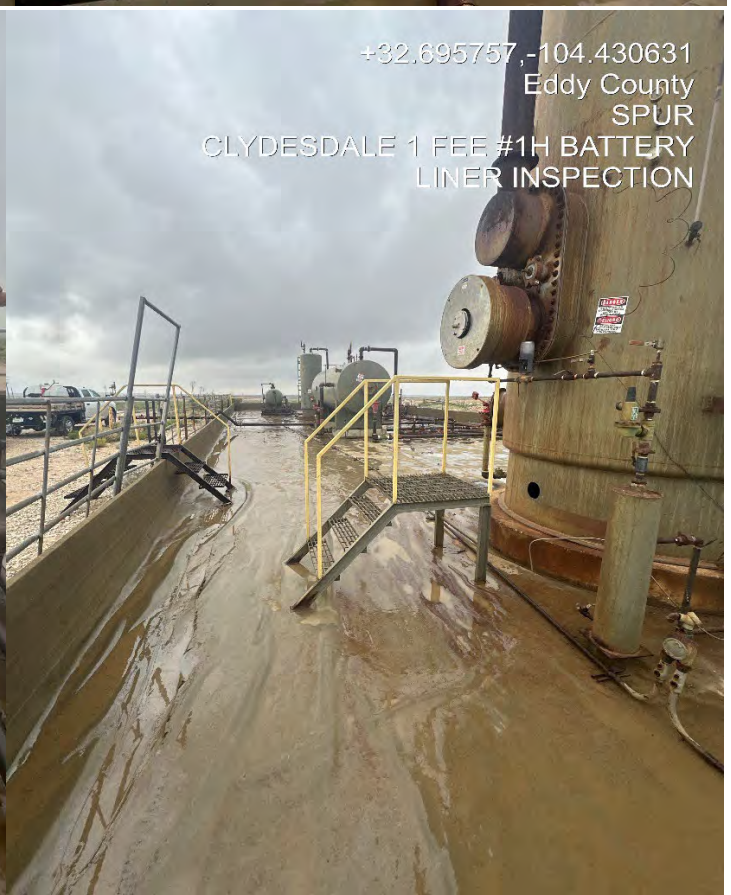
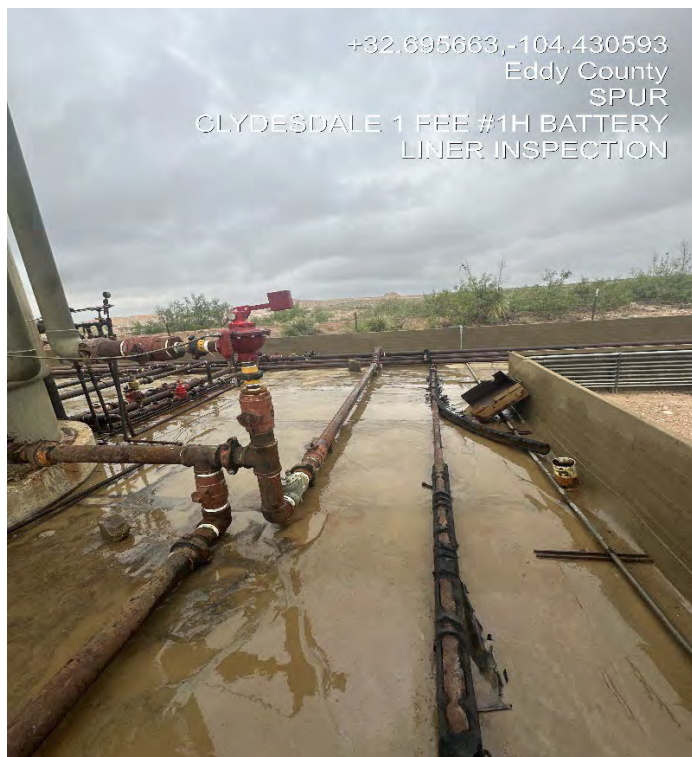
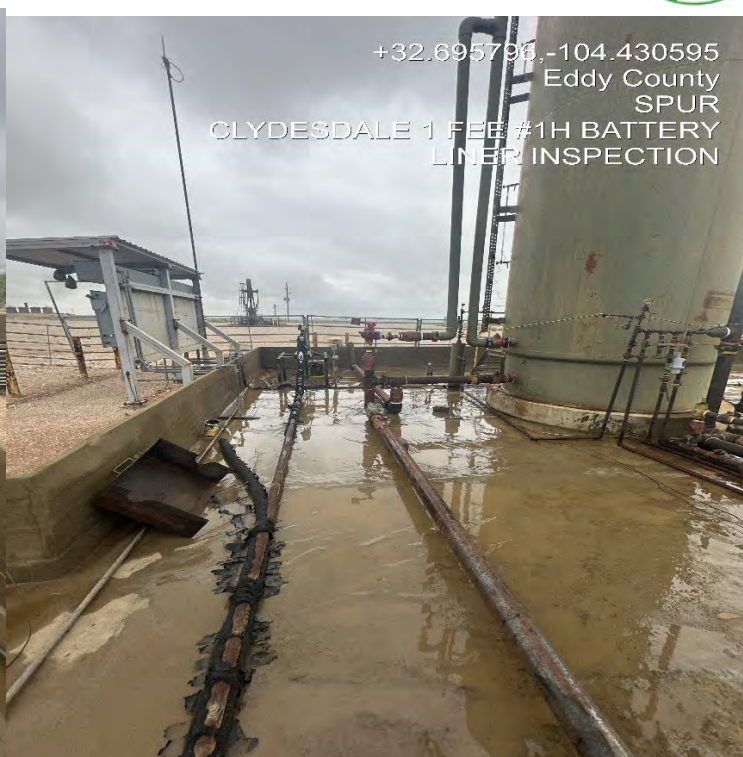
## Liner Inspection-

On June 24, 2024, Pima Environmental conducted a liner inspection at the Clydesdale, covering approximately 5,300 square feet. We concluded that the liner and containment maintained their integrity and successfully retained the fluids. The liner inspection form and photographic documentation are available in Appendix C.

Visualization	Yes	No	Comments
Is there a tear in the liner?		X	
Are there holes in the liner?		X	
Is the liner retaining any fluids?	X		The liner has a film of water due to pressure washing activities.
Does the liner have integrity to contain a leak?	X

Beginning on June 24, 2024, Pima Environmental was deployed to the Clydesdale site to perform remediation activities. Pima personnel started pressure washing the lined containment from the northernmost part of the central tank battery containment, moving southward to the southernmost tank, to eliminate any residual contamination.
