**RE: Liner Inspection and Closure Report**  
**Lee 3 Fee 6H Battery**  
**API No. 30-015-41463**  
**GPS: Latitude 32.682922 Longitude -104.370895**  
**UL- N, Section 03, Township 19S, Range 26E**  
**Eddy County, NM**  
**NMOCD Reference No. NAPP2215933441**

# Lee 3 Fee 6H Battery

## Liner Inspection-

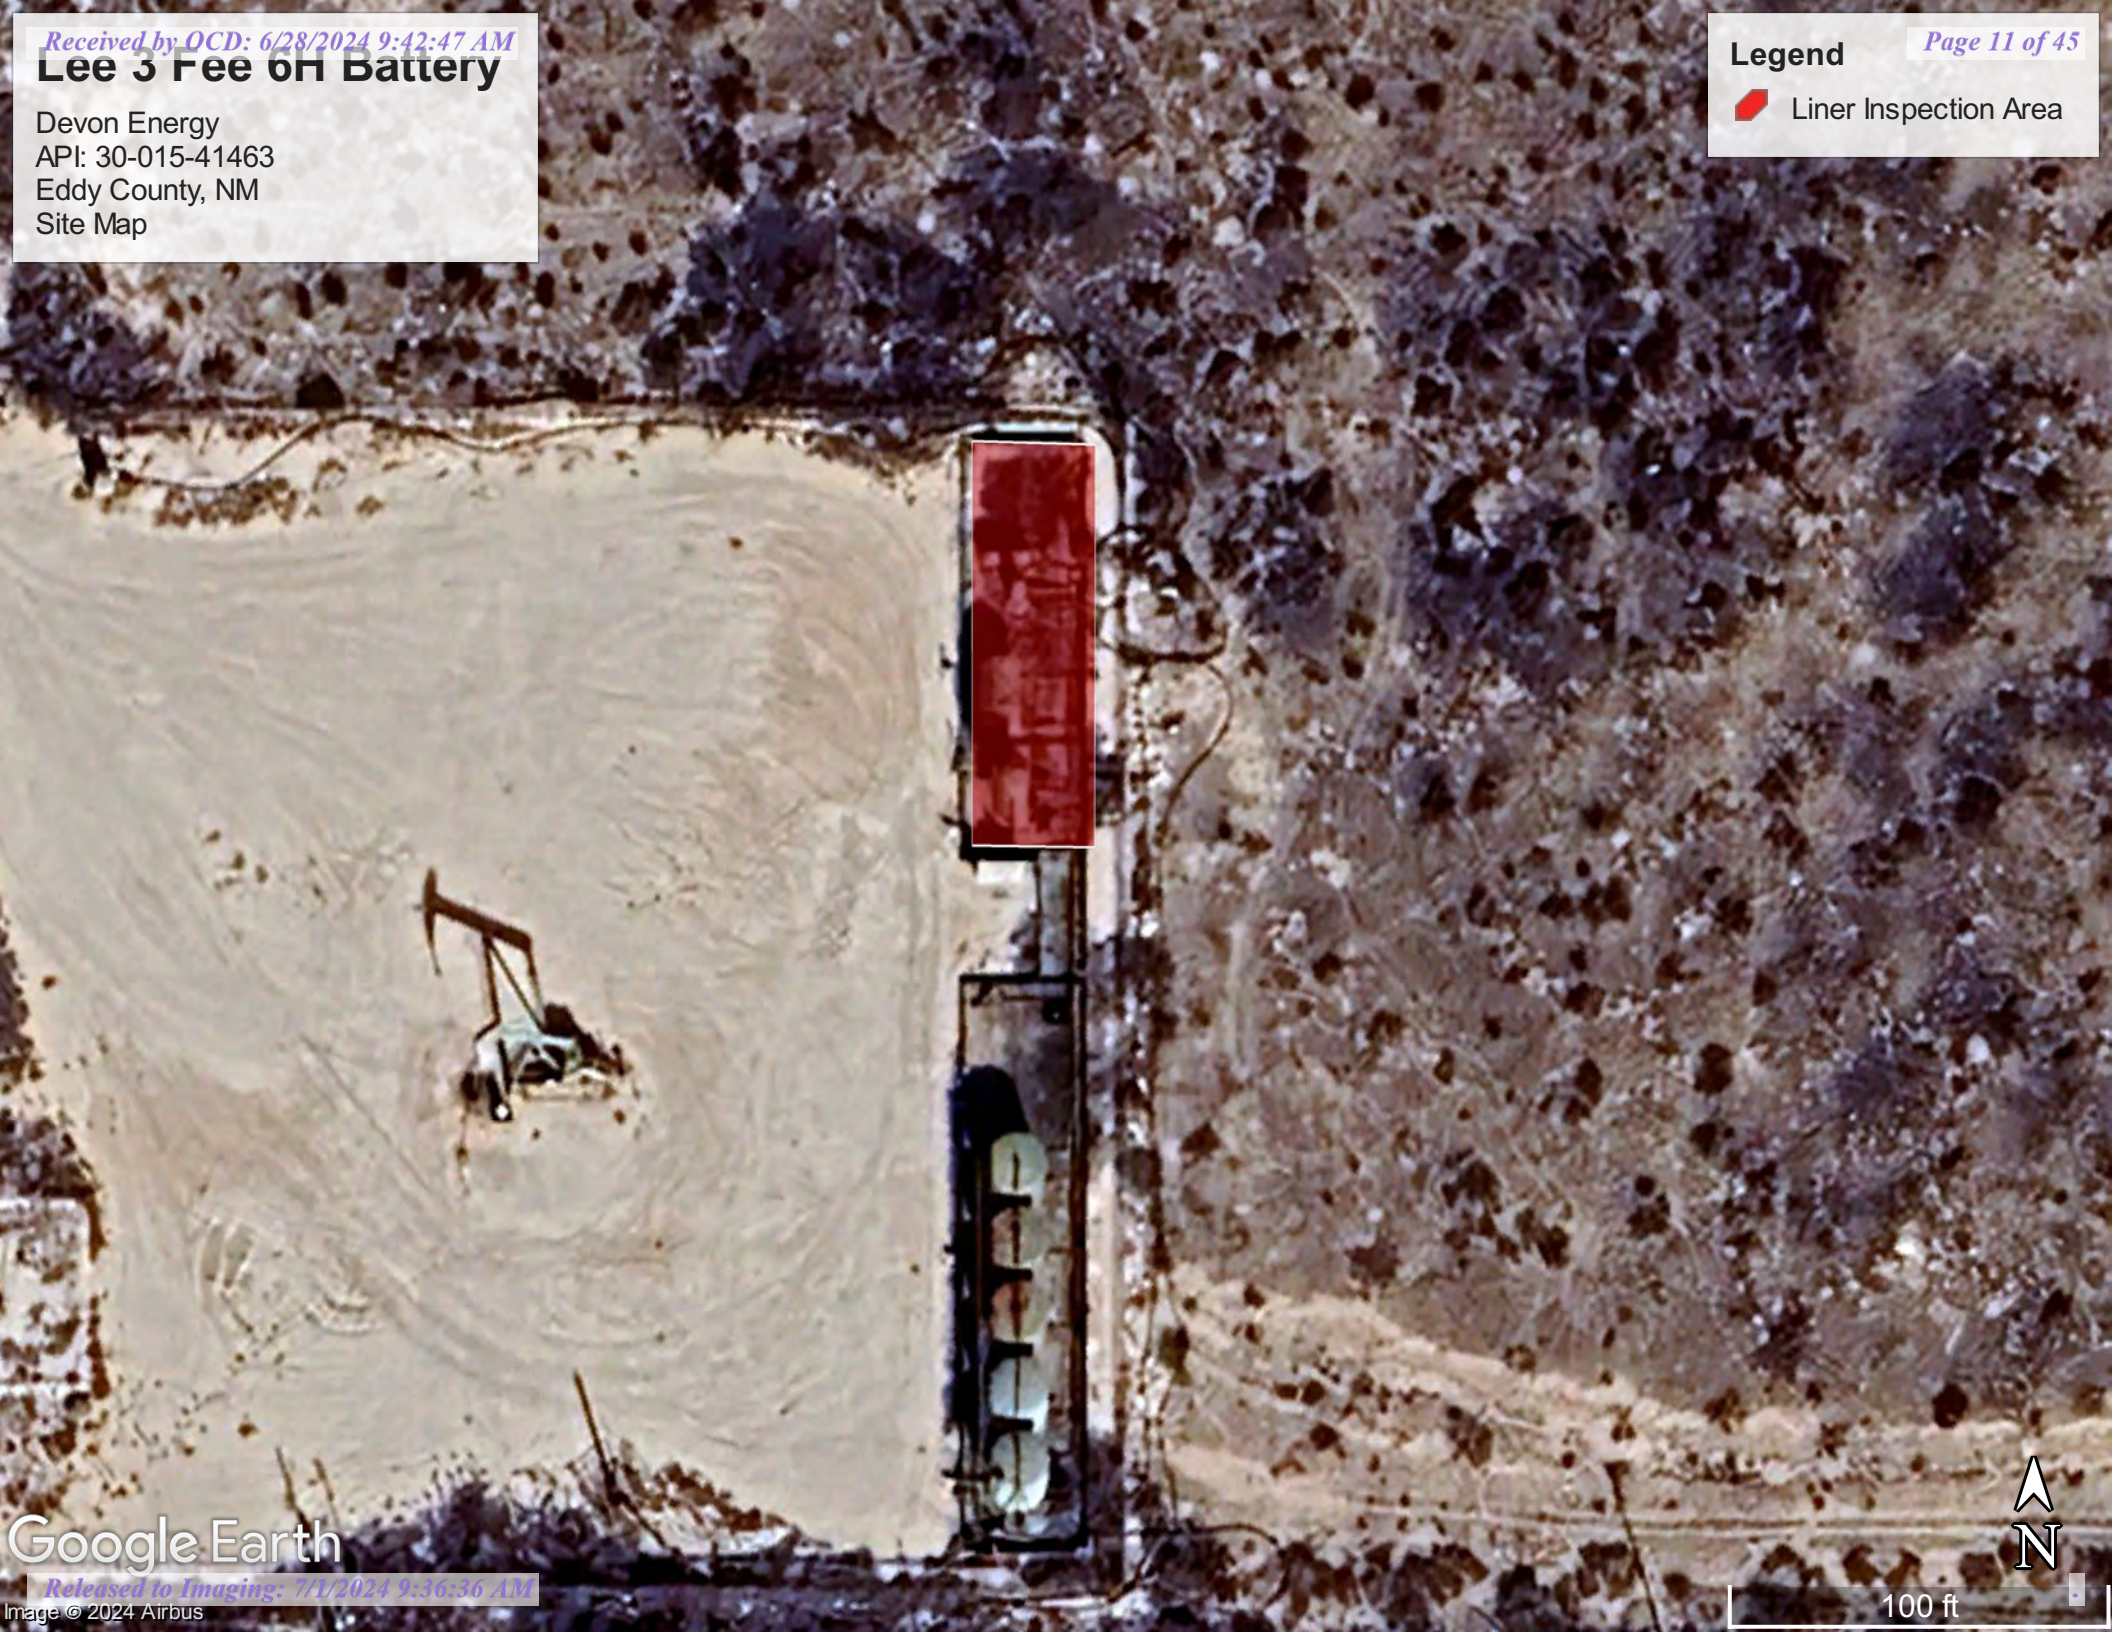
Devon Energy  
API: 30-015-41463  
Eddy County, NM  
Site Map

Liner Inspection Area

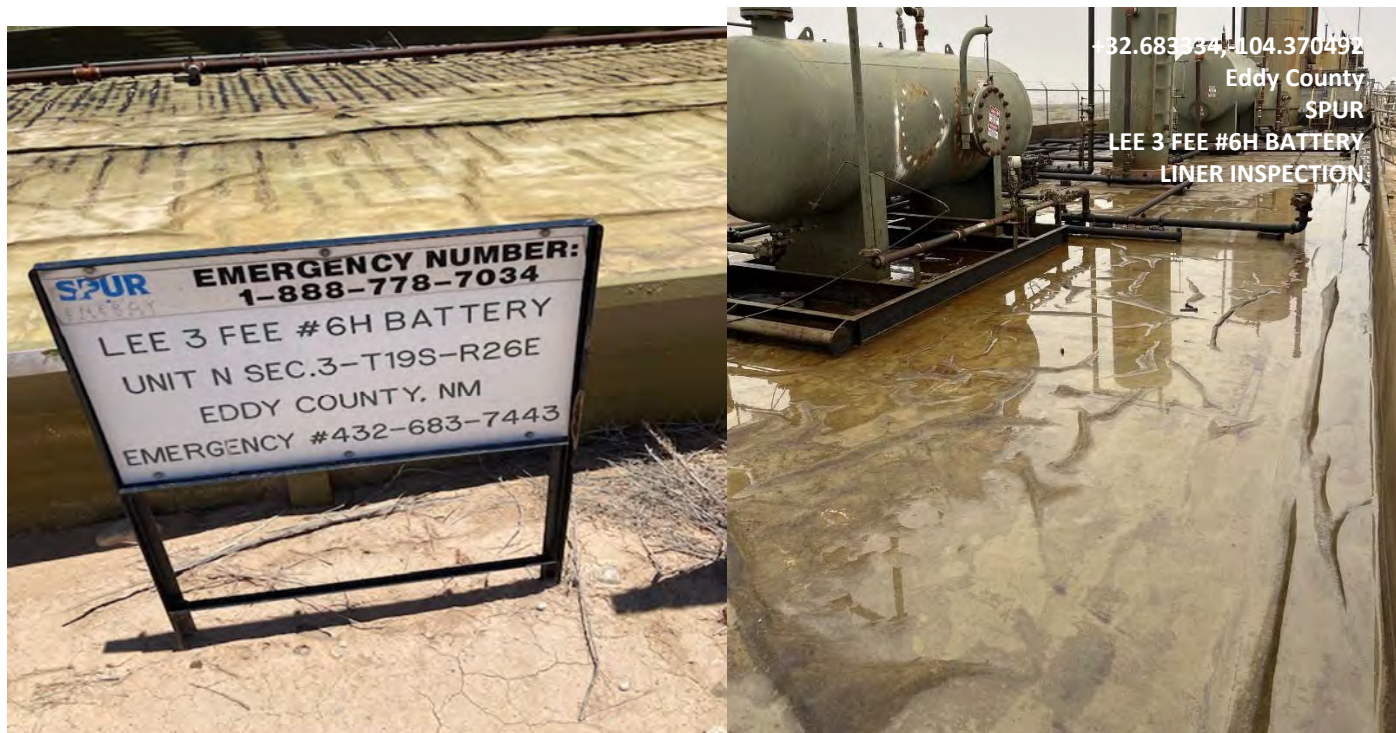
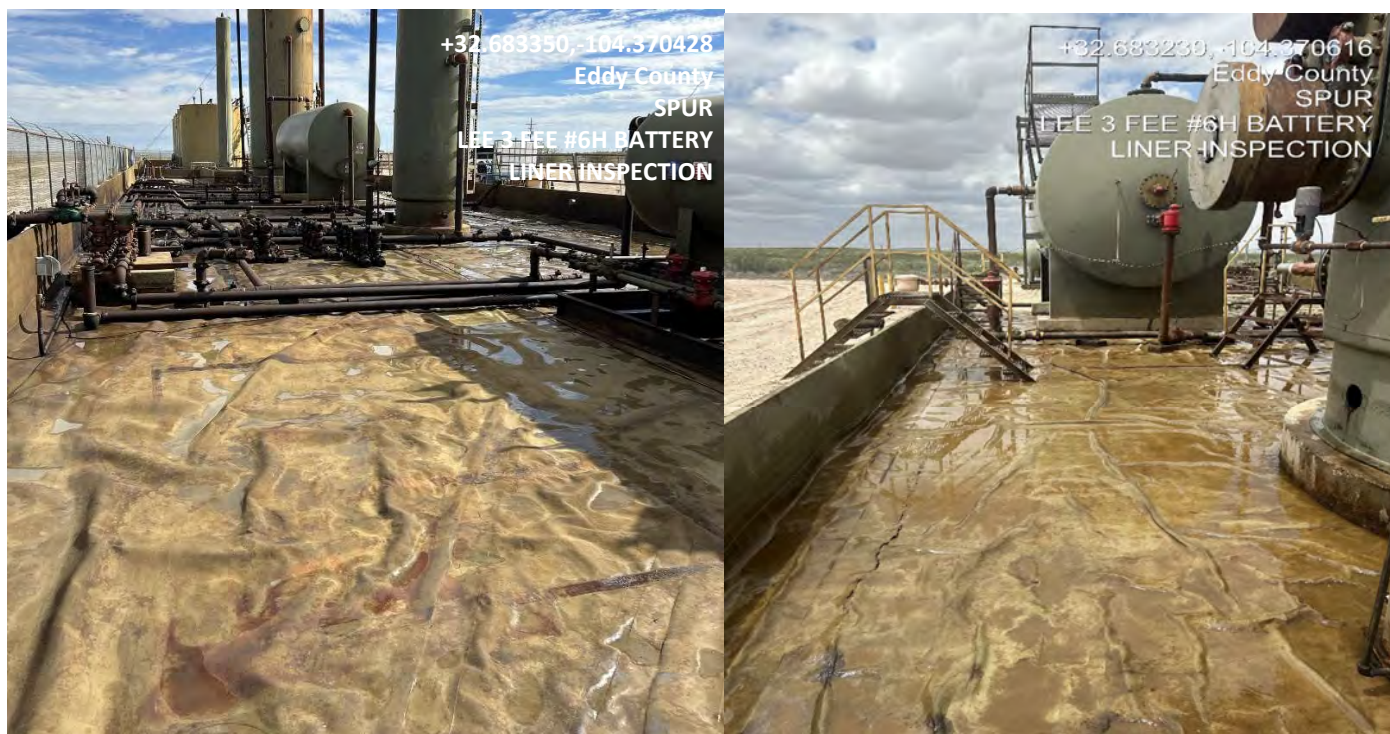
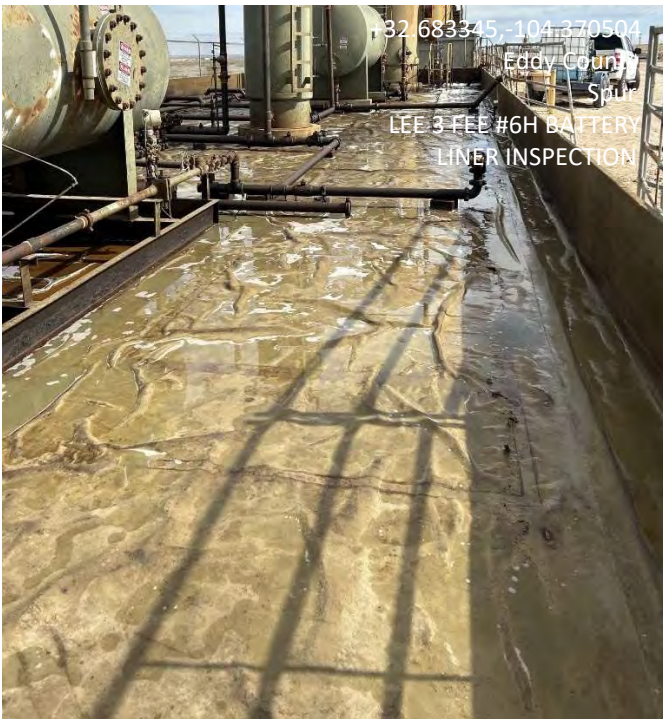
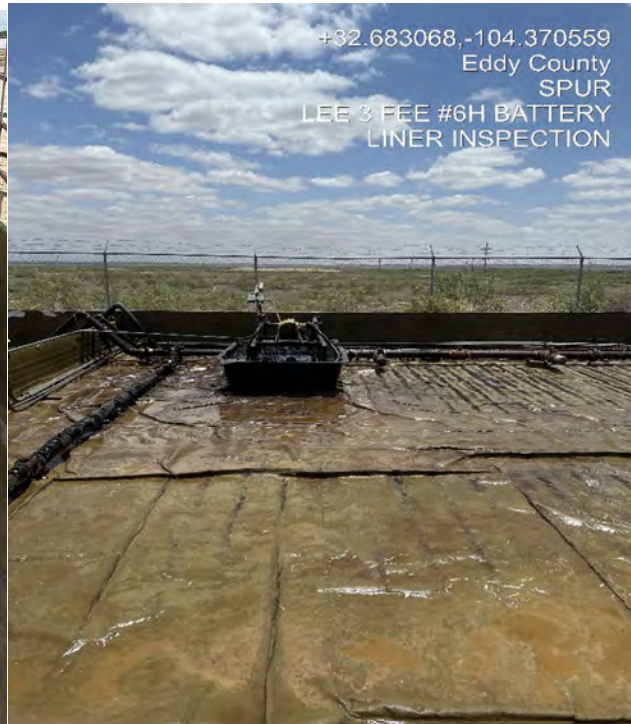
On June 25, 2024, Pima Environmental conducted a liner inspection at the Lee, covering approximately 3,400 square feet. We concluded that the liner and containment maintained their integrity and successfully retained the fluids. The liner inspection form and photographic documentation are available in Appendix C.

| Summarize any additional remediation activities not included by answers (above) | <b>LINER WAS PRESSURE WASHED AND INSPECTED AND THE LINER WAS FOUND TO BE ABLE TO CONTAIN LEAKS</b> |

Beginning on June 25, 2024, Pima Environmental was deployed to the Lee site to perform remediation activities. Pima personnel started pressure washing the lined containment located on the northeast portion of the engineered pad. They began at the northernmost part of the lined containment and worked their way towards the southernmost part to eliminate any residual contamination.
