Liner Inspection Closure Report

Mule 23 CTB 2

Prepared by Pima Environmental Services, LLC for
Devon Energy Production, LP

**RE: Liner Inspection and Closure Report
Mule 23 CTB 2
Facility ID fAPP2313833783
GPS: Latitude 32.1218234 Longitude -103.7471688
ULSTR – B – 23 – 25S – 31E 467 FNL 2194 FEL Eddy County, NM
NMOCD Incident ID nAPP2417929598**

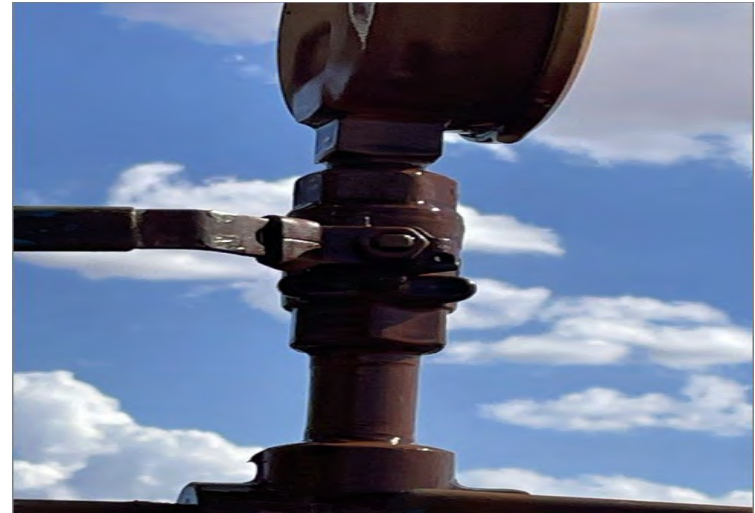
nAPP2417929598: On June 26, 2024, Water was spraying out of a valve on a water transfer pump. 10.3 bbls released and recovered in a lined containment. The liner was visually inspected by Devon field staff for any pinholes or punctures; none were found. Based on this inspection there is no evidence that the spilled fluids left containment.

Point of Release

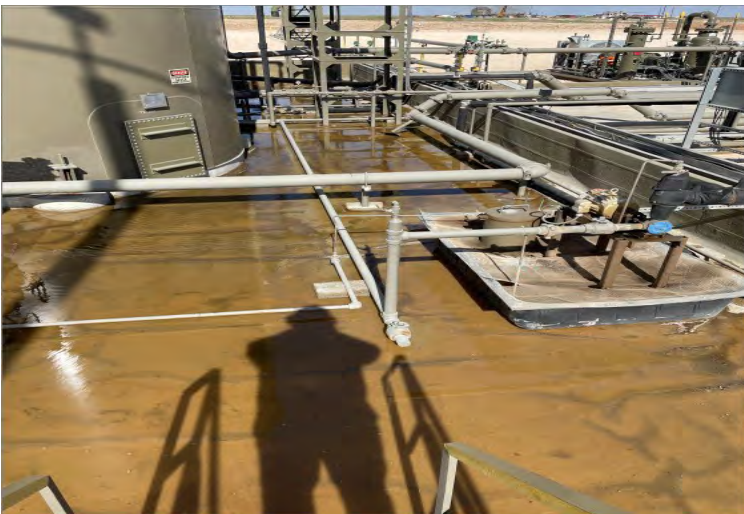
Released Fluid in Containment

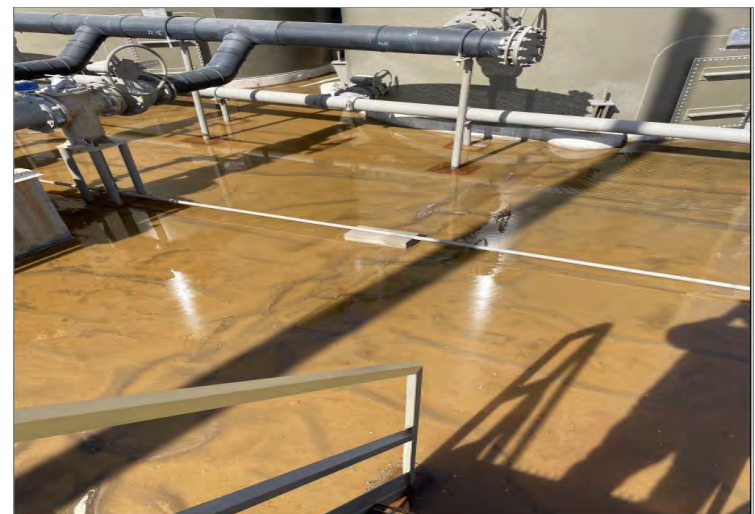
Release Fluid in Containment

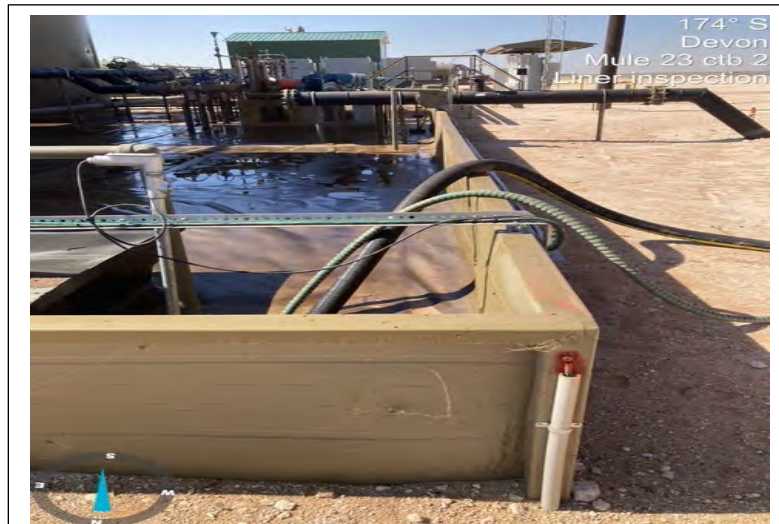
Power washing & inspection Northwest corner looking South
