## LINER INSPECTION CLOSURE REPORT

Incident ID nAPP2416931381

**Exmoor 15 CTB 2**

Facility ID fAPP2333921910

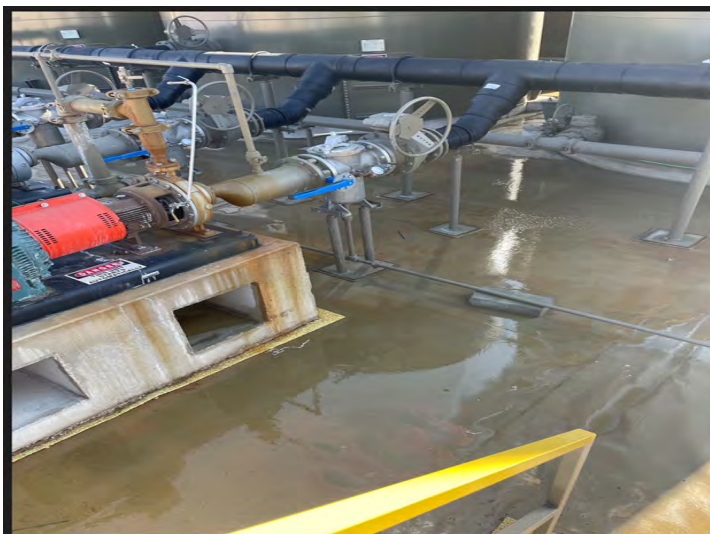
### Photograph No. 1

**nAPP2416931381:** On June 14, 2024, 1/4" nipple on water transfer pump was broken. 7.3 bbls produced water released in lined containment. 7 bbls recovered. The liner was visually inspected by Devon field staff for any pinholes or punctures; none were found. Based on this inspection there is no evidence that the spilled fluids left containment.

**Description:** Point of release

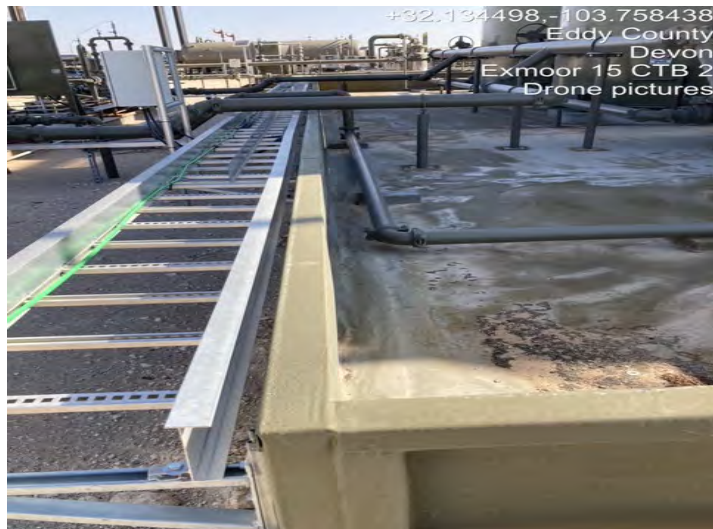
### Photograph No. 2

**Description:** Pre-inspection, liner/containment needs power washed

On June 27, 2024, Pima personnel mobilized equipment to the site to perform power washing of the liner/containment. A vacuum truck accompanied the crew to recover the power washing fluids. At this time the remaining 0.3 bbls missed during the initial recovery effort, were also recovered.

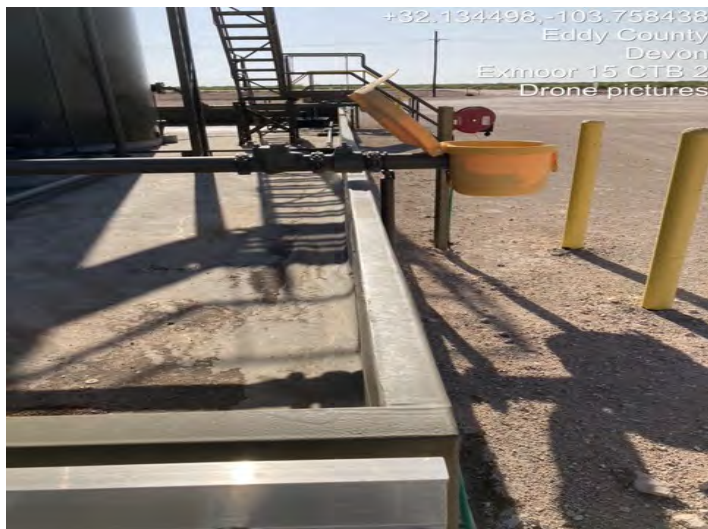
### Photograph No. 3

**Description:** Pre-inspection, liner/containment needs power washed

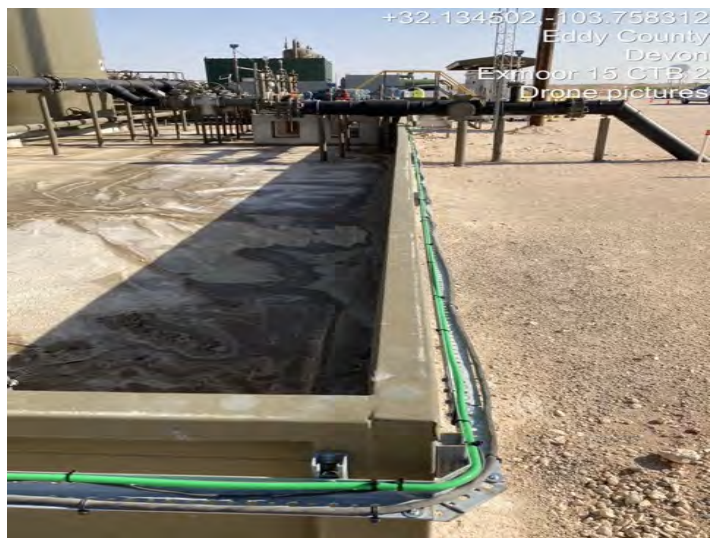
Photograph No. 4

**Description:** Pre-inspection, liner/containment needs power washed

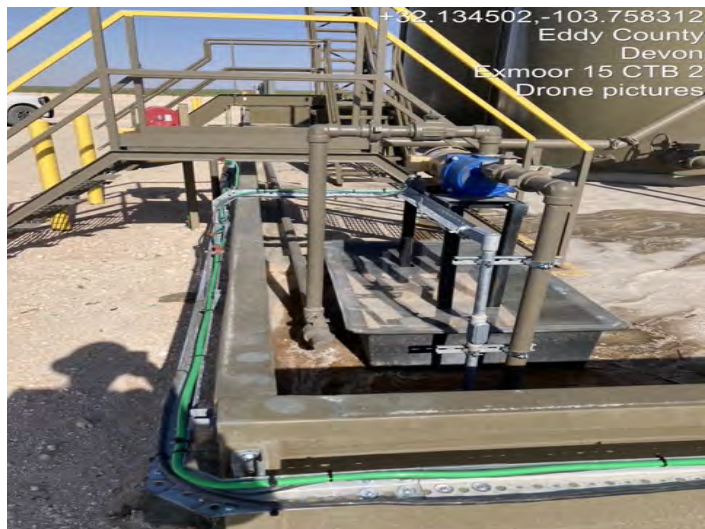
Photograph No. 5

**Description:** Pre-inspection, liner/containment needs power washed

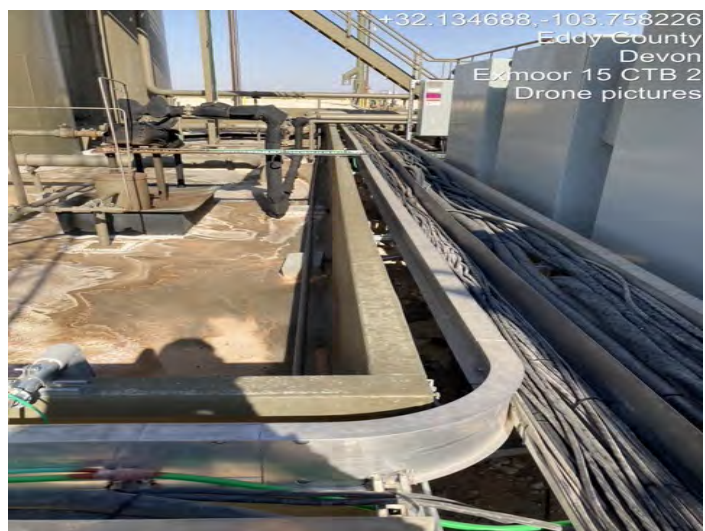
Photograph No. 6

**Description:** Pre-inspection, liner/containment needs power washed

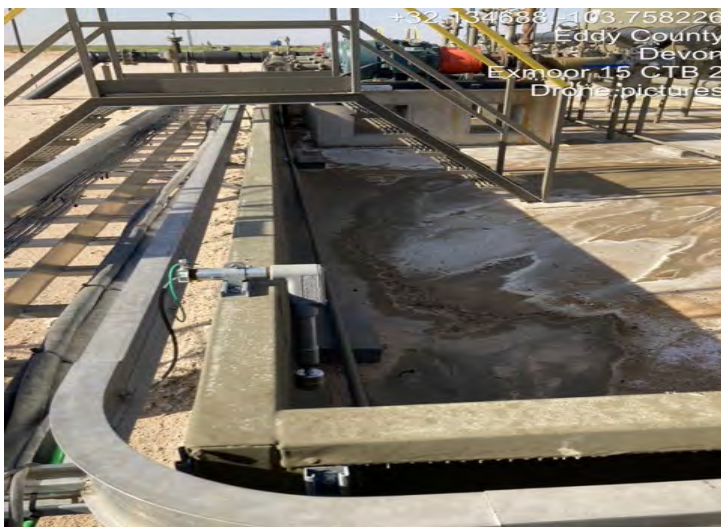
### Photograph No. 7

**Description:** Pre-inspection, liner/containment  
needs power washed

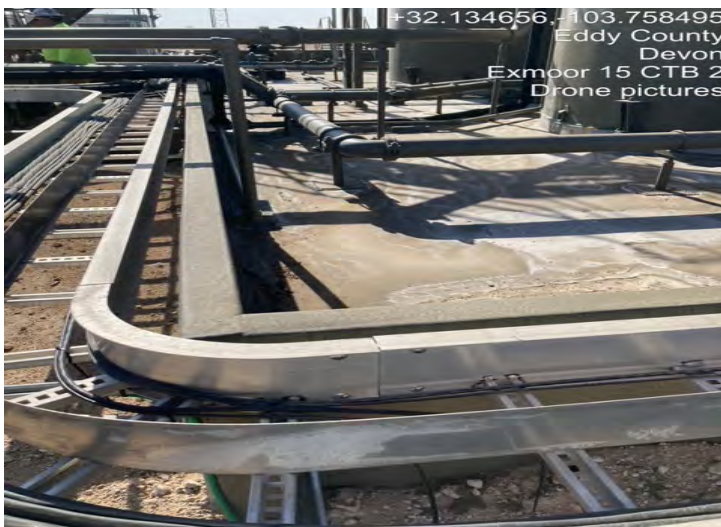
### Photograph No. 8

**Description:** Pre-inspection, liner/containment  
needs power washed

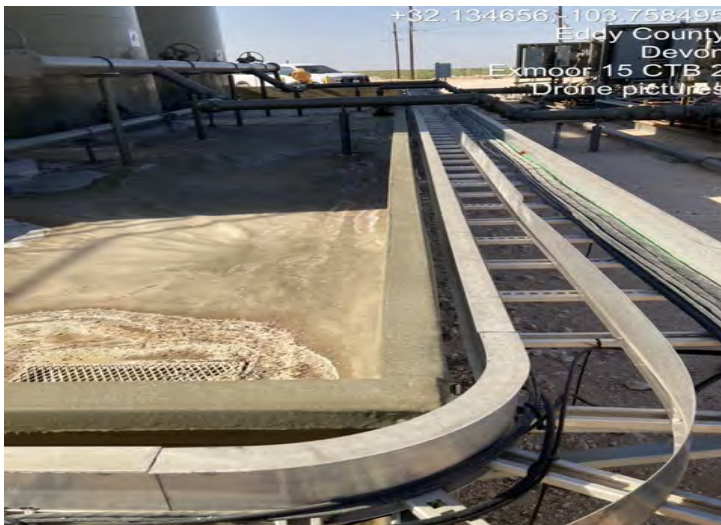
### Photograph No. 9

**Description:** Pre-inspection, liner/containment  
needs power washed

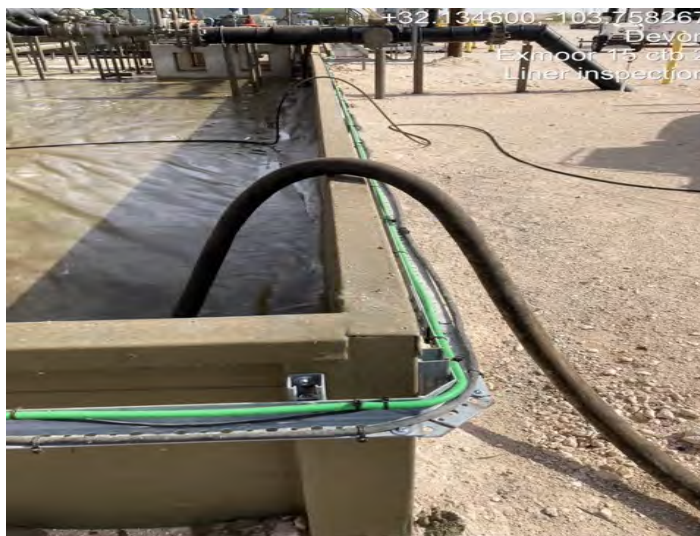
Photograph No. 1

On June 28, 2024, after Devon submitted the 48-hour notification, application ID: 357579 to the OCD, Pima Environmental conducted a liner inspection at this location. Pima concluded that this liner and containment maintained its integrity and was able to retain the fluids. The liner inspection form and photographic documentation can be found in Appendix C.

Description: Post-wash, southeast corner looking north

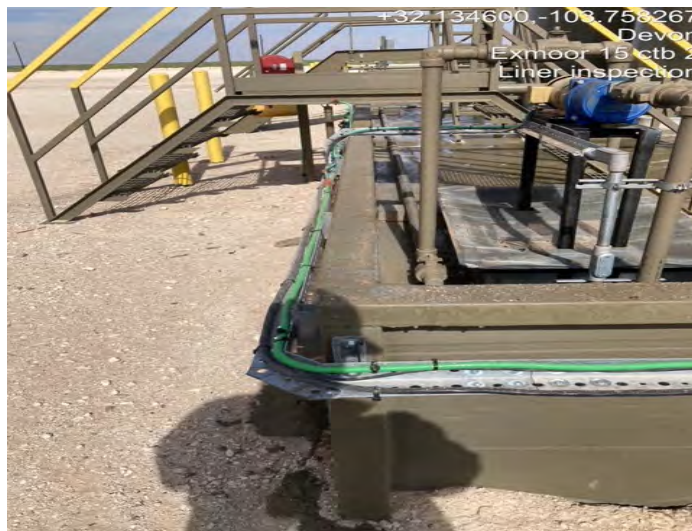
Photograph No. 2

Description: Post-wash, southeast corner looking west

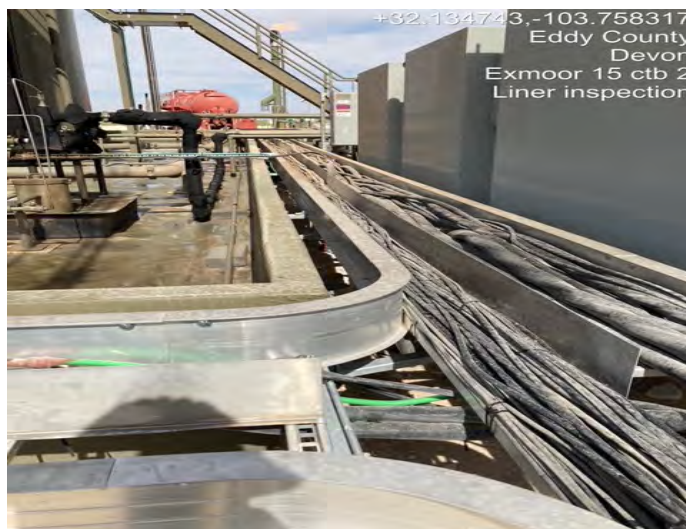
Photograph No. 3

Description: Post-wash, northeast corner looking west

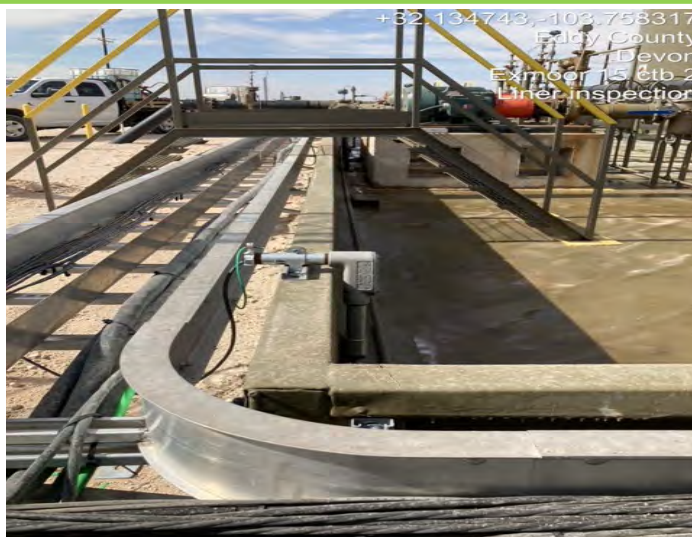
Photograph No. 4

**Description:** Post-wash, northeast corner looking south

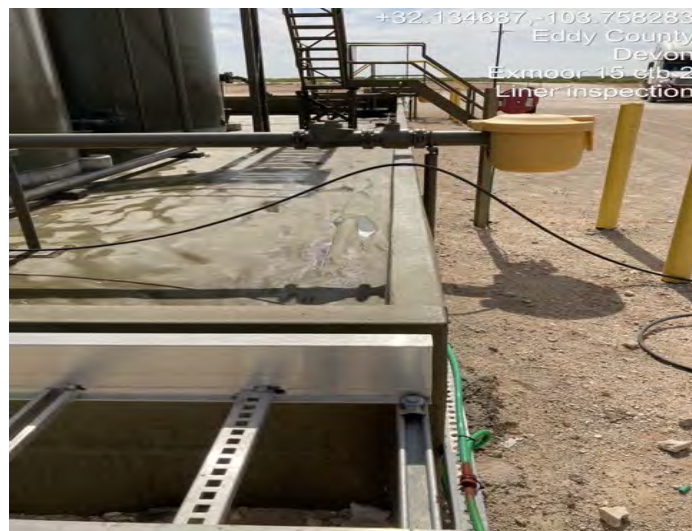
Photograph No. 5

**Description:** Post-wash, southwest corner looking east

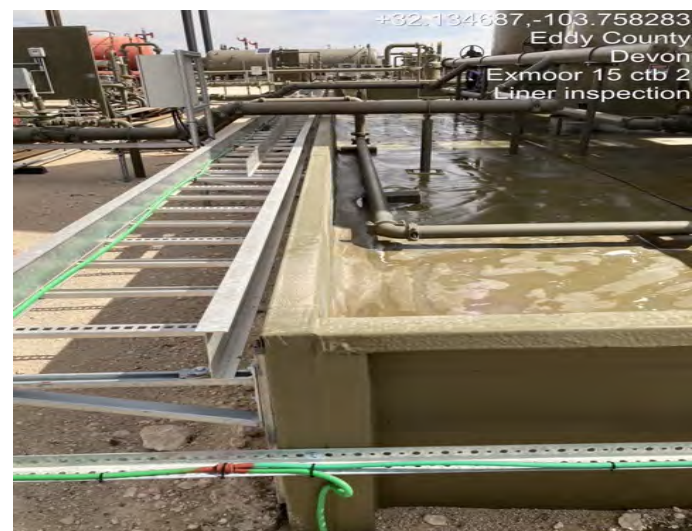
Photograph No. 6

**Description:** Post-wash, southwest corner looking north

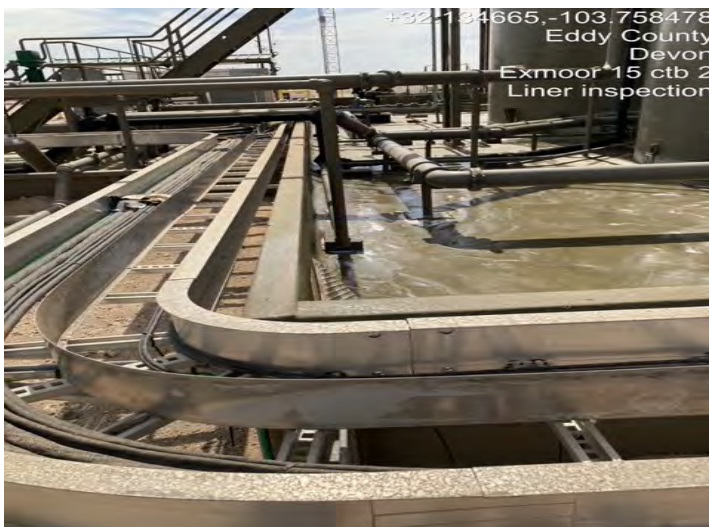
### Photograph No. 7

**Description:** Post-wash, northwest corner looking east

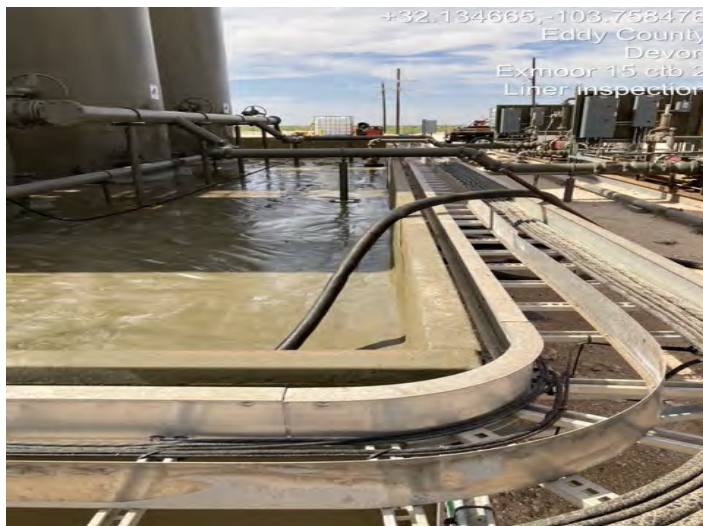
### Photograph No. 8

**Description:** Post-wash, northwest corner looking south

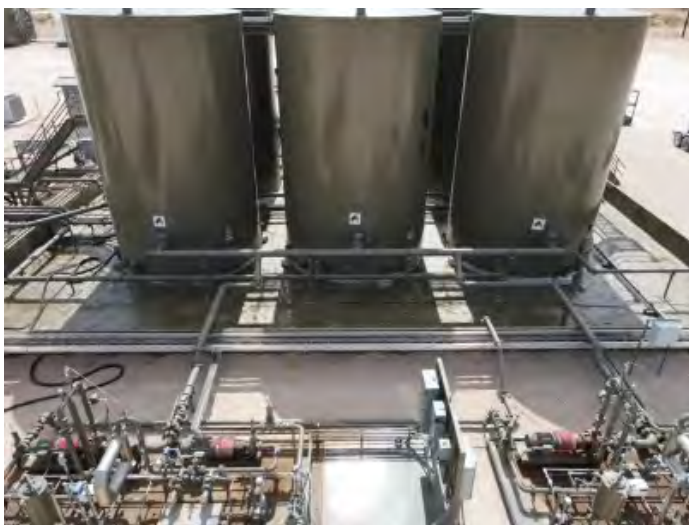
### Photograph No. 9

**Description:** Post-wash, aerial view west side

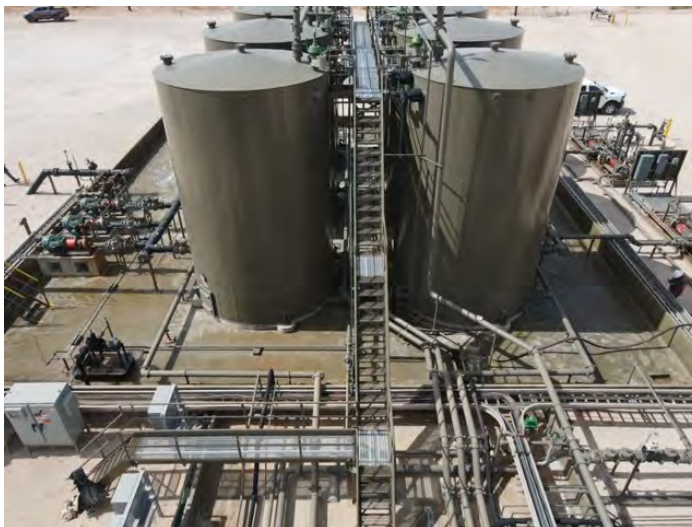
Photograph No. 10

Description: Post-wash, aerial view north side

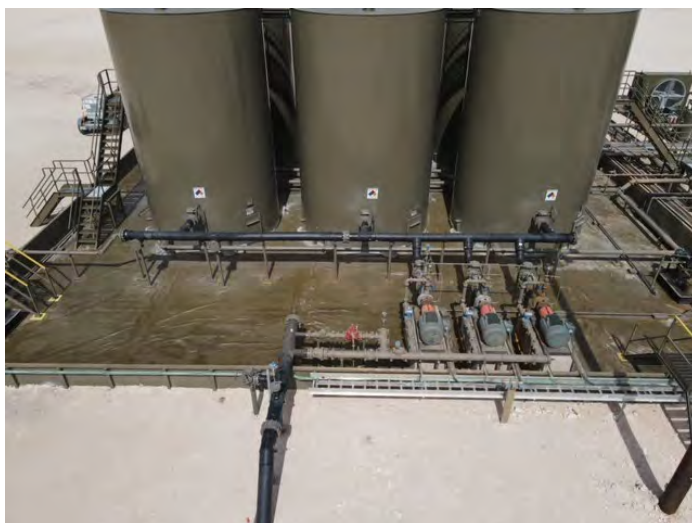
Photograph No. 11

Description: Post-wash, aerial view east side

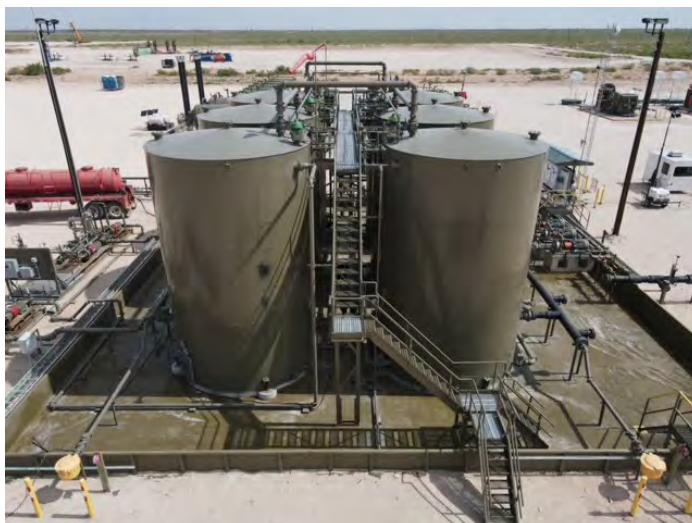
Photograph No. 12

Description: Post-wash, aerial view south side

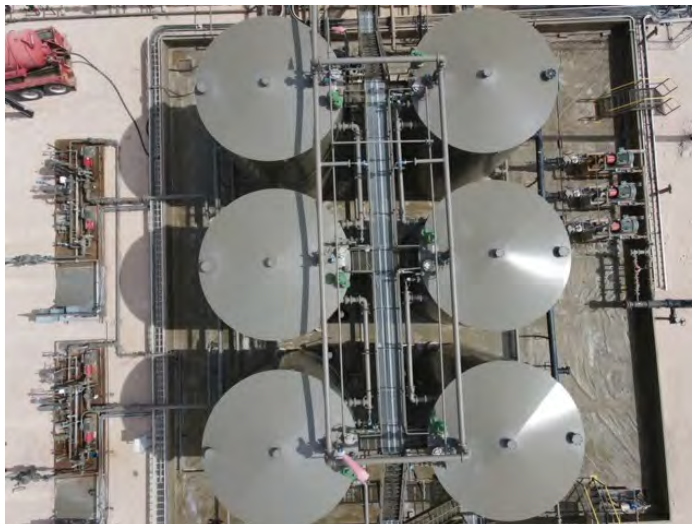
### **Photograph No. 13**

**Description:** Post-wash, aerial view overhead
