LINER INSPECTION CLOSURE REPORT

Incident ID NAPP2421124014

Right Meow 31 CTB 7

Prepared By: Pima Environmental Services, LLC

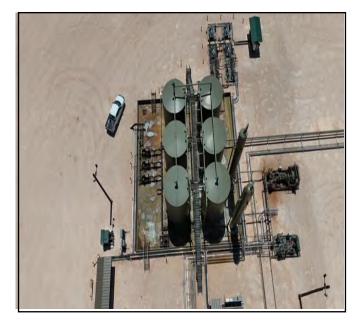
Aerial photo of liner taken prior to power washing.

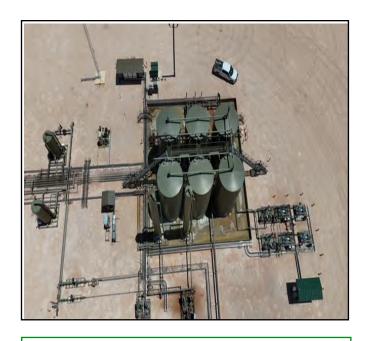
Aerial photo of liner taken prior to power washing, taken facing North.

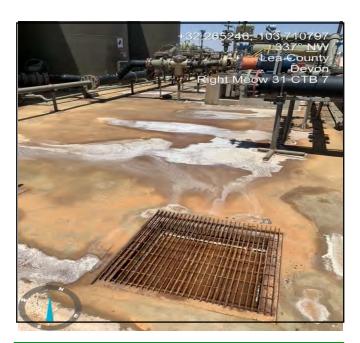
Photo of liner taken prior to power washing, taken facing Northwest.

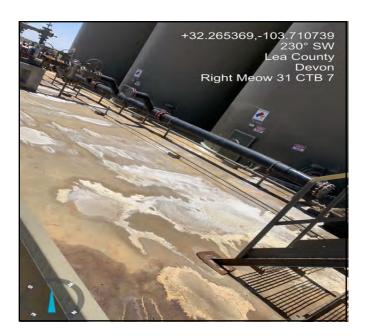
Photo of liner taken prior to power washing, taken facing Southwest.

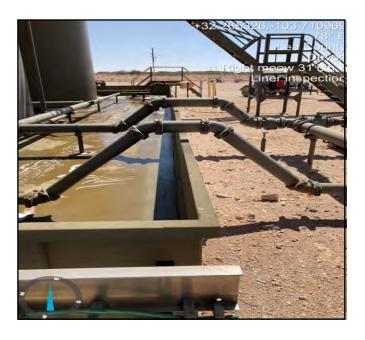
Photo taken pursuant to power washing, taken facing Northeast.

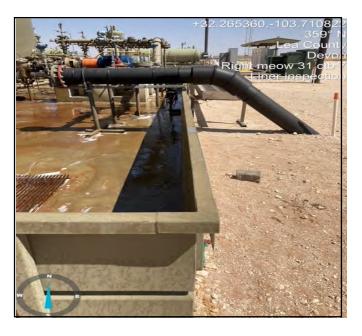
Photo taken pursuant to power washing, taken facing North.

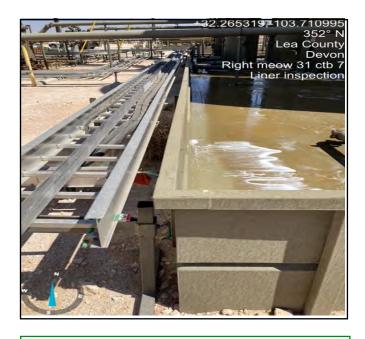
Photo taken pursuant to power washing, taken facing Northwest.

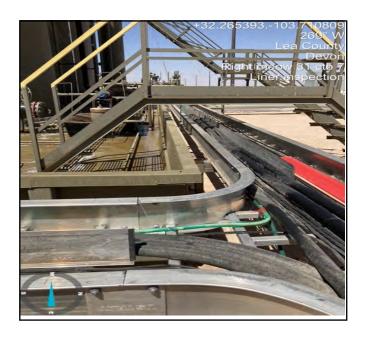
Photo taken pursuant to power washing, taken facing West.

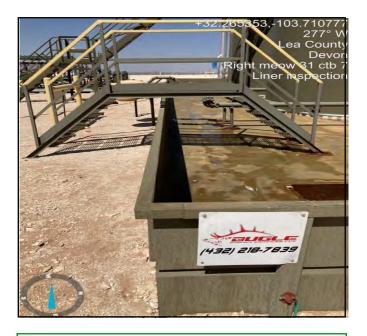
Photo taken pursuant to power washing, taken facing Northwest.

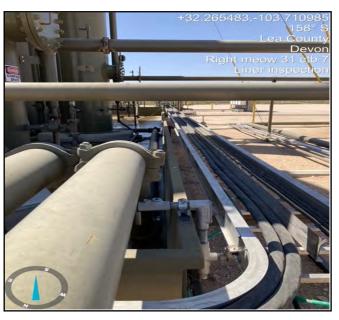
Photo taken pursuant to power washing, taken facing Southeast.

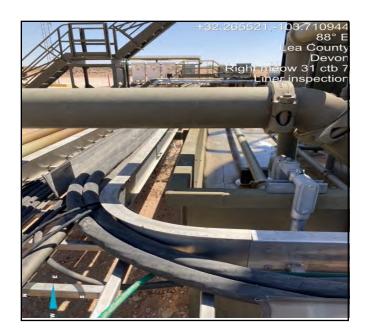
Photo taken pursuant to power washing, taken facing East.

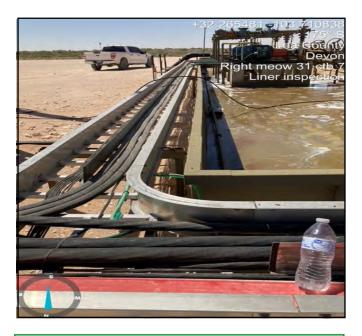
Photo taken pursuant to power washing, taken facing South.

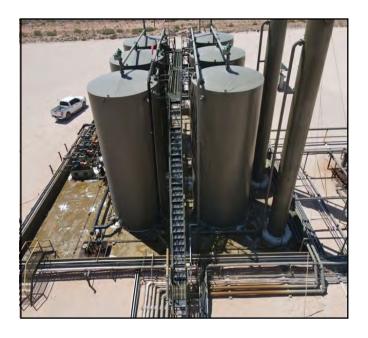
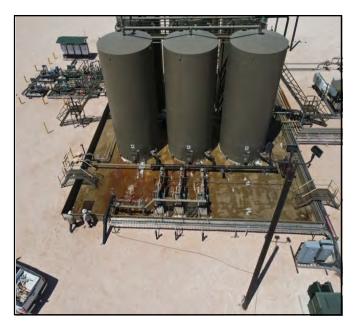
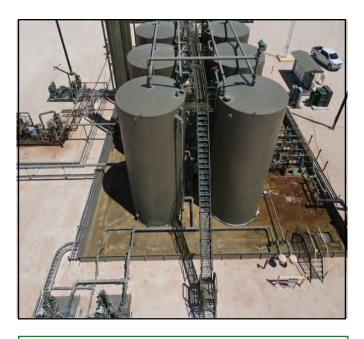
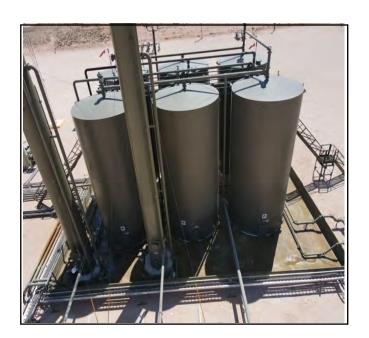
Aerial photo of liner.
