PREPARED BY: PIMA ENVIRONMENTAL SERVICES, LLC

Kool Aid State Battery
Incident ID nAPP2421530638

Liner Inspection and Closure Report

October 7, 2024

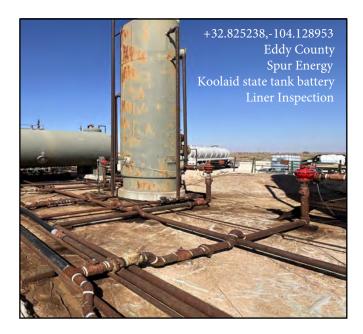
Image of liner pursuant to being power washed.

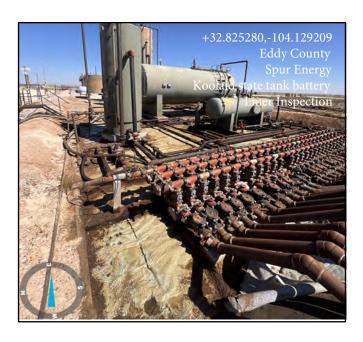
Image of liner pursuant to being power washed.

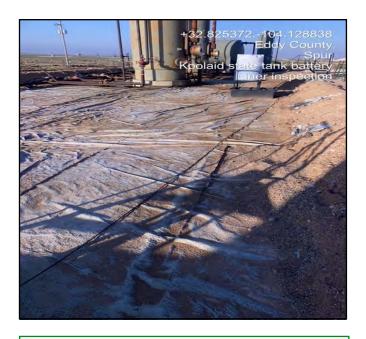
Image of liner pursuant to being power washed.

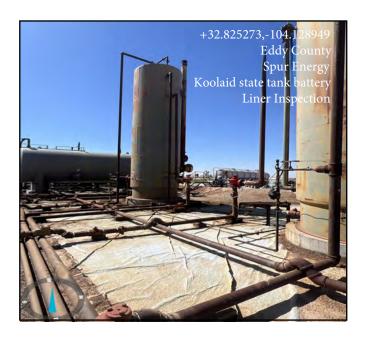
Image of liner pursuant to being power washed.

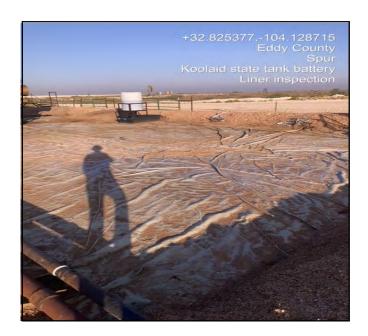
Image of liner pursuant to being power washed.

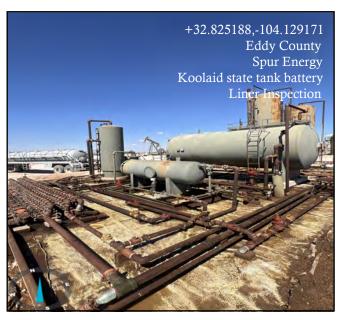
Image of liner pursuant to being power washed.

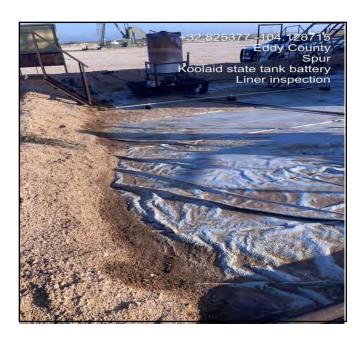
Image of liner pursuant to being power washed.
