LINER INSPECTION CLOSURE REPORT

Incident ID NAPP2429033179

Fighting Okra 18 CTB 3

Facility ID fAPP2123646509

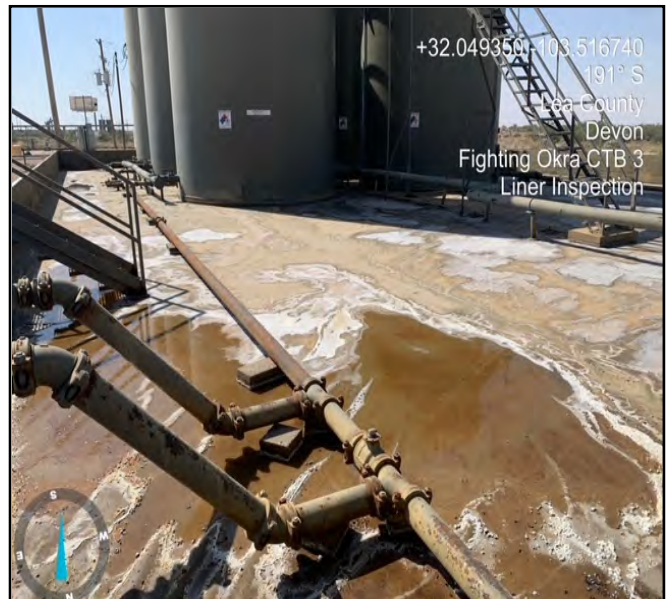
Photo of liner taken prior to power washing.
Facing South.

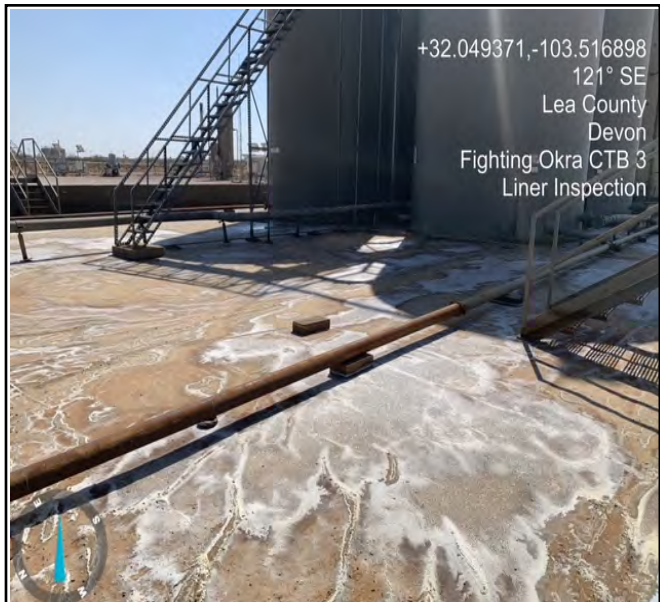
Photo of liner taken prior to power
washing. Facing Southeast.

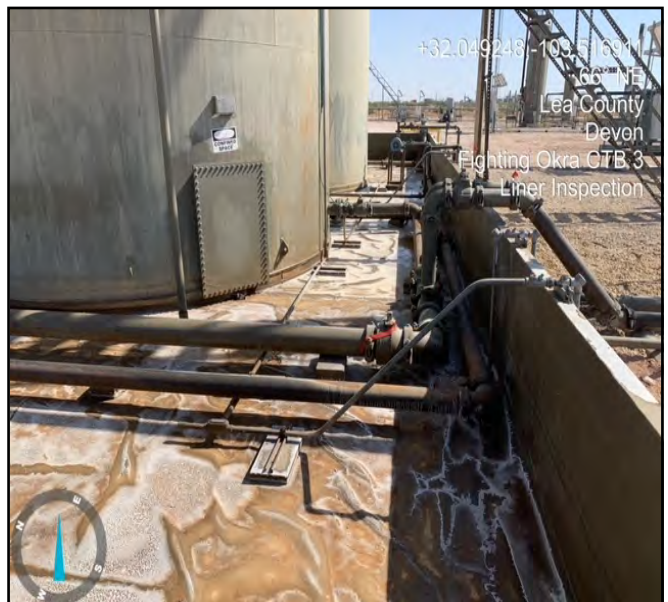
Photo of liner taken prior to power washing.
Facing Northeast.

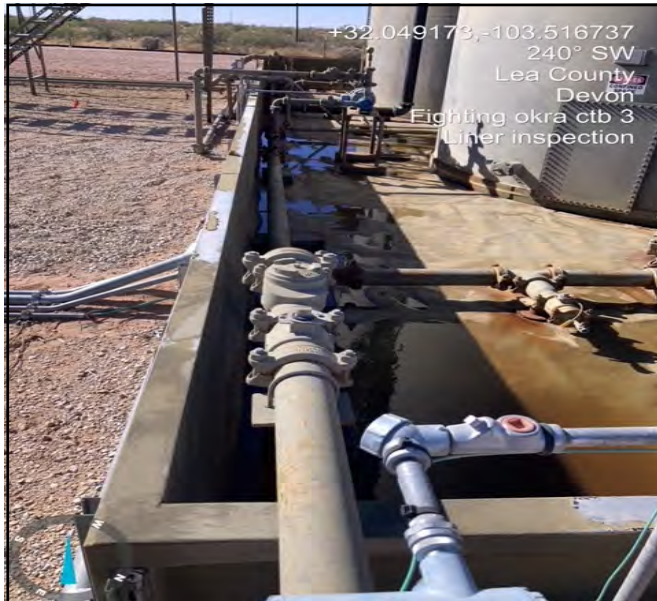
Photograph taken after power washing.
Residual rainwater, Facing southwest.

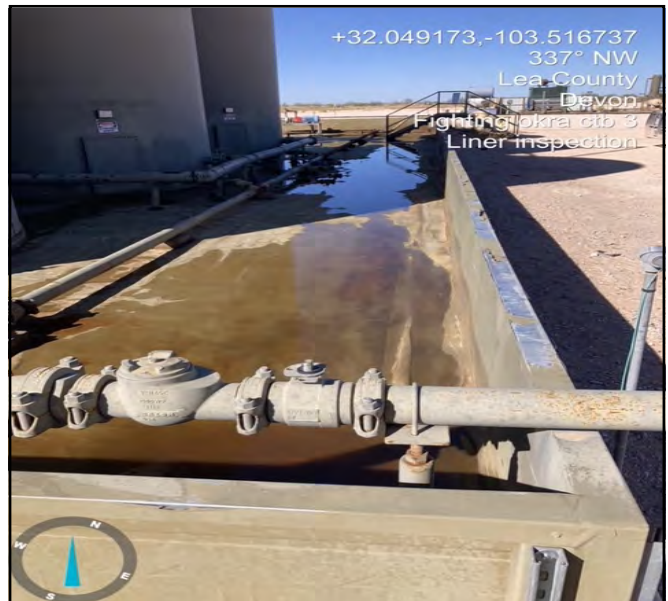
Photograph taken after power washing.
Residual rainwater, Facing Northwest.

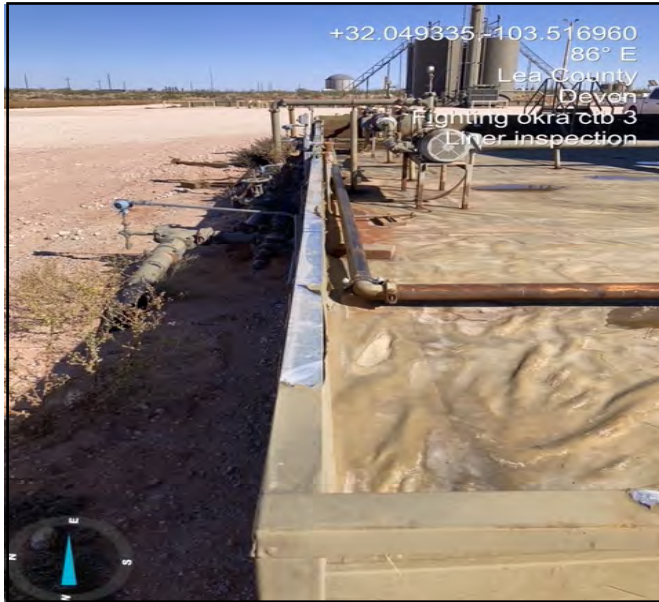
Photograph taken after power washing.
Residual rainwater, Facing East.

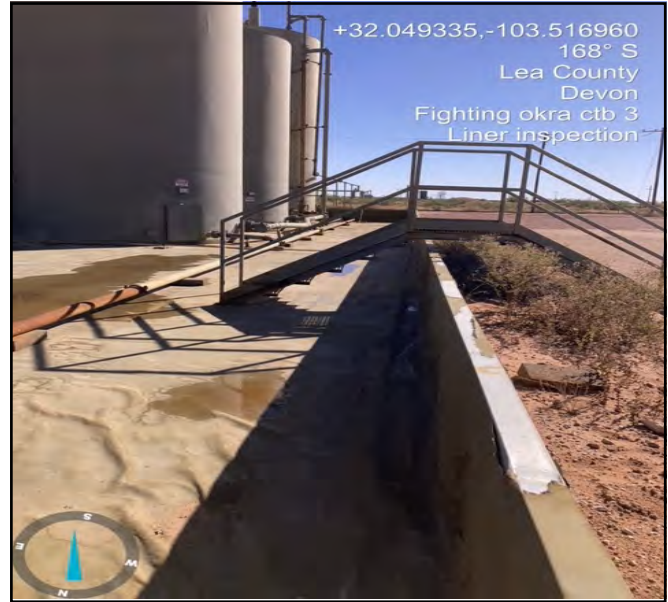
Photograph taken after power washing.
Residual rainwater, Facing South.

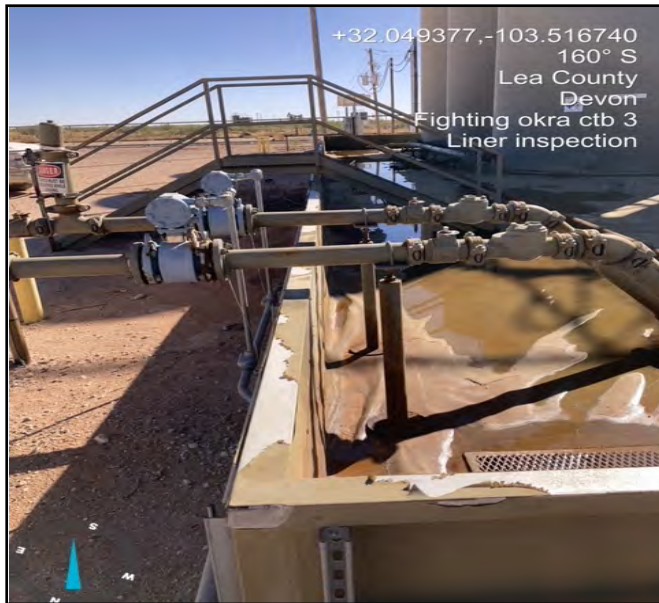
Photograph taken after power washing.
Residual rainwater, Facing South.

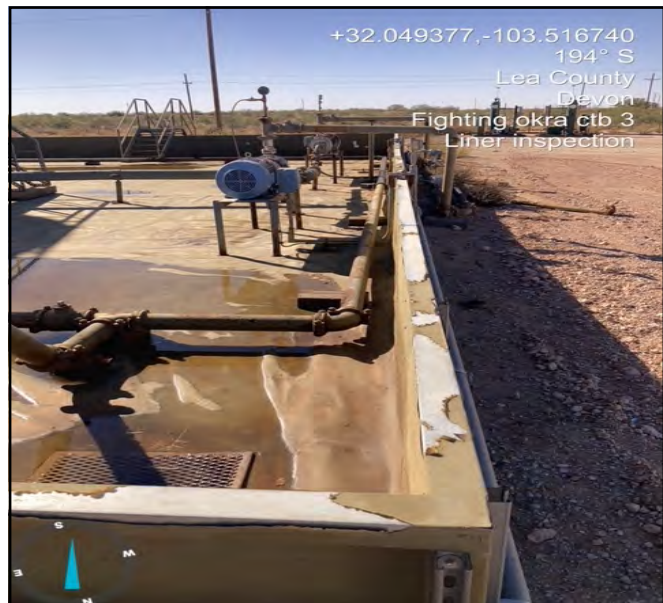
Photograph taken after power washing.
Residual rainwater, Facing South.
