Aid North 14 13 State Com Battery

Incident ID nAPP2428740038

Liner Inspection and Closure Report

RE: Liner Inspection and Closure Report
Aid North 14 13 State Com Battery
API No. 30-015-54076
GPS: Latitude 32.83938 Longitude -104.14534
UL- B, Section 14, Township 17S, Range 28E
NMOCD Reference No. NAPP2428740038

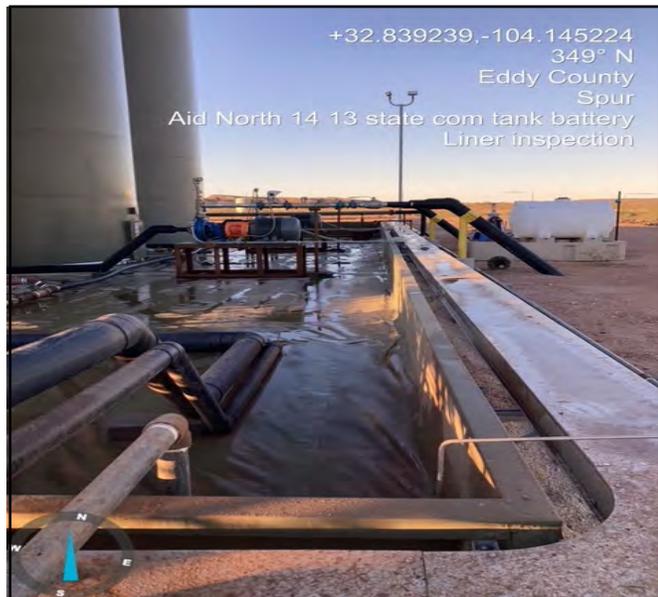
Photo of liner pursuant to being power washed facing North. Fluid from power washer.

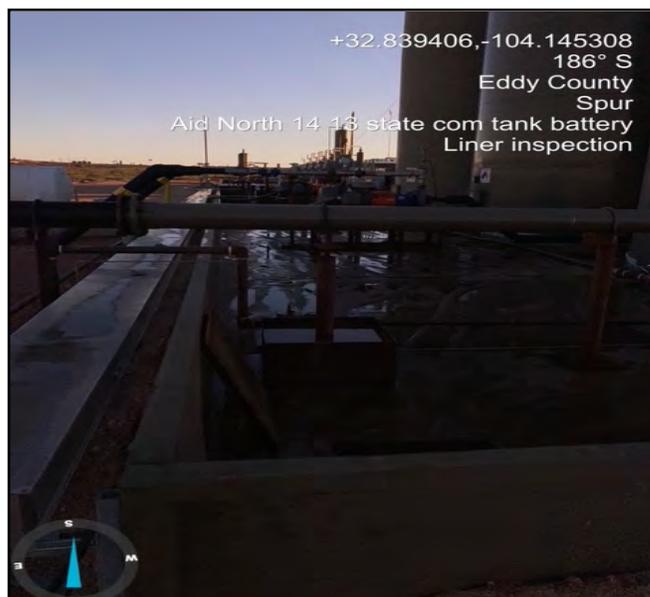
Photo of liner pursuant to being power washed facing South. Fluid from power washer.

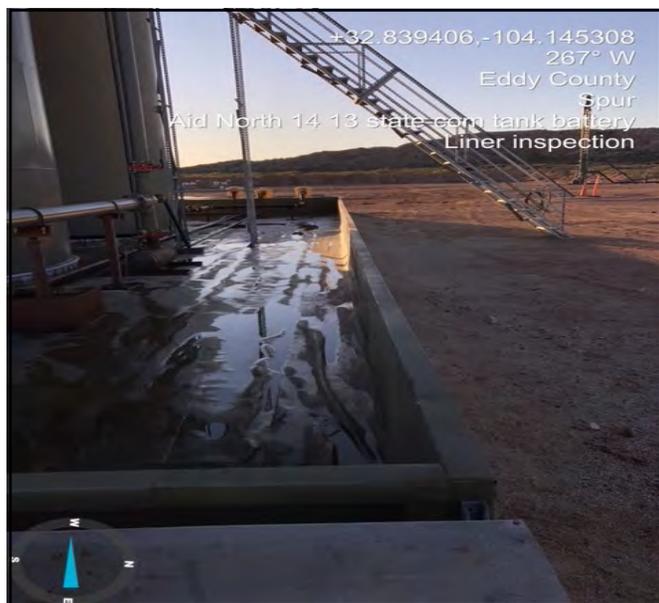
Photo of liner pursuant to being power washed facing West. Fluid from power washer

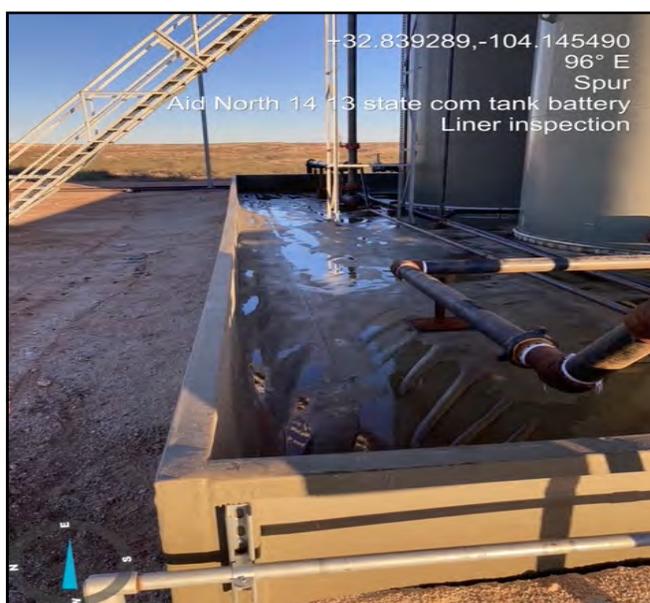
Photo of liner pursuant to being power washed facing East. Fluid from power washer.

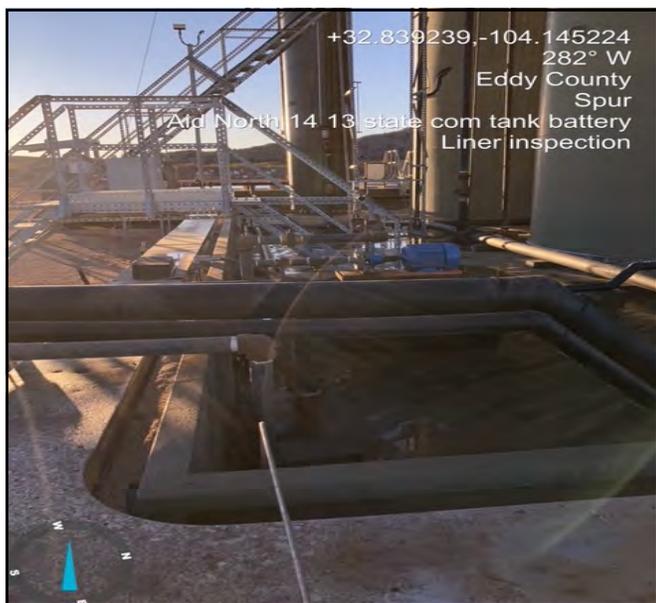
Photo of liner pursuant to being power washed facing West. Fluid from power washer

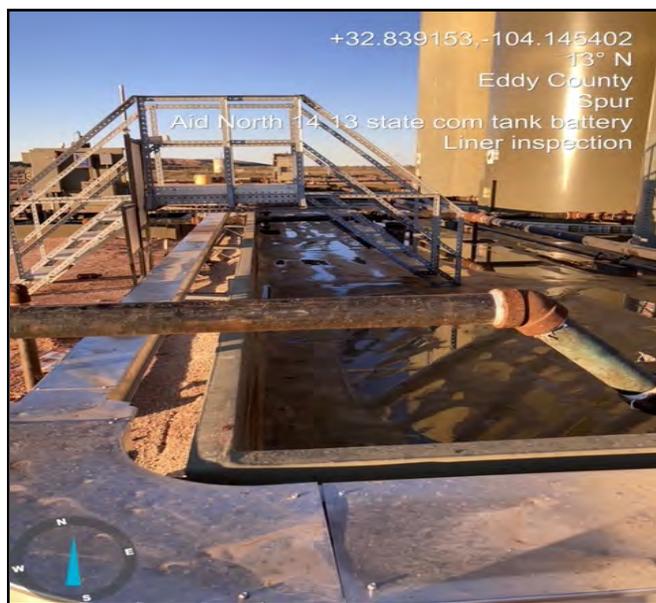
Photo of liner pursuant to being power washed facing North. Fluid from power washer.

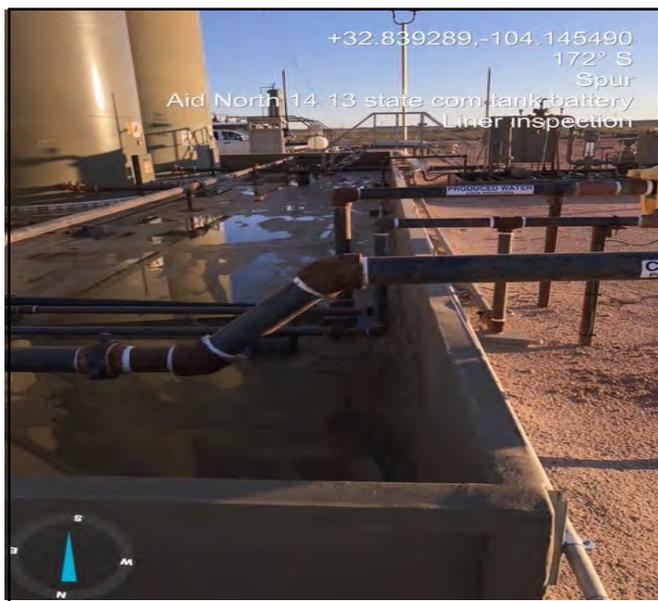
Photo of liner pursuant to being power washed facing South. Fluid from power washer.

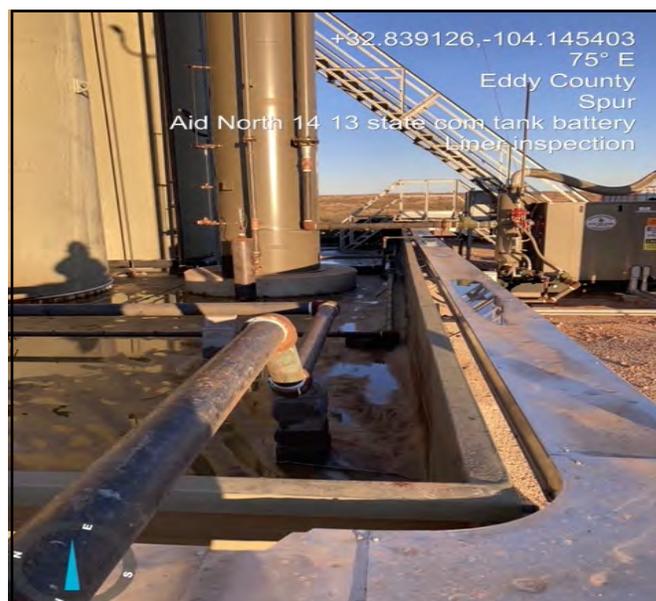
Photo of liner pursuant to being power washed facing East. Fluid from power washer
