PROJECT # 5E33088 BG# 5

SUBJECT: Closure Request Report for the RDX Federal 21 #022/ 21-22 Pad, Incident ID #'s nAPP2430235253 and nAPP2430930089, Eddy County, New Mexico.

Site Inspection Report

Site Name: RDX Federal 21 #022

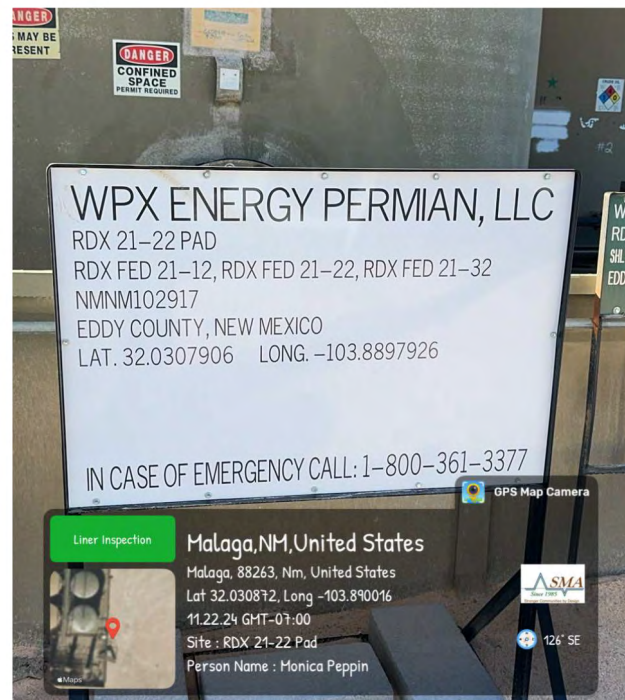
**Photograph #1: Lease sign for
proof of being at correct site**

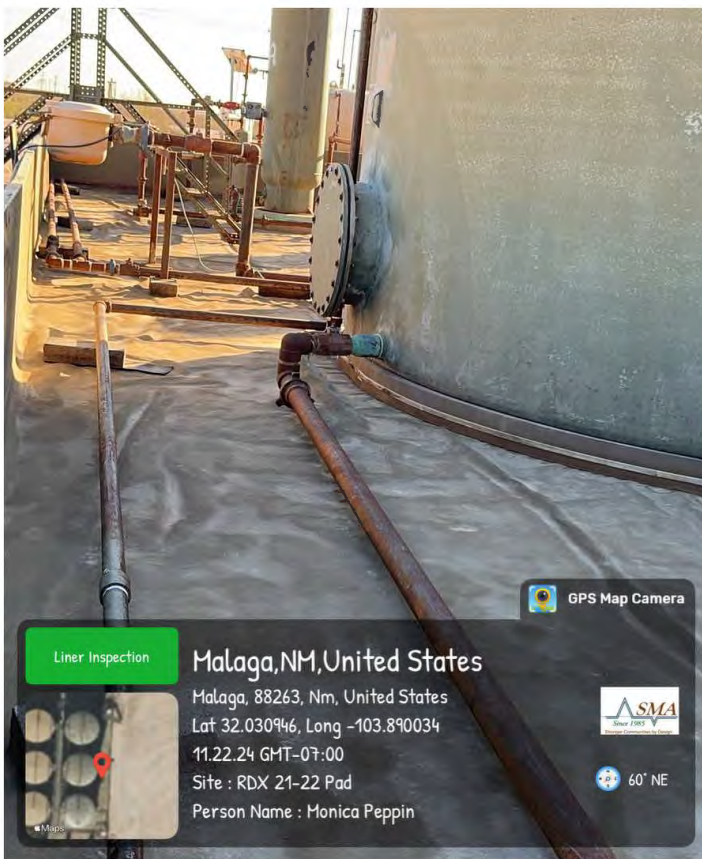
Photograph #3: East side showing east to south area

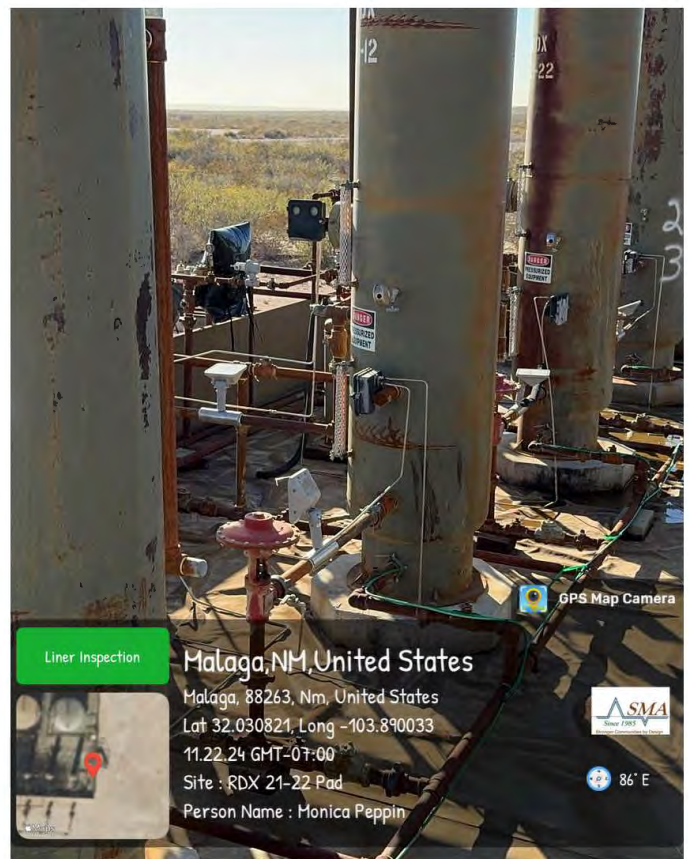
Photograph #4: east side looking west showing south end of liner

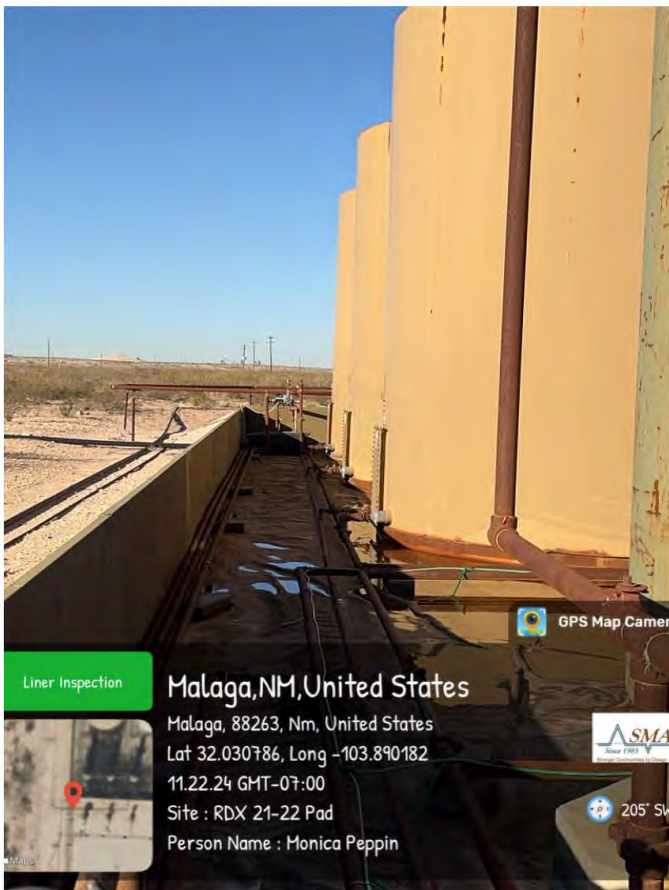
Photograph #5: Facing north from southwest corner showing west side of containment

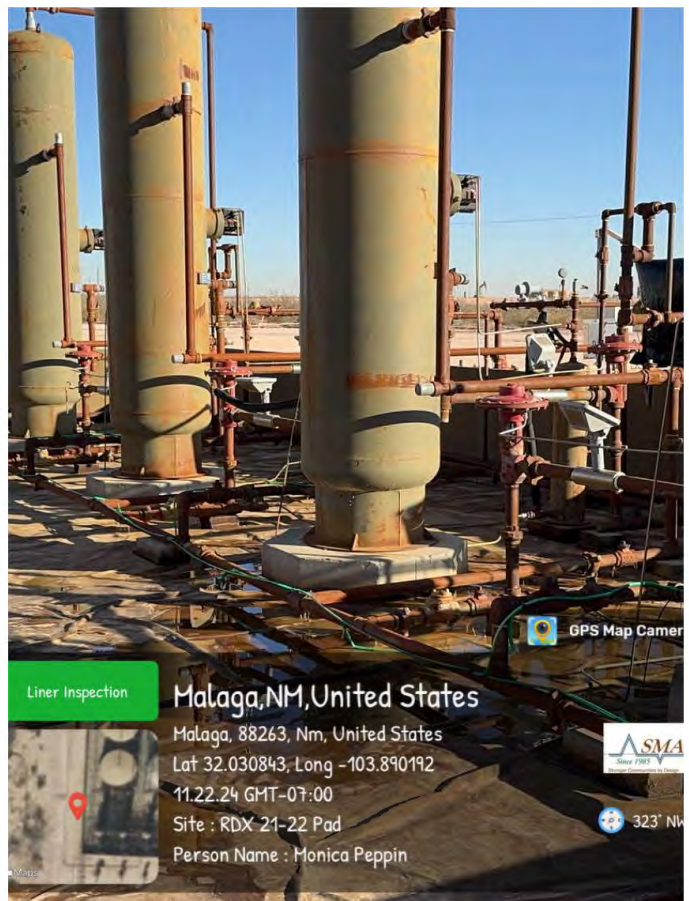
Photograph #6: Facing southeast to show south end from southwest corner

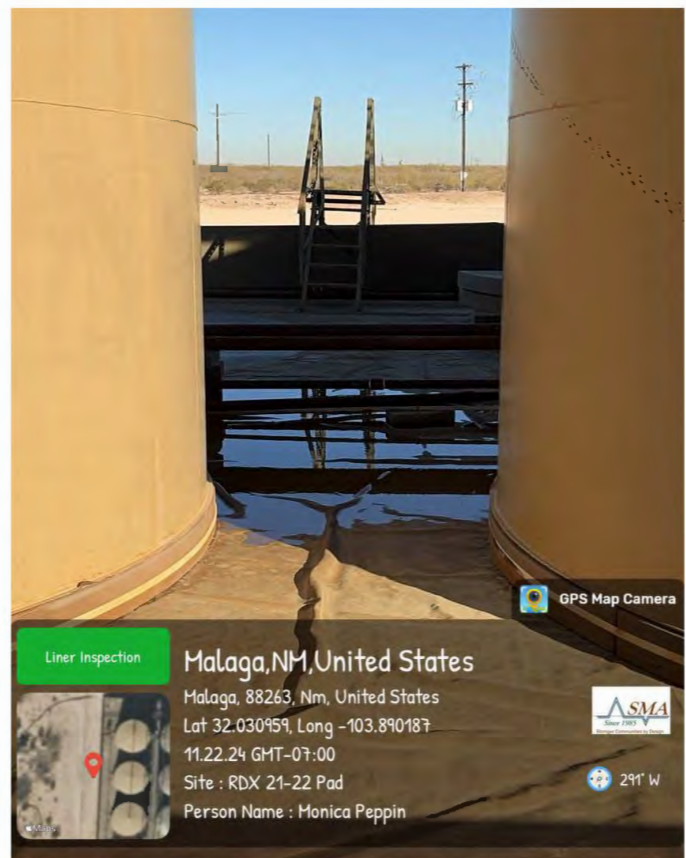
Photograph #8: Facing east from west middle area of containment

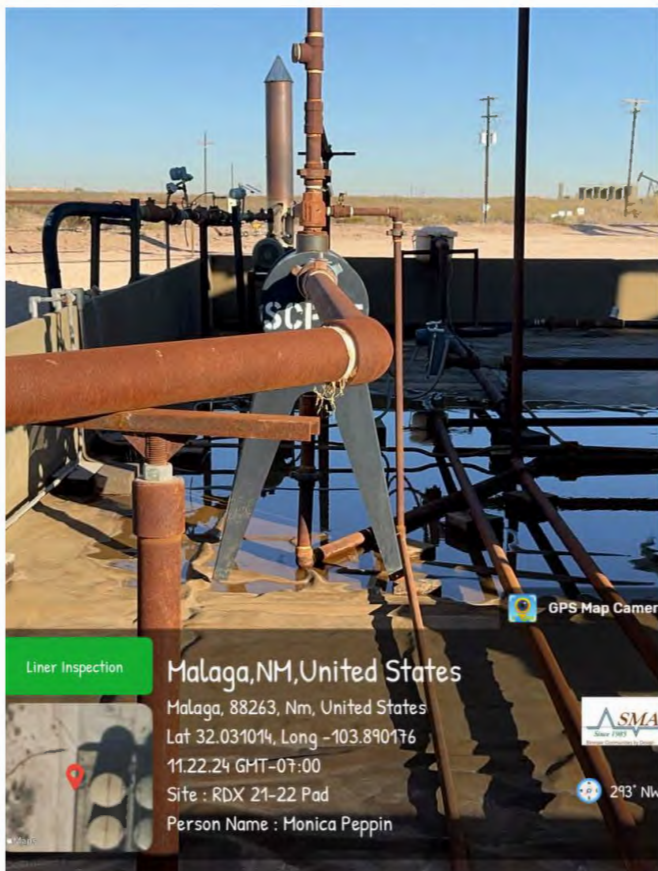
Photograph #9: Facing east from west/northwest side

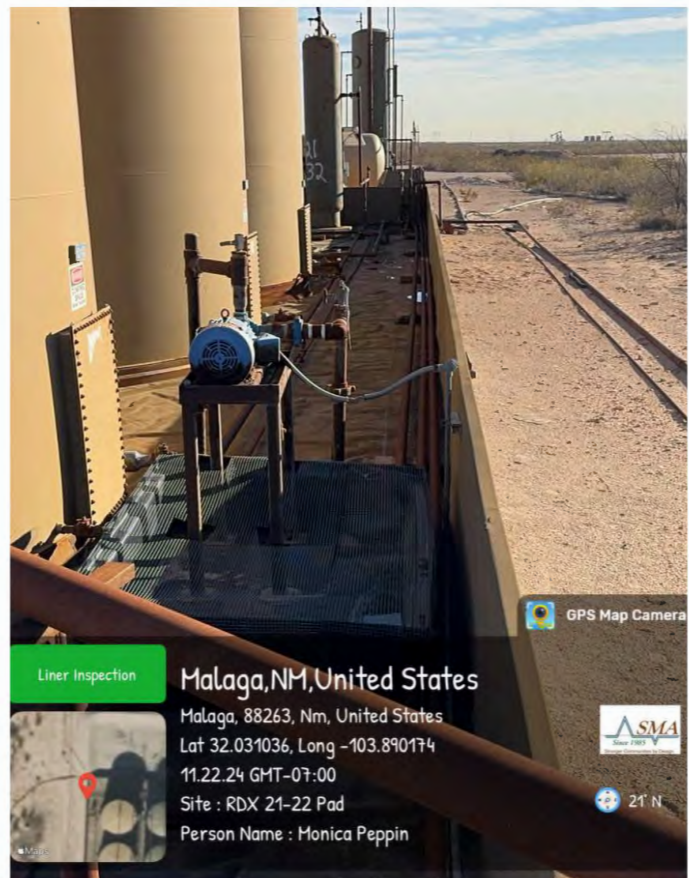
Photograph #10: Facing south from north west corner

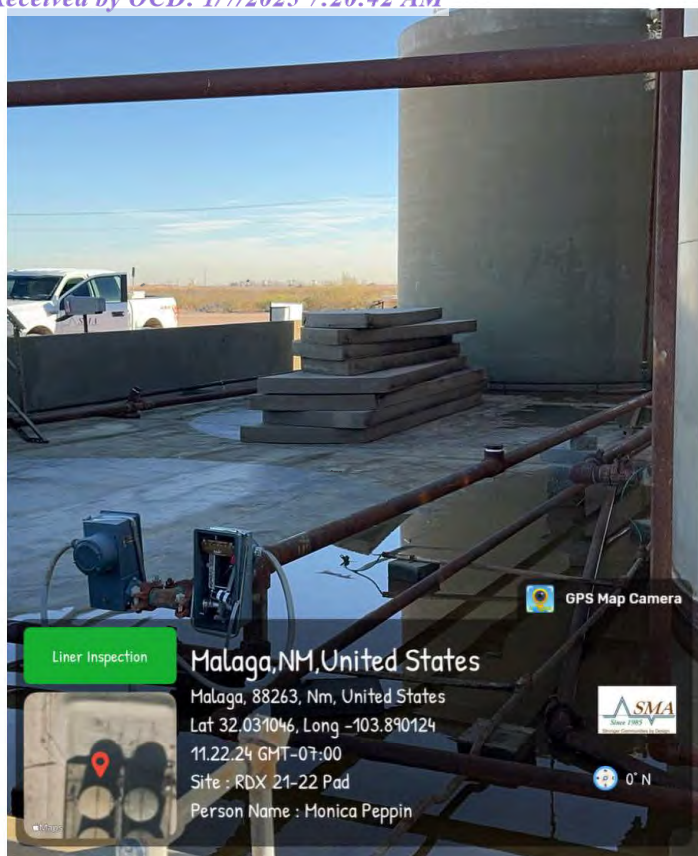
Photograph #11: Facing south from northwest corner

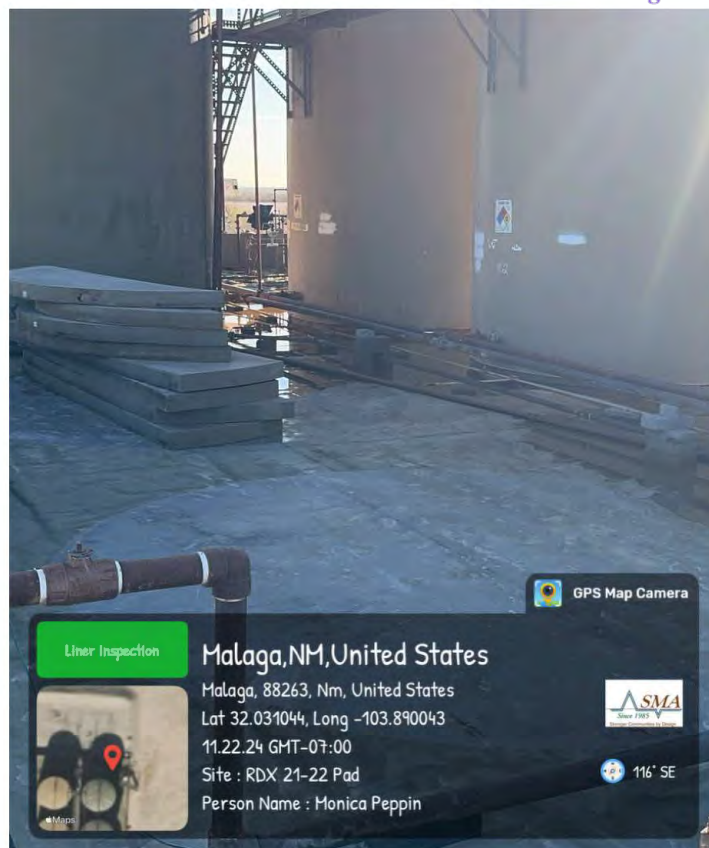
Photograph #12: Facing south from northeast side of containment

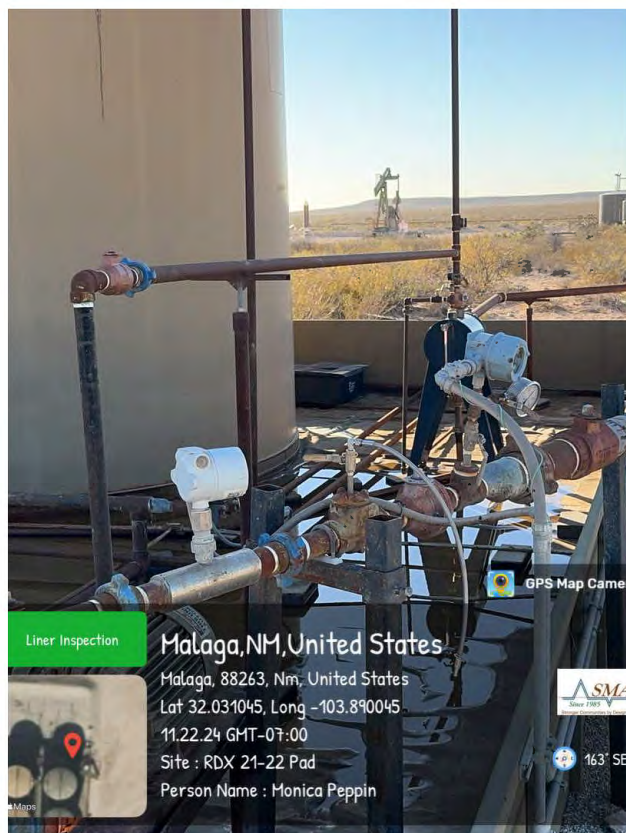
Photograph #13: north end of containment facing west

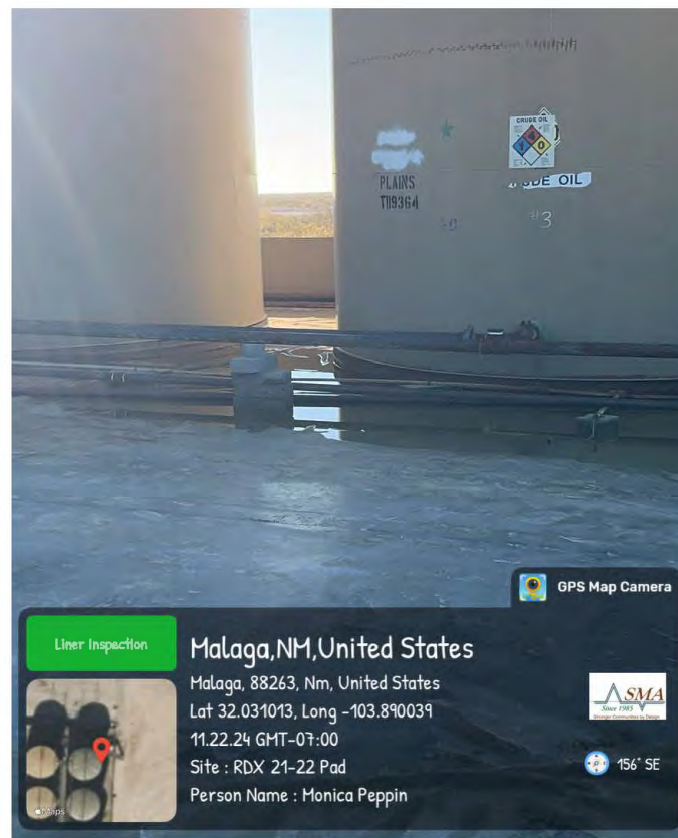
Photograph #14: Facing west/southwest from mid area on east side

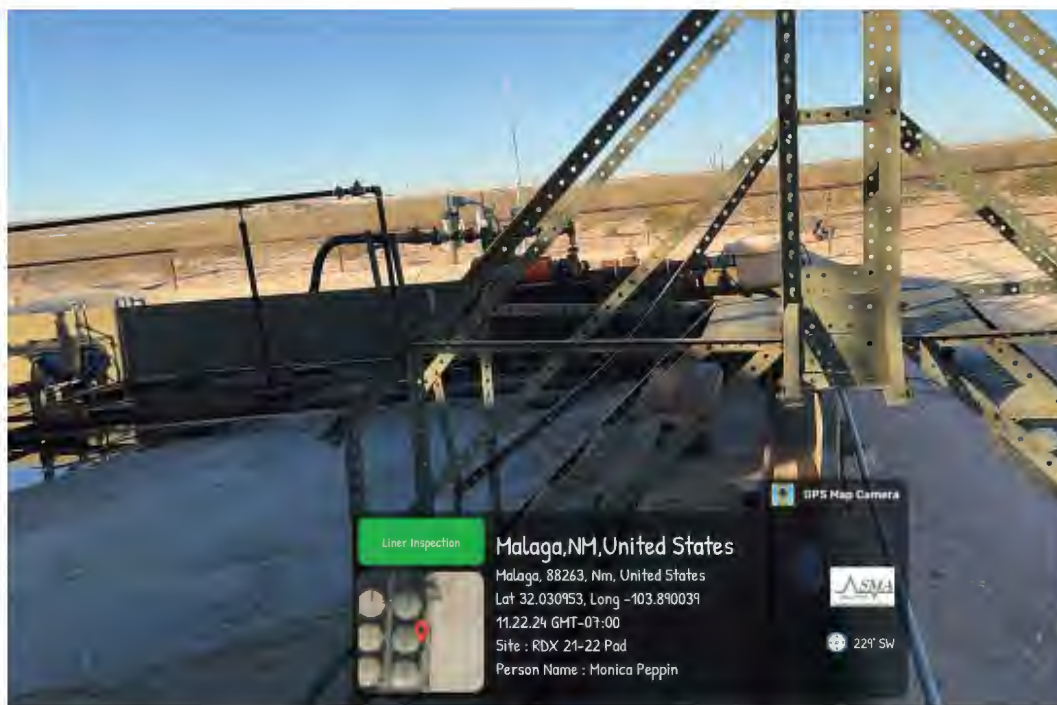
Photograph #15: Facing north to show northeast corner of containment near steps
