SUBJECT: Closure Request Report for the Big Cat 9 CTB 2, Incident ID # nAPP2433733620,
 Facility ID fAPP2329744254, Lea County, New Mexico.

Site Assessment and Photolog

Client: Devon Energy
 Facility ID: fAPP2329744254
 Federal ID: NMNM126065
 Site: Big Cat 9 CTB 2

Incident ID: nAPP2433733620
 Project Manager: Monica Peppin
 Project Owner: Jim Raley

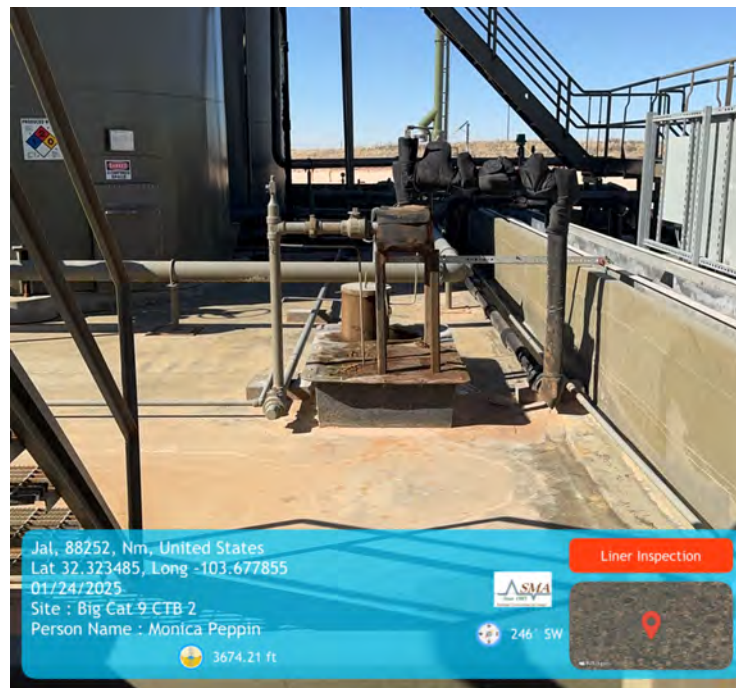
Photograph #2: East side of containment looking north.

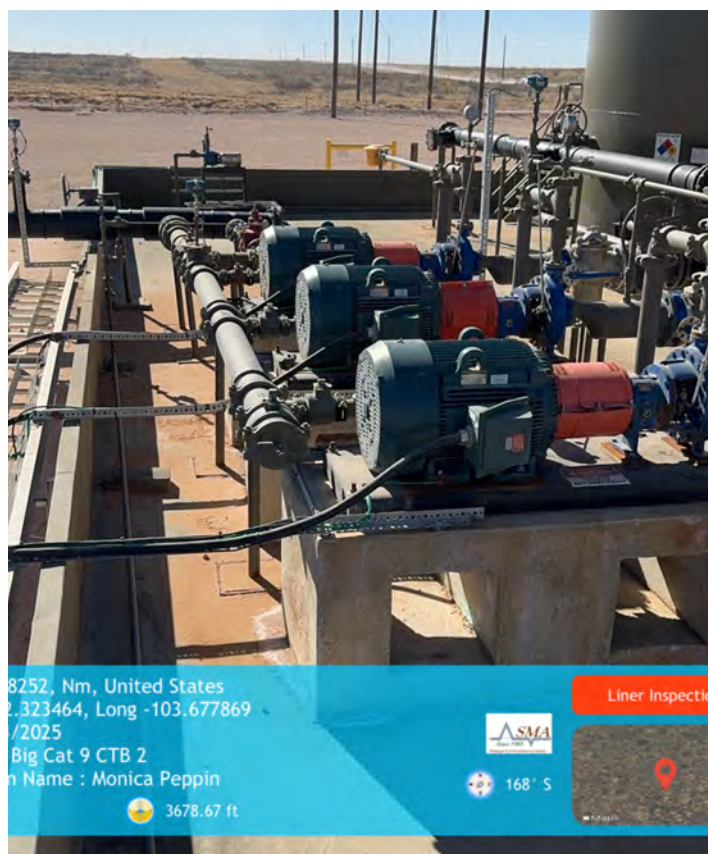
Photograph #3: East wall area where transfer pumps are located facing south.

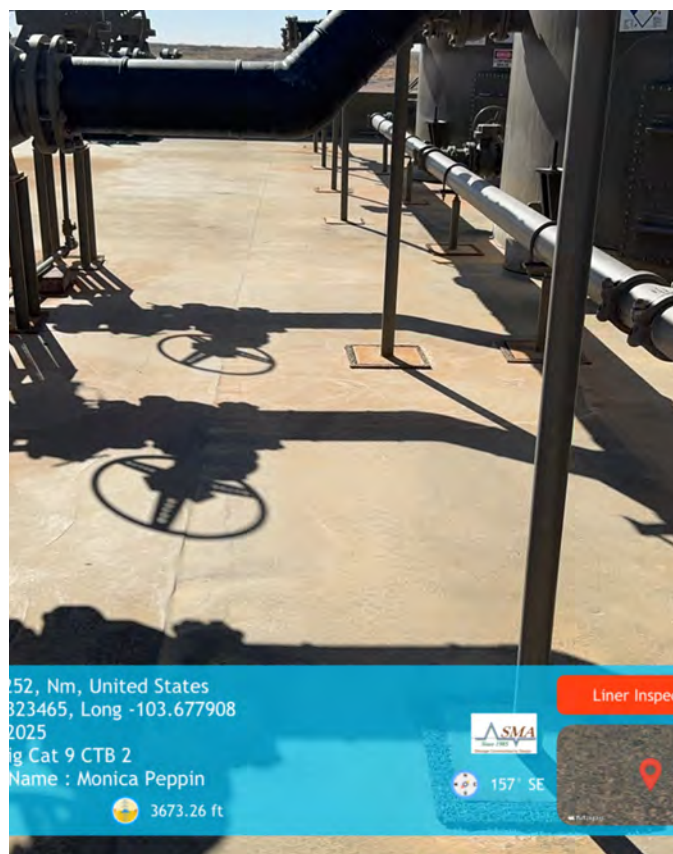
Photograph #4: East area between transfer pumps and storage tanks.

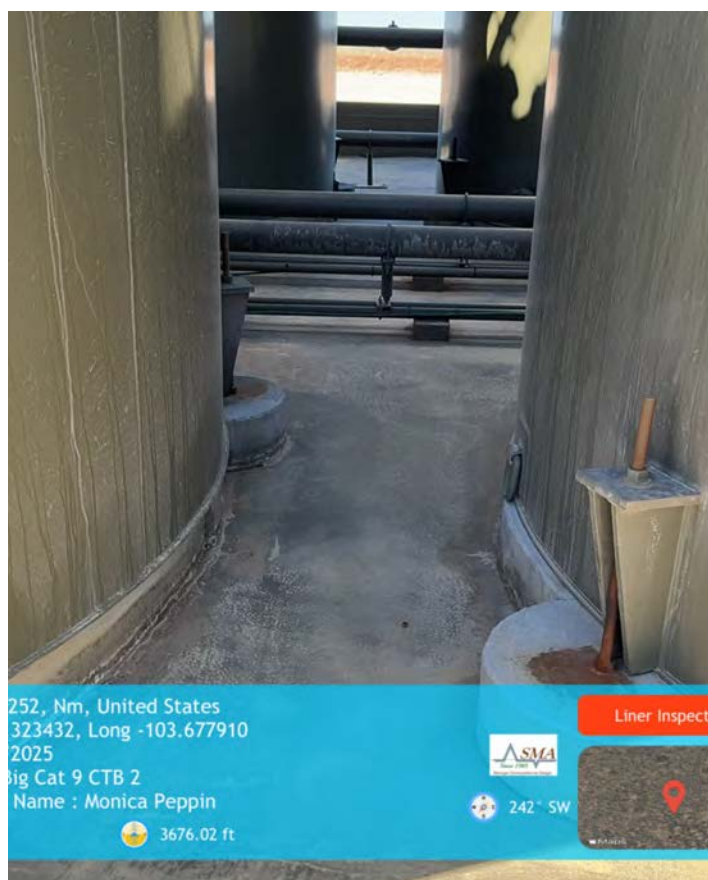
Photograph #5: Facing east viewing
 liner between tanks.

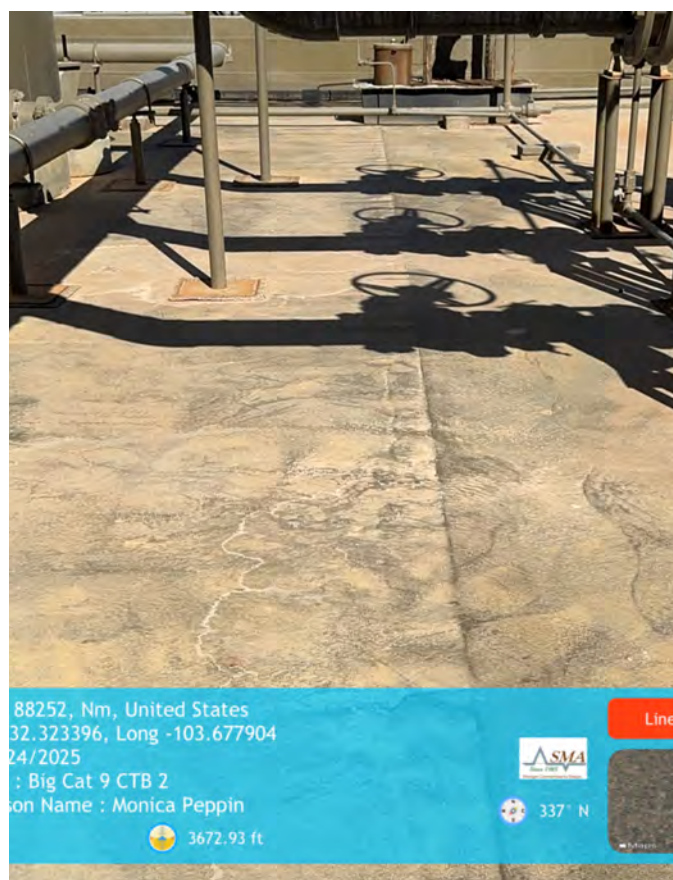
Photograph #6: Viewing east area
 facing north.

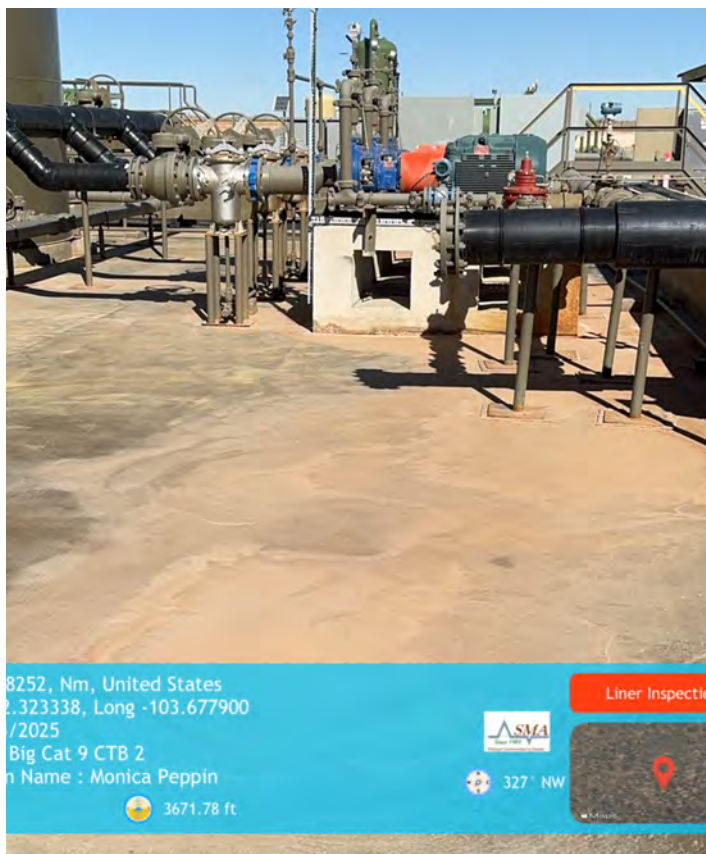
Photograph #7: Facing north from southeast corner.

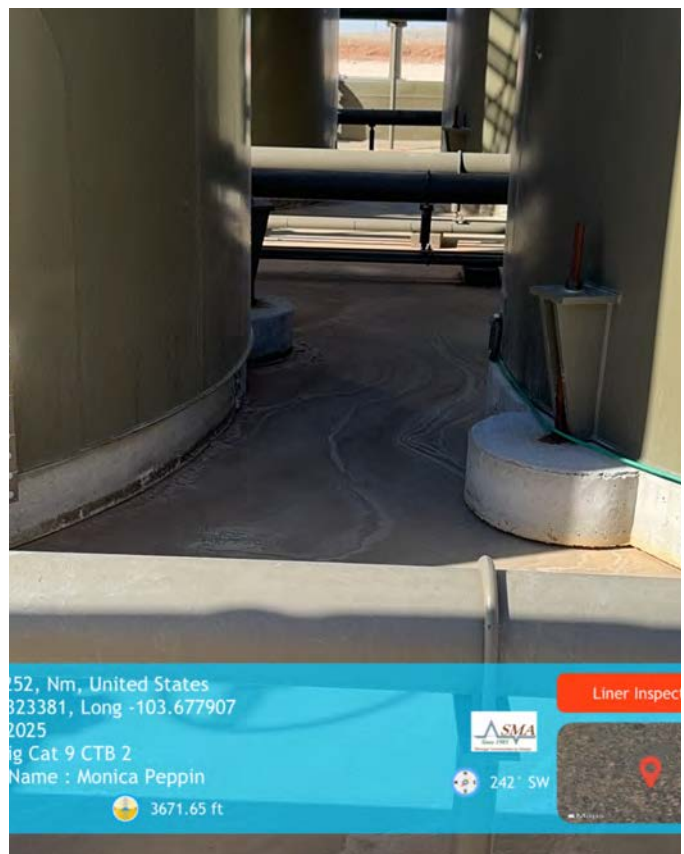
Photograph #8: Viewing liner between tanks facing west.

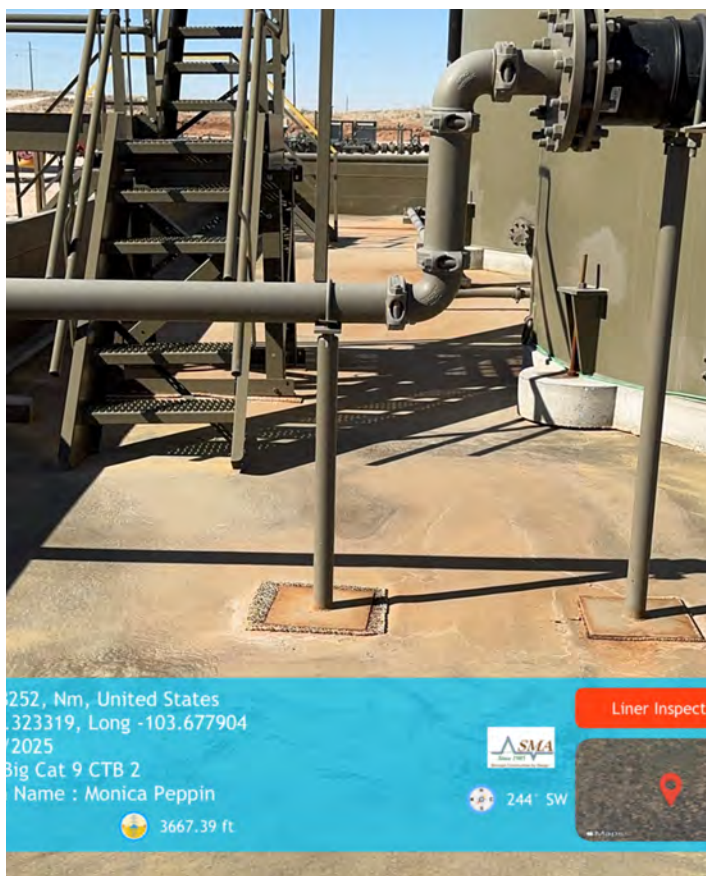
Photograph #9: West view of south wall area

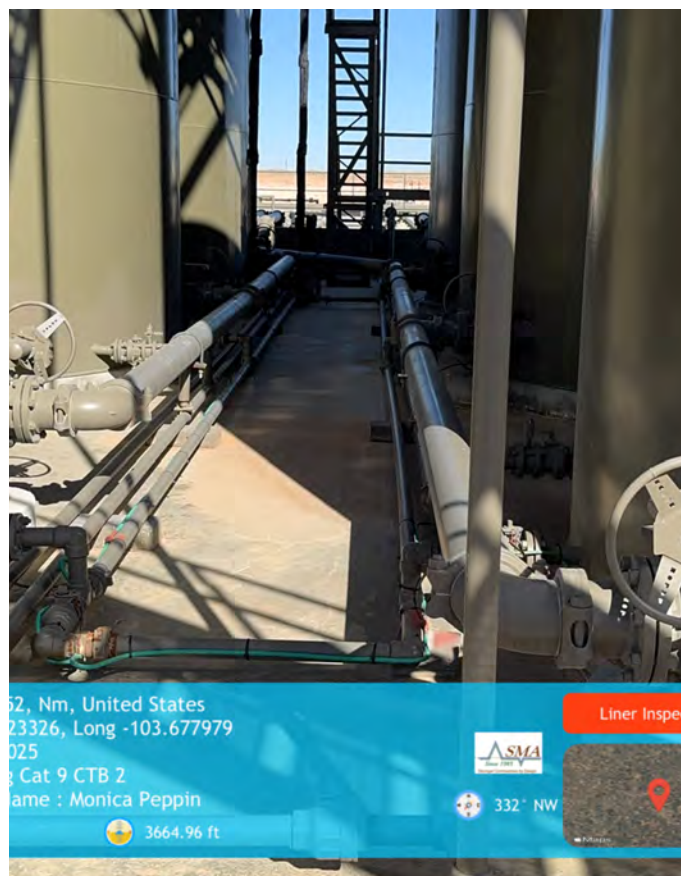
Photograph #10: South view between tanks.

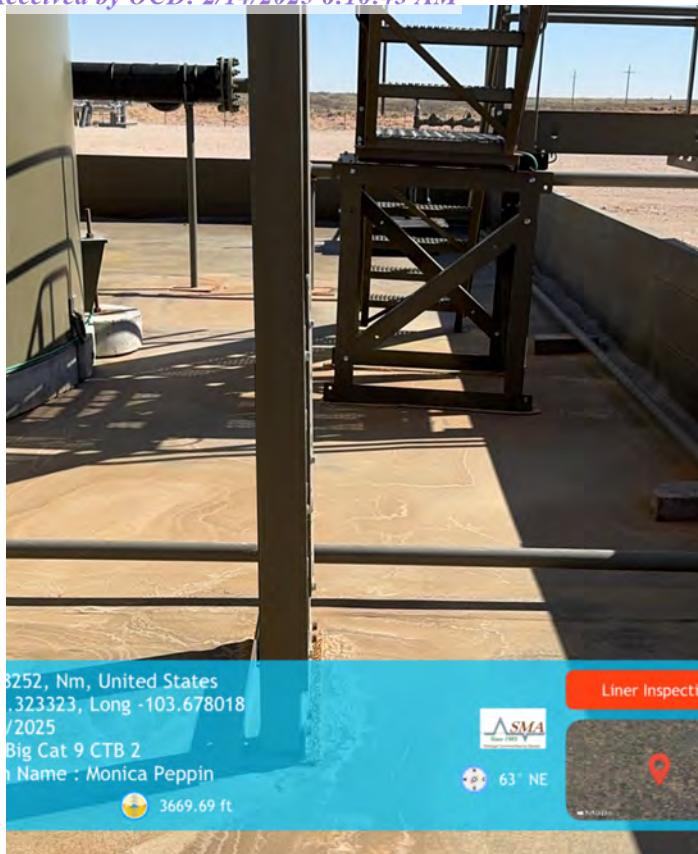
Photograph #11: East view of south wall area near catwalk.

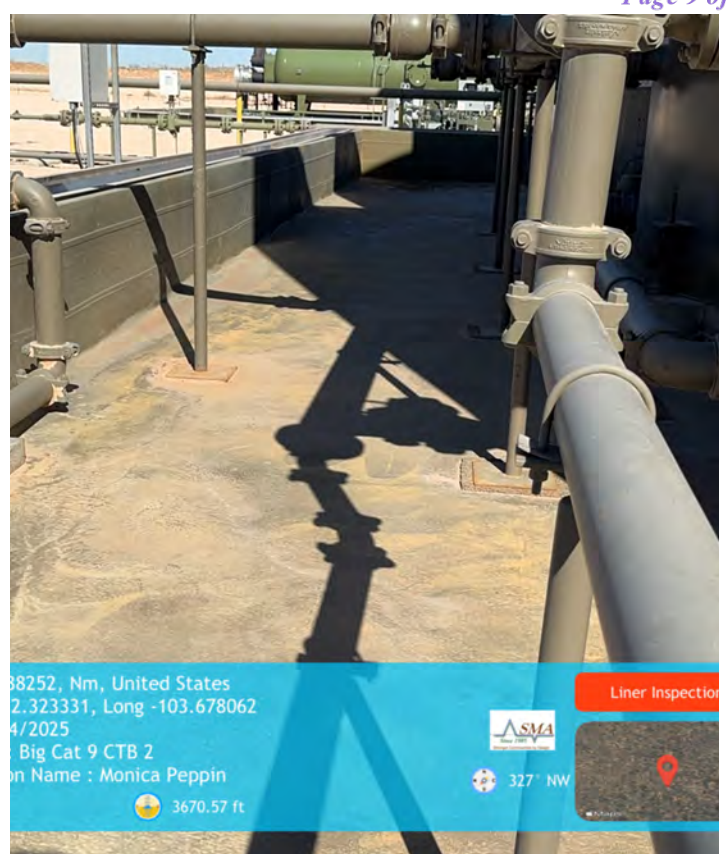
Photograph #12: Facing north viewing northwest area.

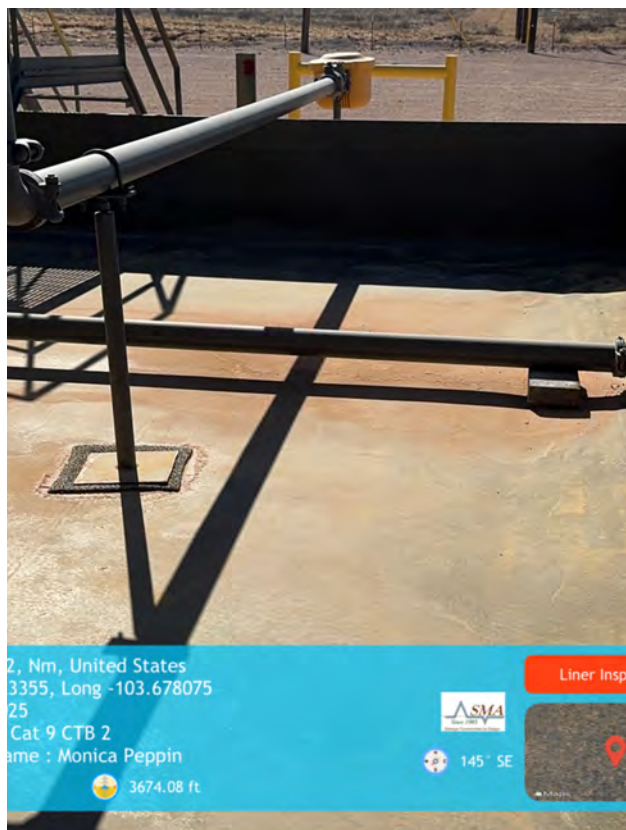
Photograph #13: Facing south viewing area near load pot.

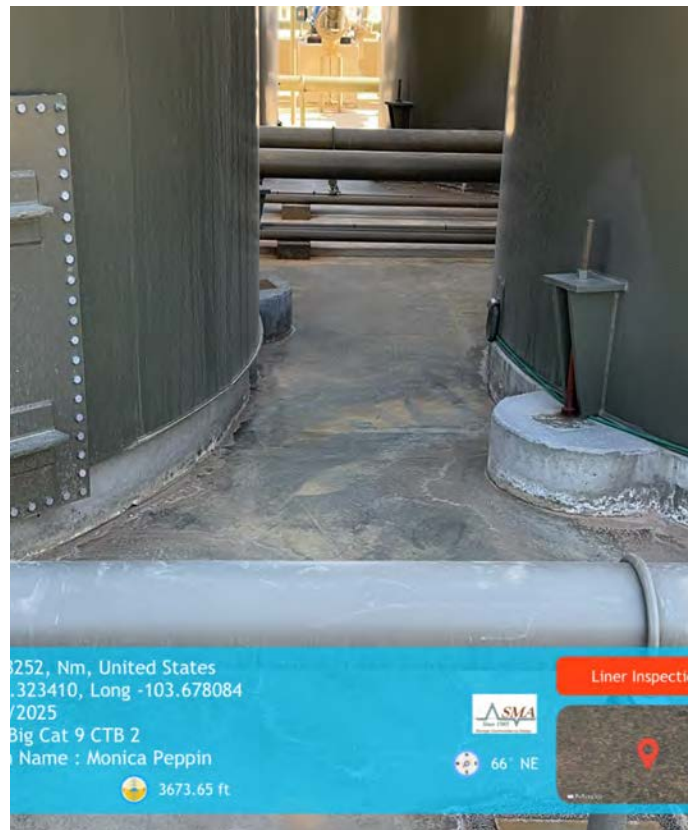
Photograph #14: View of liner between tanks facing east.

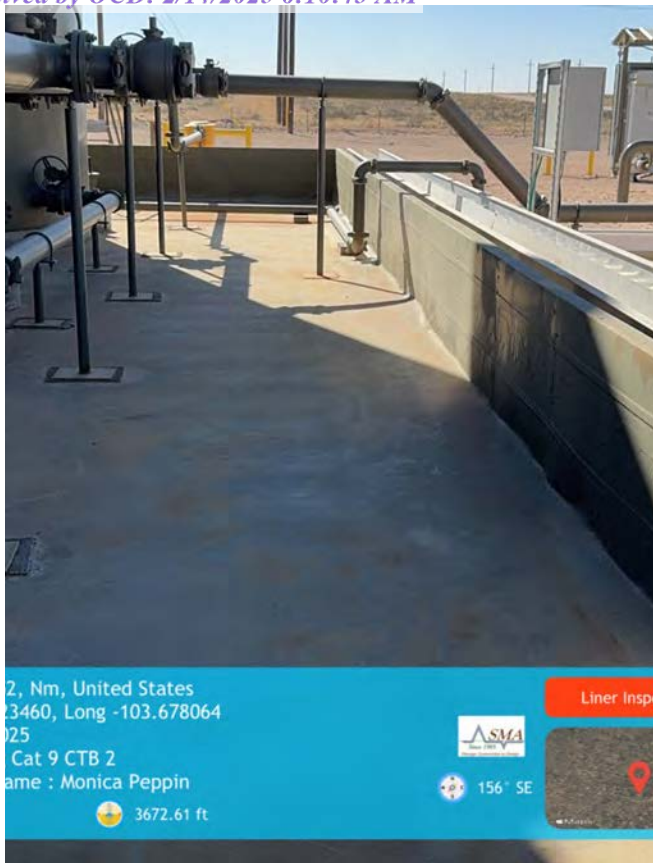
Photograph #15: Facing south looking down west wall.

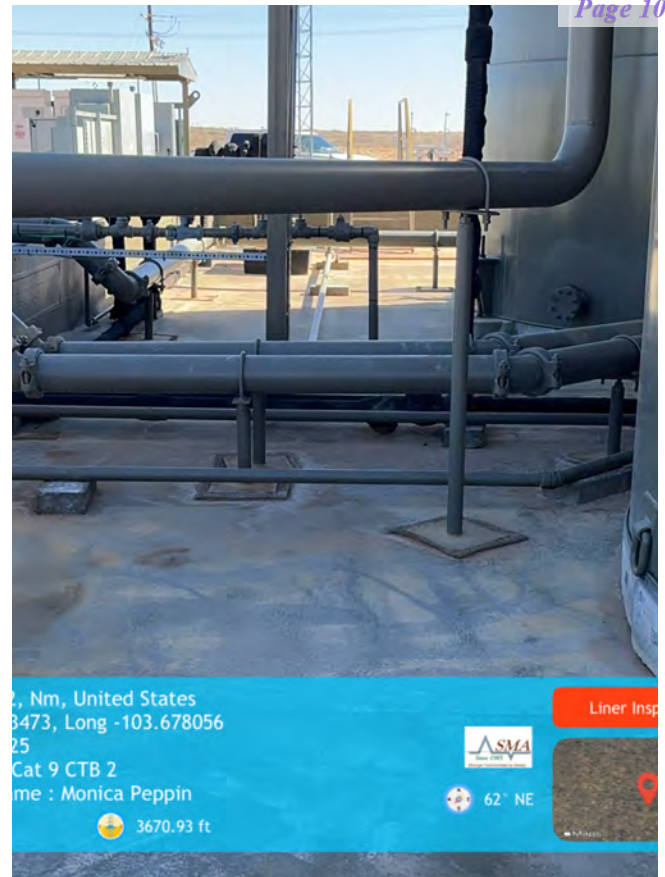
Photograph #16: East view of northern liner under equipment.

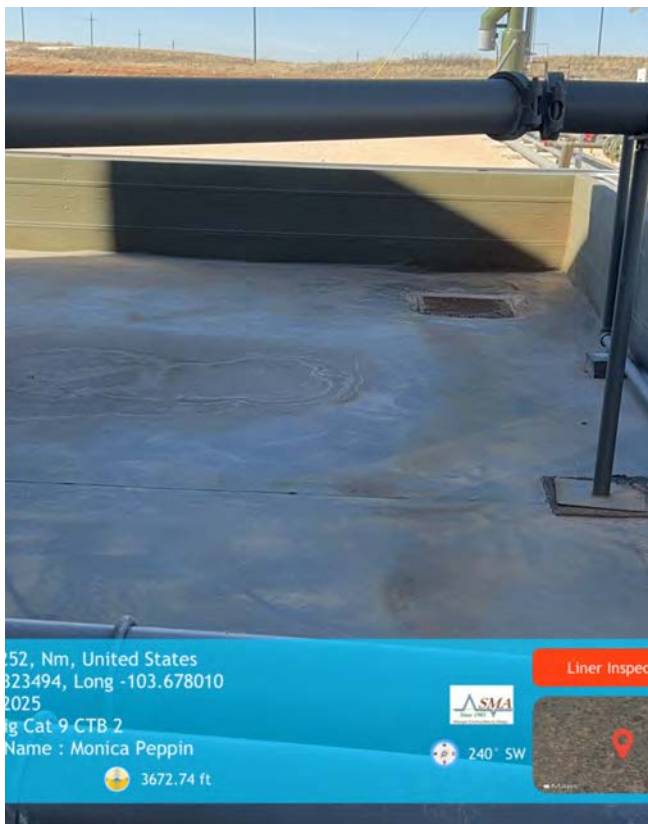
Photograph #17: View of northwest corner.

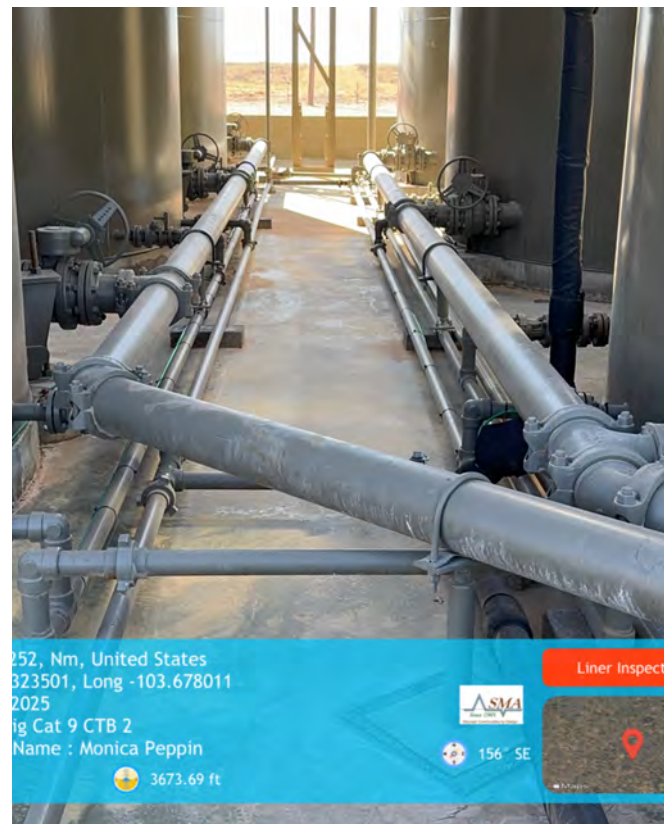
Photograph #18: Facing south viewing liner between tanks.

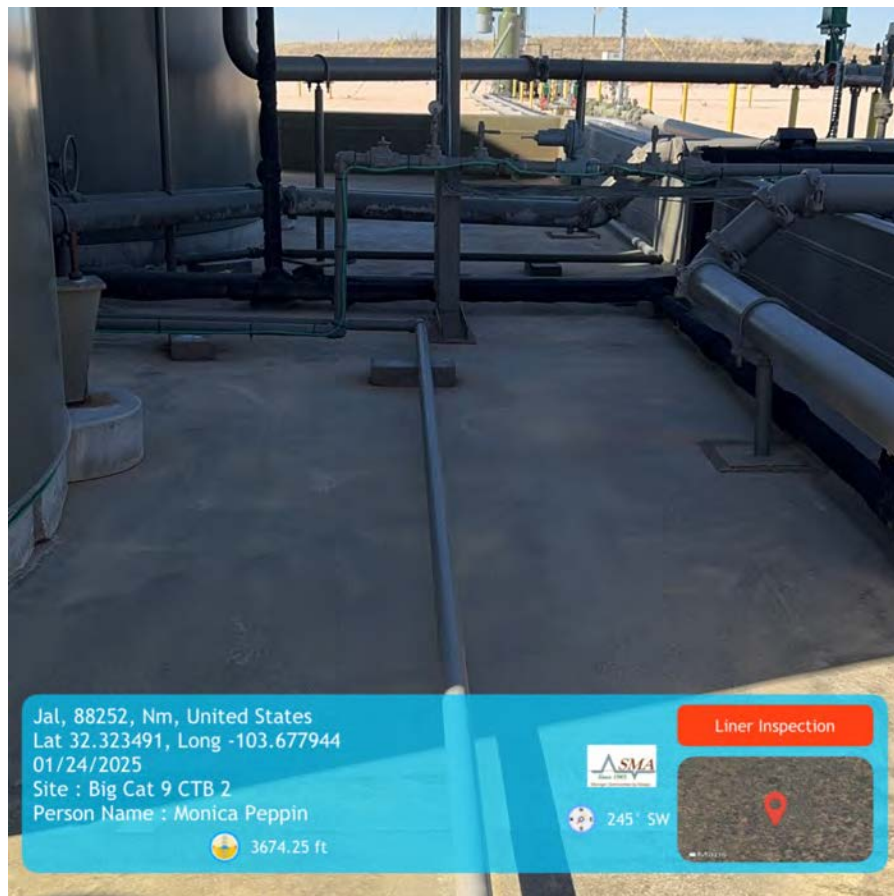
Photograph #19: View down north wall looking west.
