RE: LINER INSPECTION AND CLOSURE REPORT

**LOCATION:** Mimosa 24 Fed Battery

NMOCD REF. NO. <u>NAPP2035646158</u>

## SITE PHOTOGRAPHS DEVON ENERGY

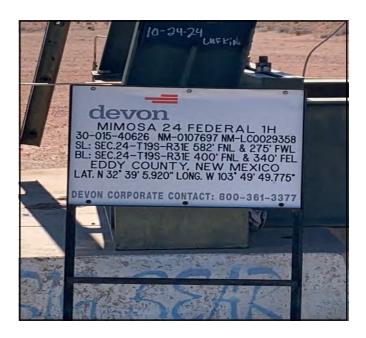
Site Information sign.

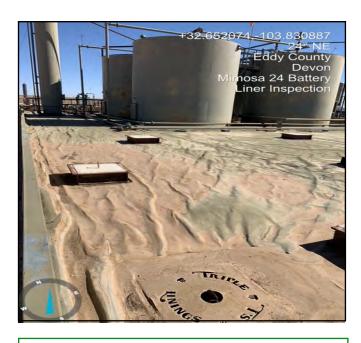
Photo of liner taken facing northeast.

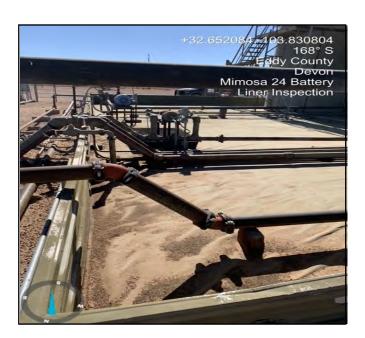
Photo of liner taken facing south.

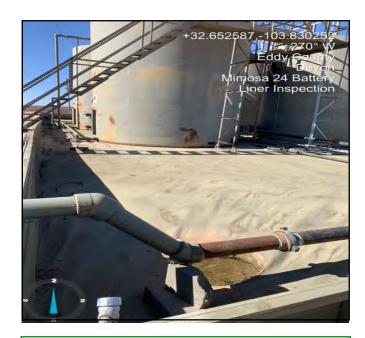
Photo of liner taken facing west.

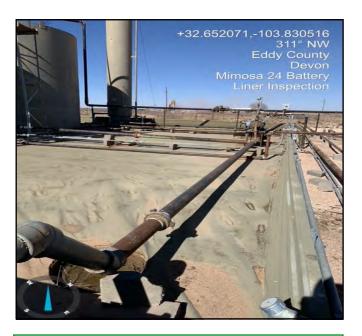
Photo of liner taken facing northwest.

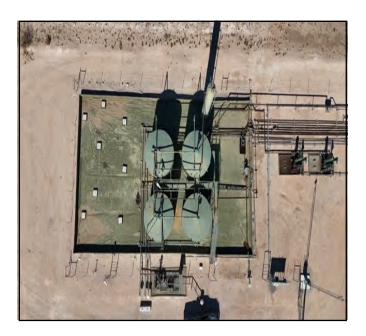
On February 27, 2025, after sending the 48-hour notification (Appendix C), Pima Environmental conducted a secondary liner inspection at this location. We concluded that this liner is intact and remains free of any holes or tears that could potentially compromise the integrity of the liner or cause any negative environmental impact. The liner inspection form can be found in Appendix C and photographic documentation can be found in Appendix D.

Aerial photo of liner.
