Our Ref.: 12663172-NMOCD-1

March 12, 2025

Closure Report  
Devon Energy Production Company, LP  
Cotton Draw 14 Battery  
Unit Letter D, Section 14, T25S, R31E  
GPS: 32.1367521, -103.75341  
Eddy County, New Mexico

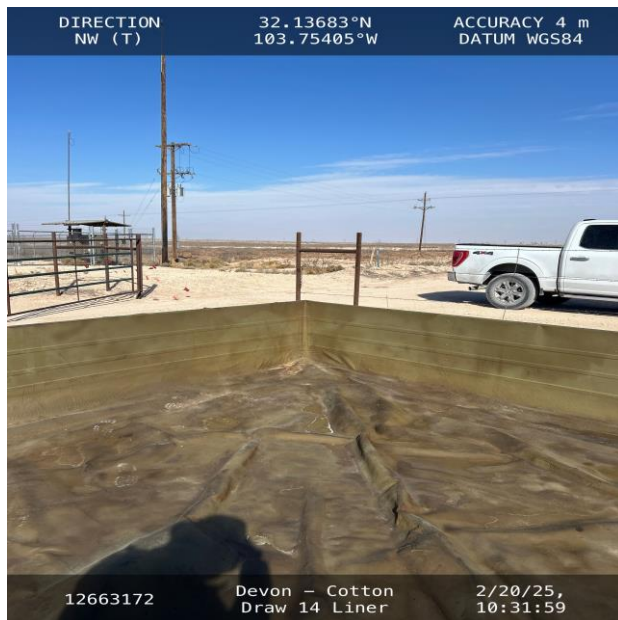
**Photo 1** View of northwestern corner of secondary containment.

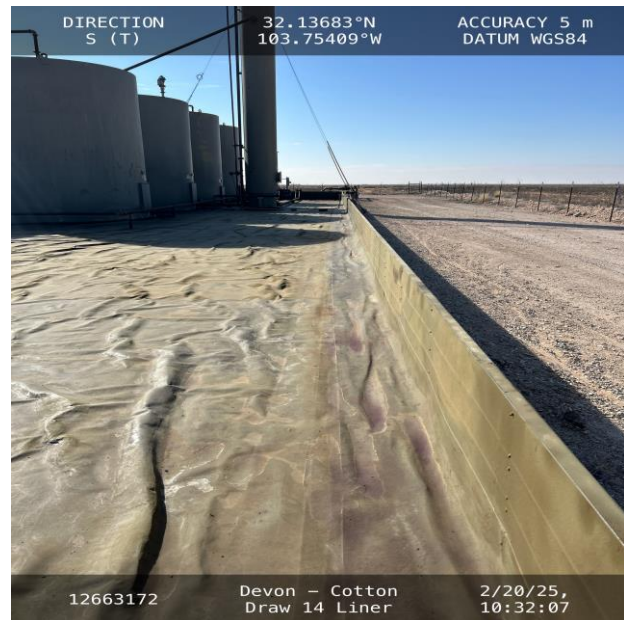
**Photo 2** View western side of secondary containment facing south.

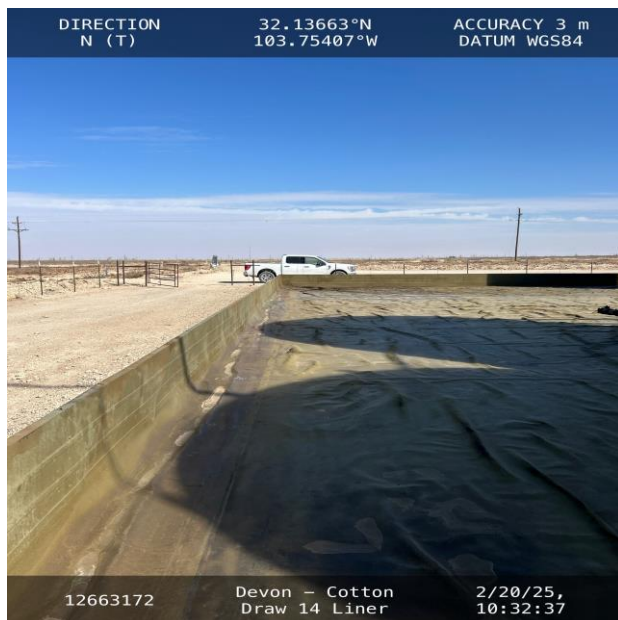
**Photo 3** View of western side of secondary containment facing north.

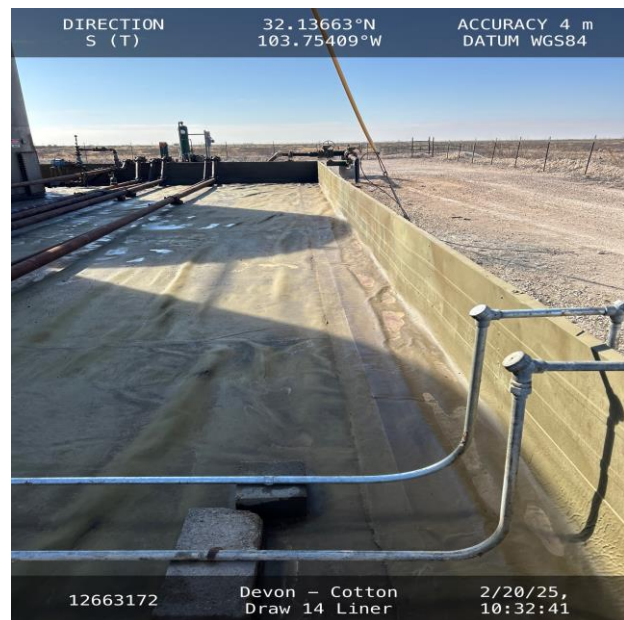
**Photo 4** View western side of secondary containment facing south.

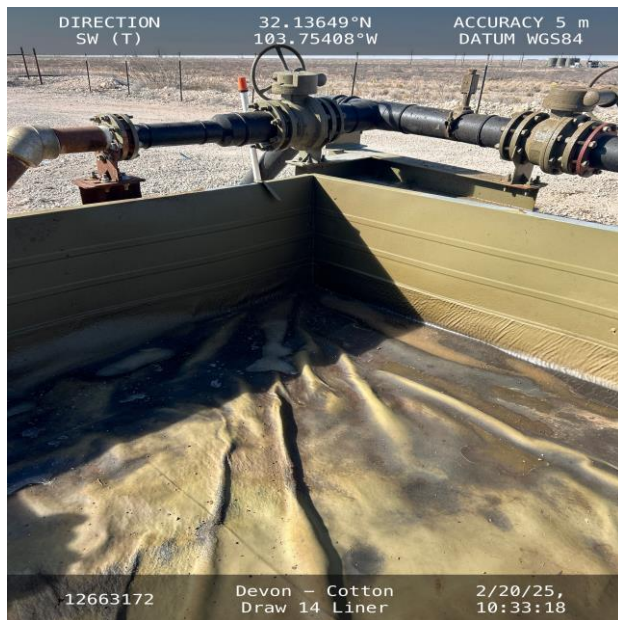
**Photo 5** View of southwestern corner of secondary containment.

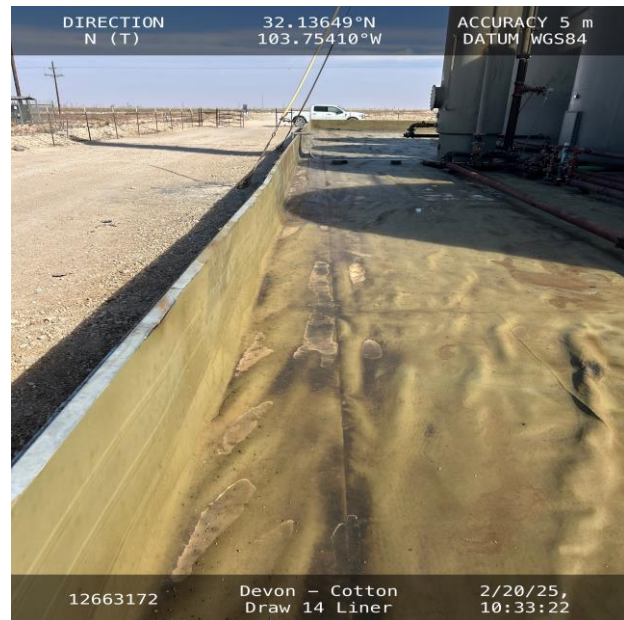
**Photo 6** View of western side of secondary containment facing north.

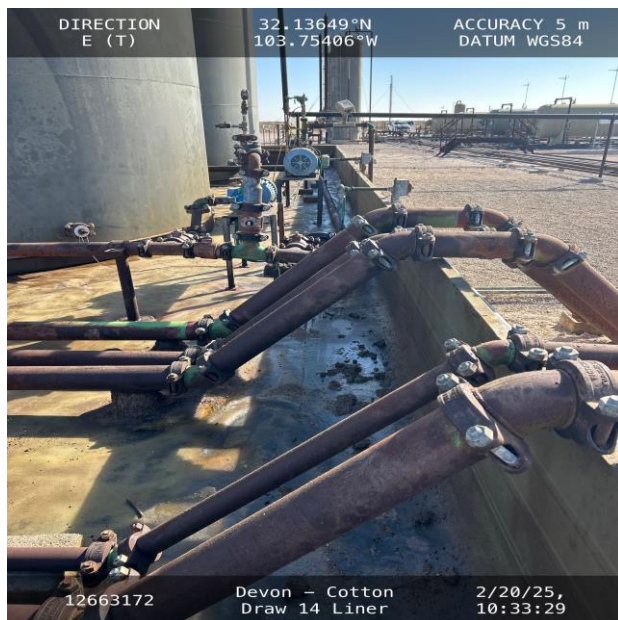
**Photo 7** View of southern side of secondary containment facing east.

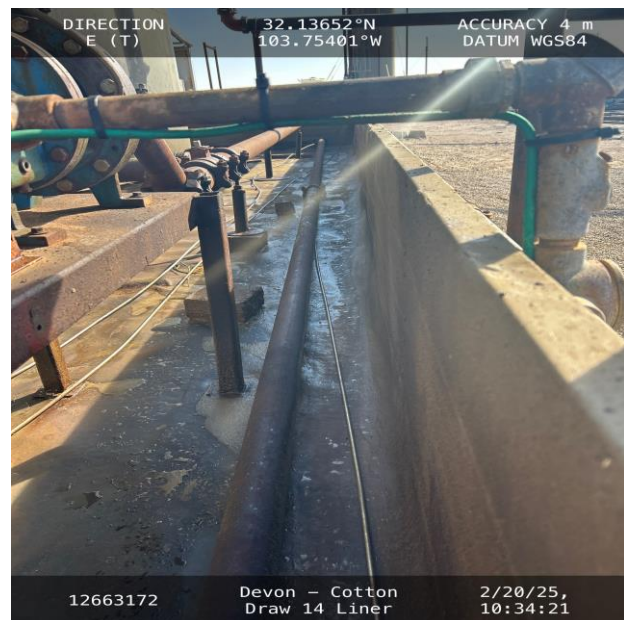
**Photo 8** View of southern side of secondary containment facing east.

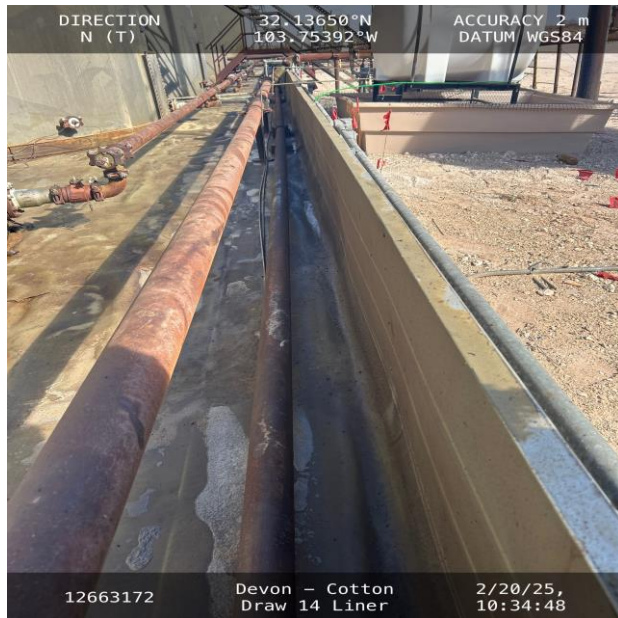
**Photo 9** View of eastern side of secondary containment facing north.

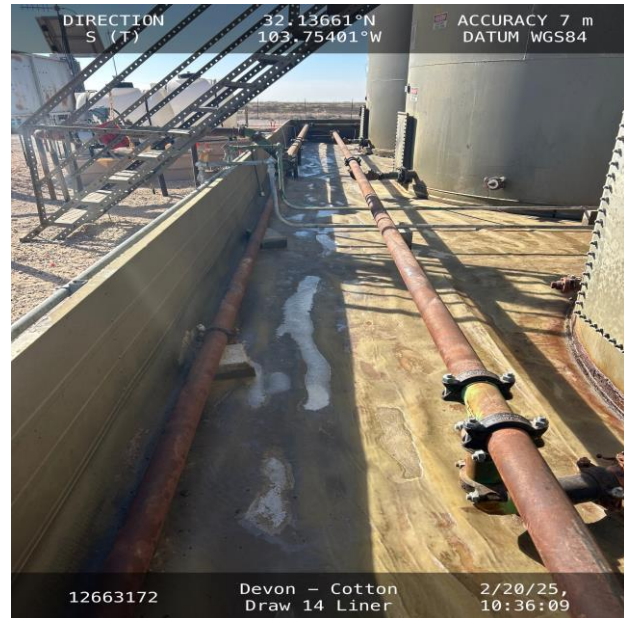
**Photo 10** View of eastern side of secondary containment facing south.

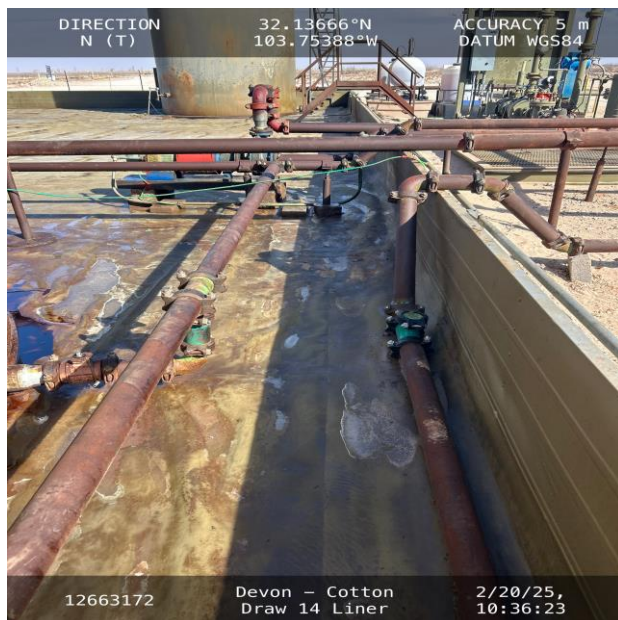
**Photo 11** View of the eastern side of secondary containment facing north.

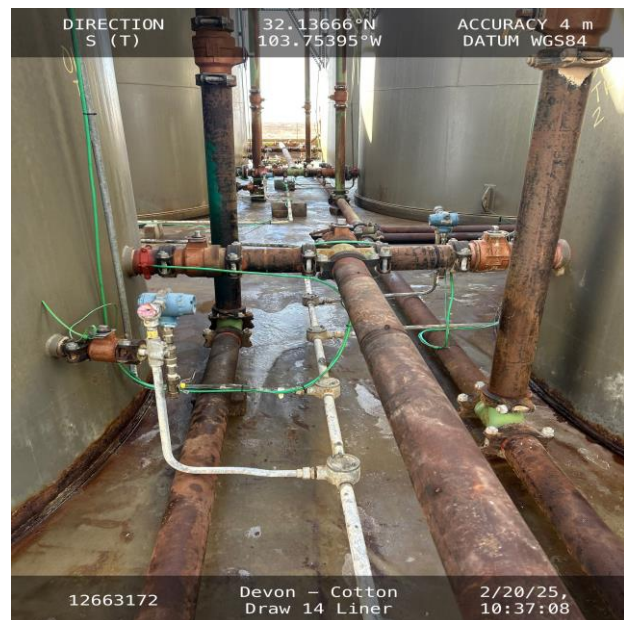
**Photo 12** View of interior containment facing south.

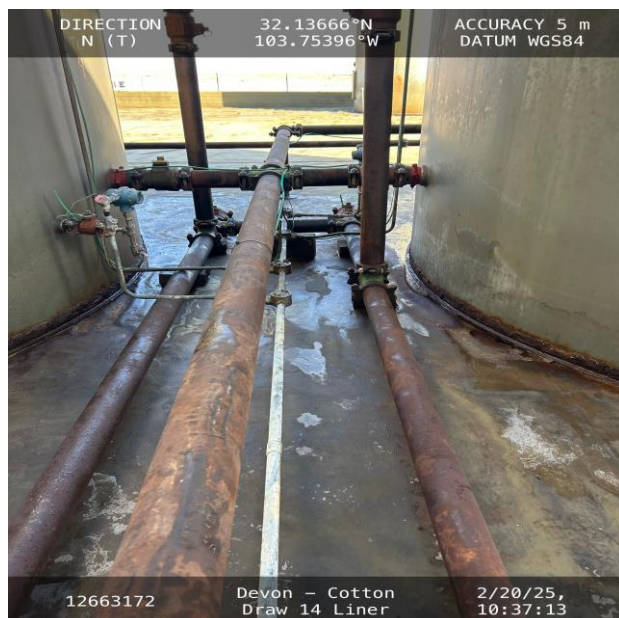
**Photo 13** View of interior containment facing north.

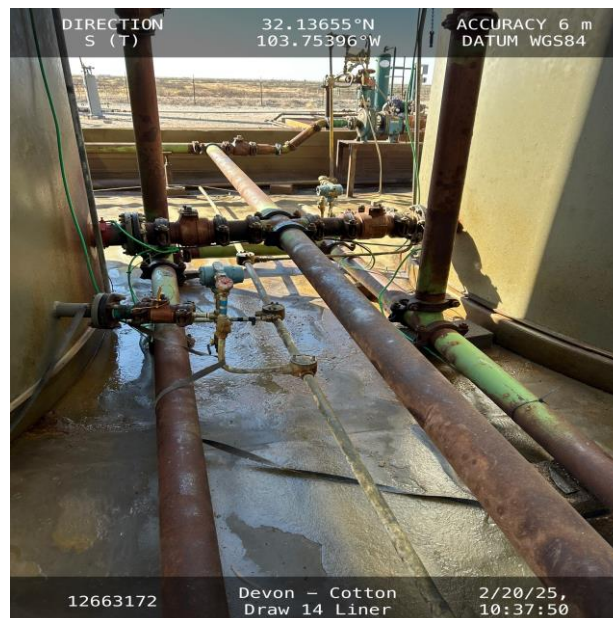
**Photo 14** View of interior portion of secondary containment facing south.

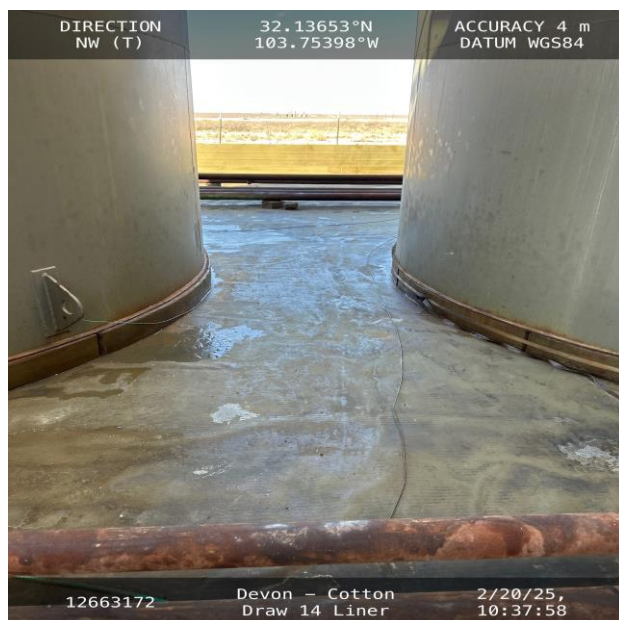
**Photo 15** View of interior portion of secondary containment facing northwest.

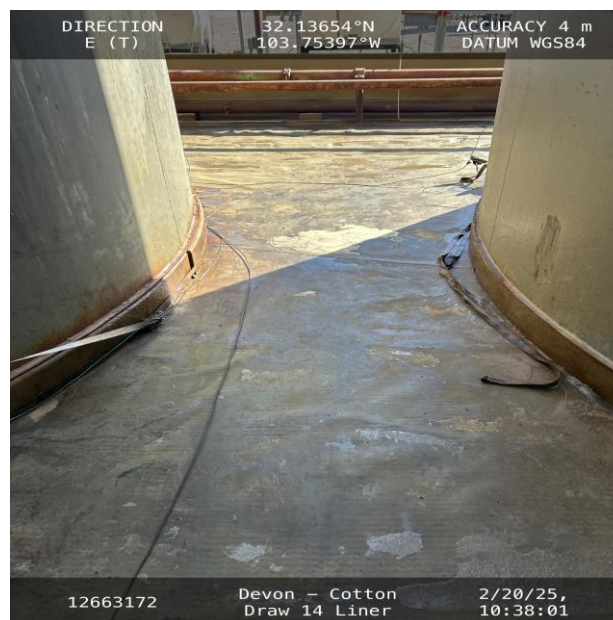
**Photo 16** View of interior portion of secondary containment facing east.

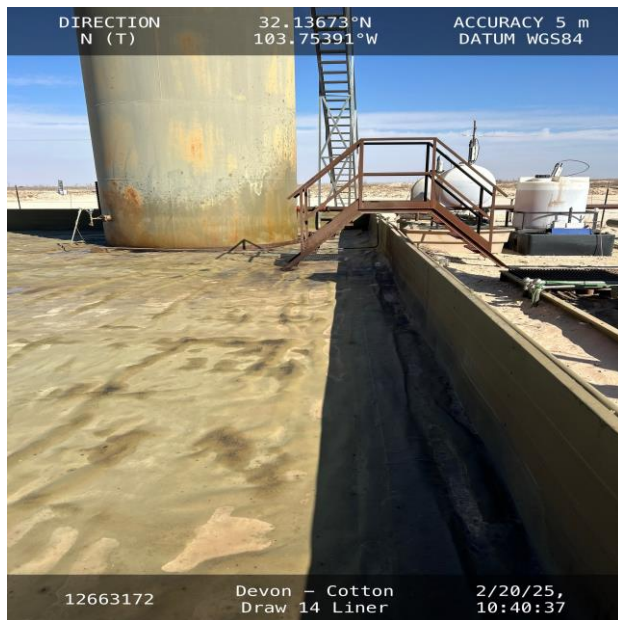
**Photo 17** View of eastern side of secondary containment facing north.

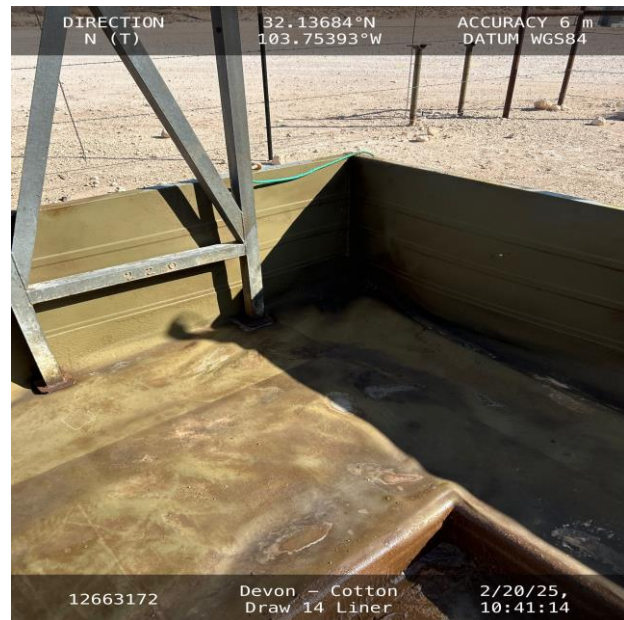
**Photo 18** View of northwestern corner of secondary containment.

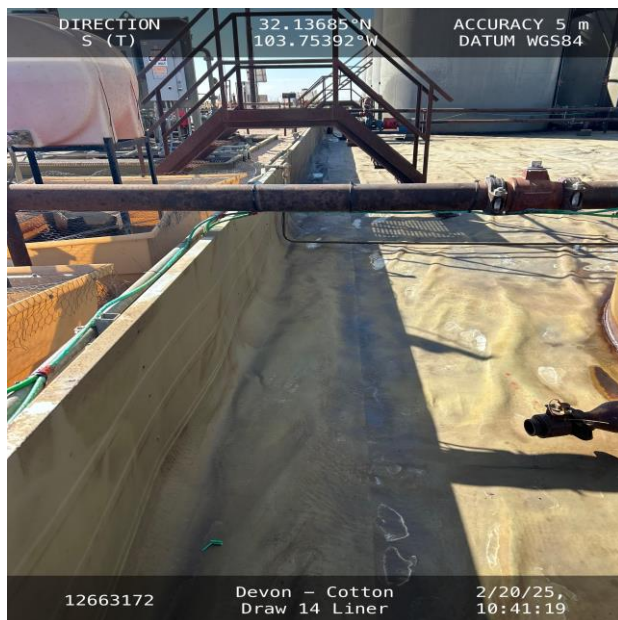
**Photo 19** View of eastern side of secondary containment facing south.

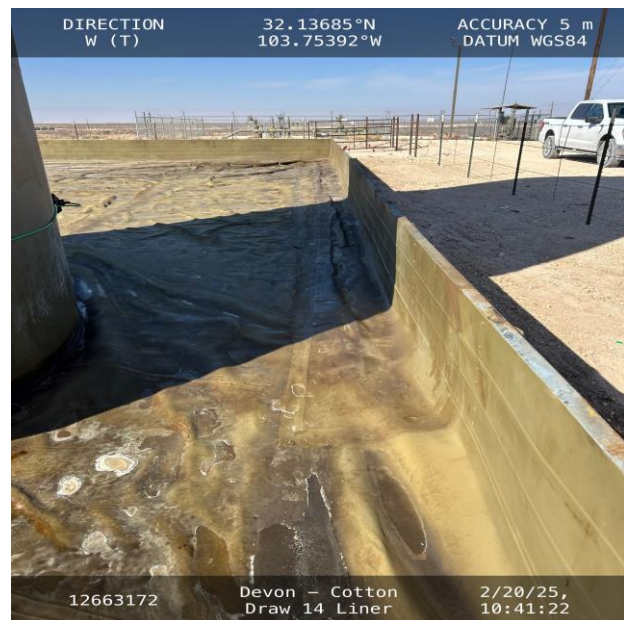
**Photo 20** View of northern side of secondary containment facing west.

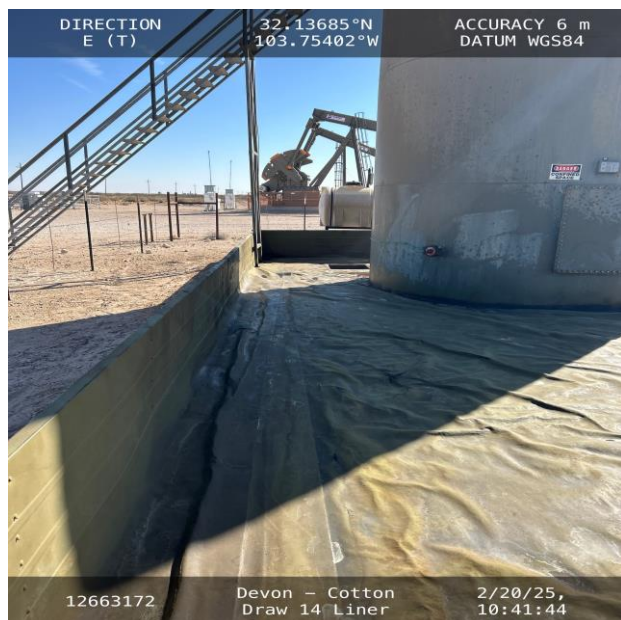
**Photo 21** View of northern side of secondary containment facing east.

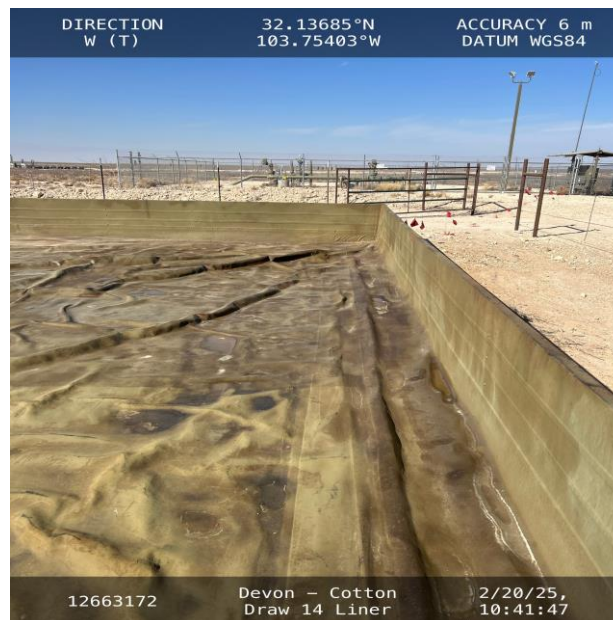
**Photo 22** View of northern side of secondary containment facing west.

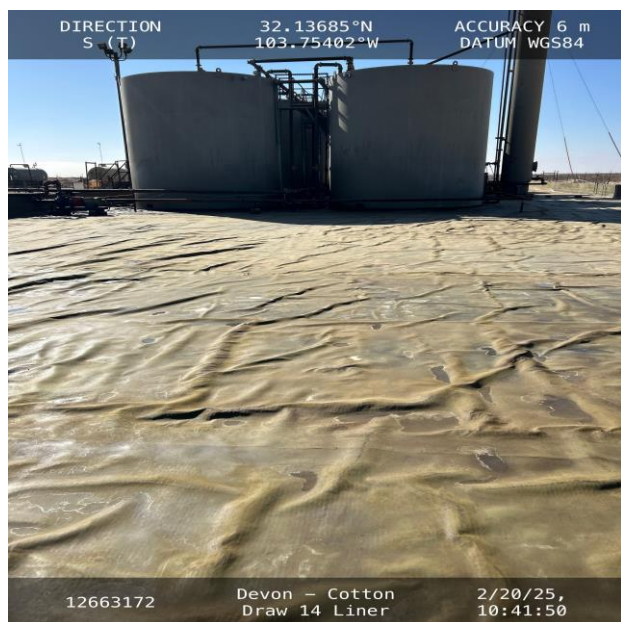
**Photo 23** View of central portion of secondary containment facing south.
