Our Ref.: 12663172-NMOCD-1

March 12, 2025

Closure Report  
Devon Energy Production Company, LP  
Cotton Draw 14 Battery  
Unit Letter D, Section 14, T25S, R31E  
GPS: 32.1367521, -103.75341  
Eddy County, New Mexico

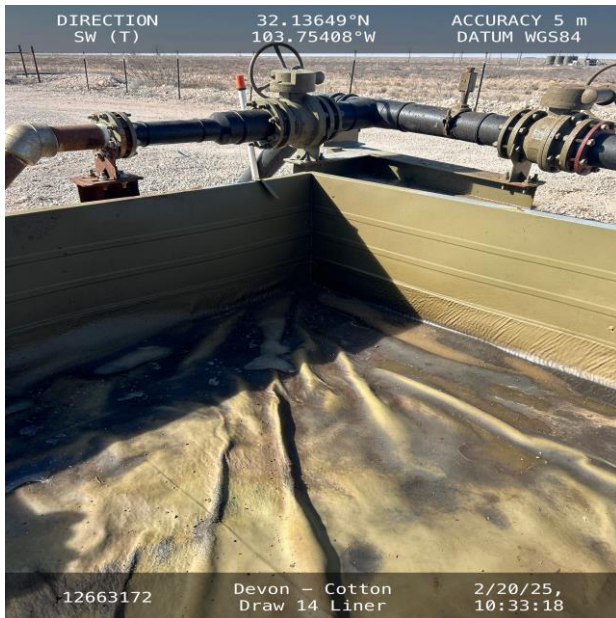
**Photo 5** View of southwestern corner of secondary containment.

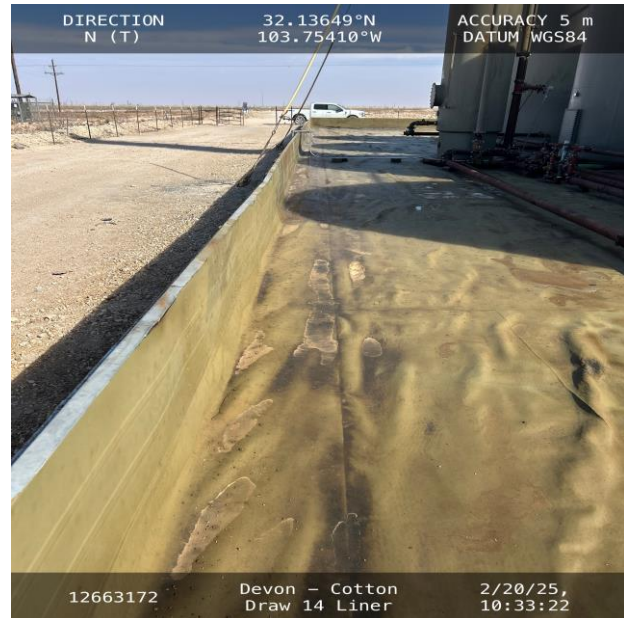
**Photo 6** View of western side of secondary containment facing north.

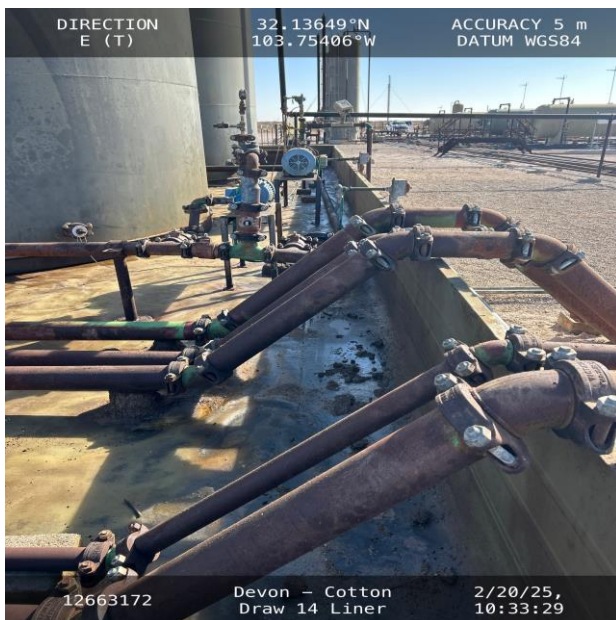
**Photo 7** View of southern side of secondary containment facing east.

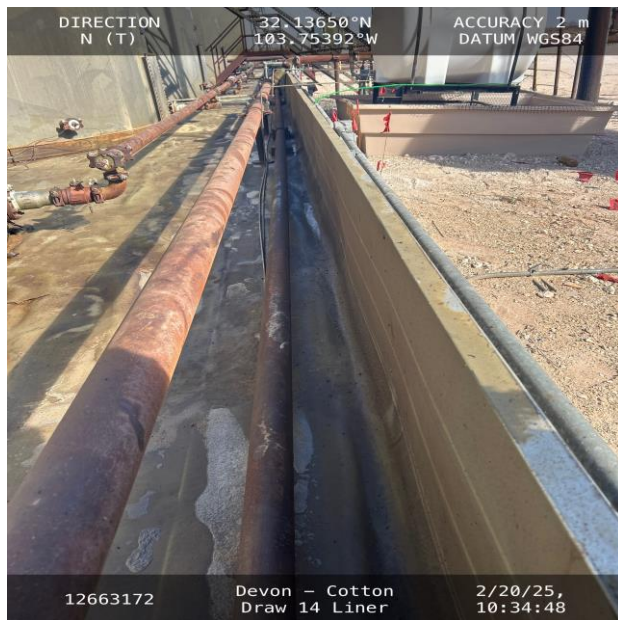
**Photo 9** View of eastern side of secondary containment facing north.

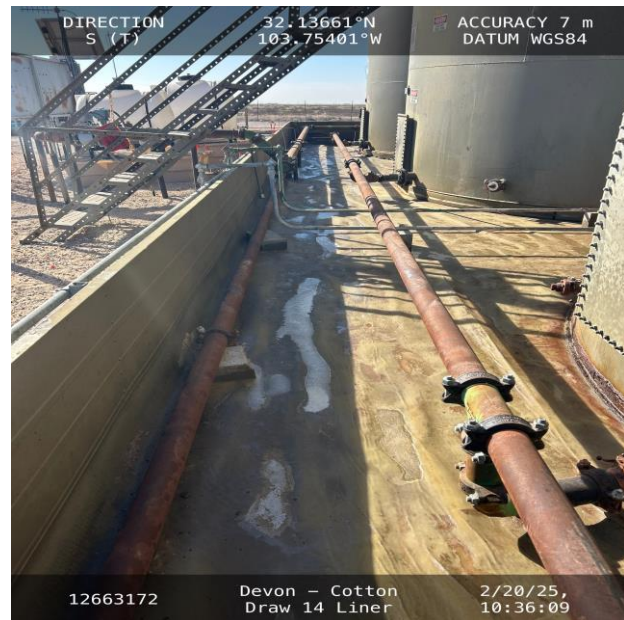
**Photo 10** View of eastern side of secondary containment facing south.

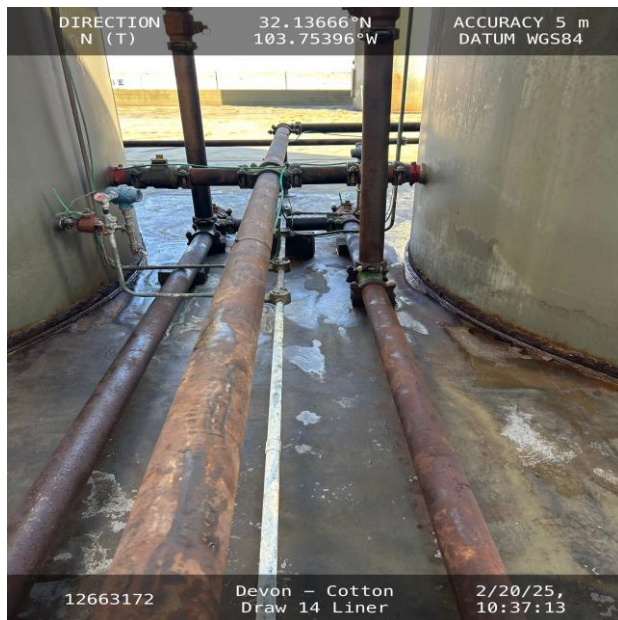
**Photo 13** View of interior containment facing north.

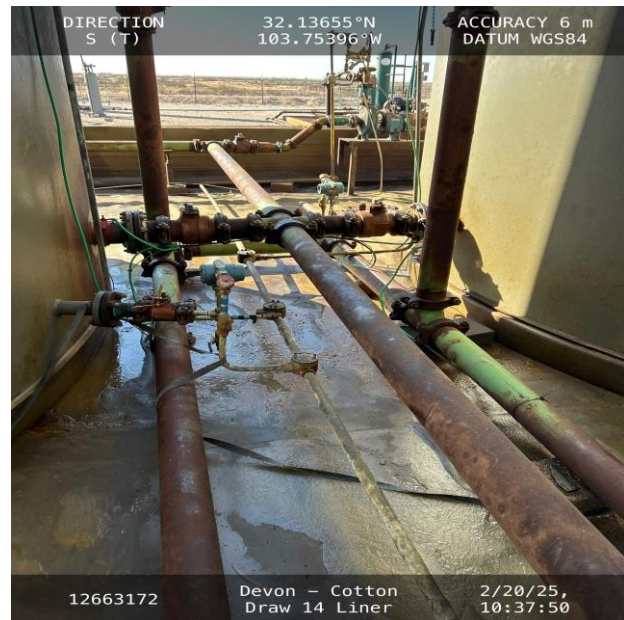
**Photo 14** View of interior portion of secondary containment facing south.

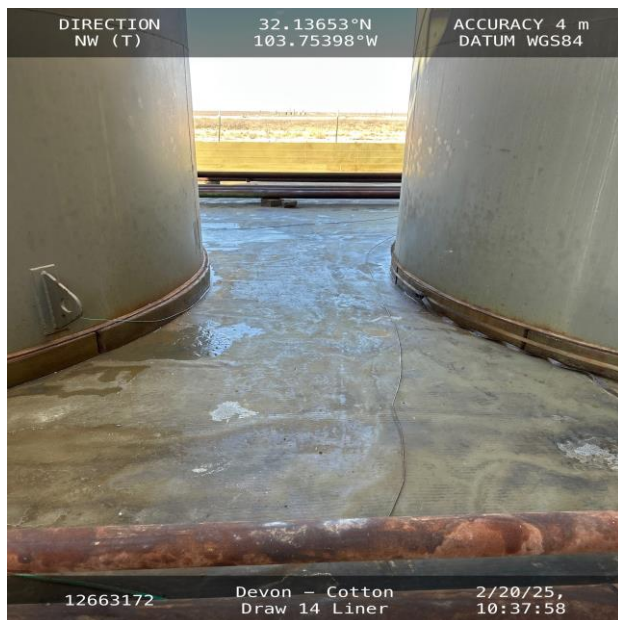
**Photo 15** View of interior portion of secondary containment facing northwest.

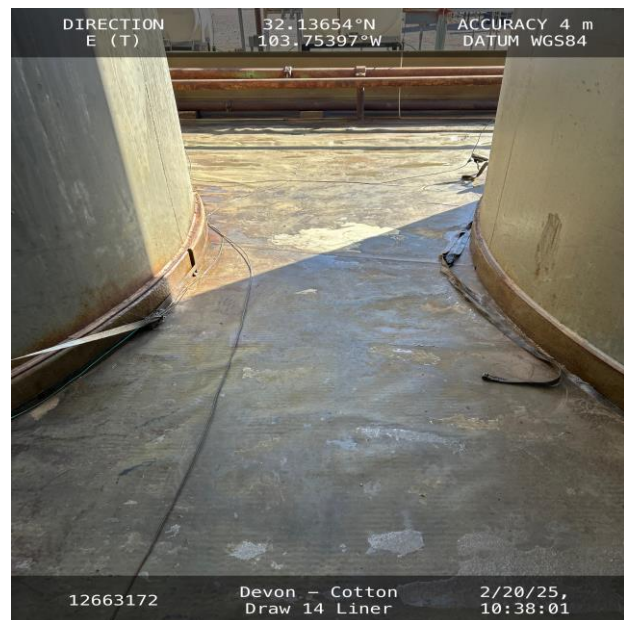
**Photo 16** View of interior portion of secondary containment facing east.

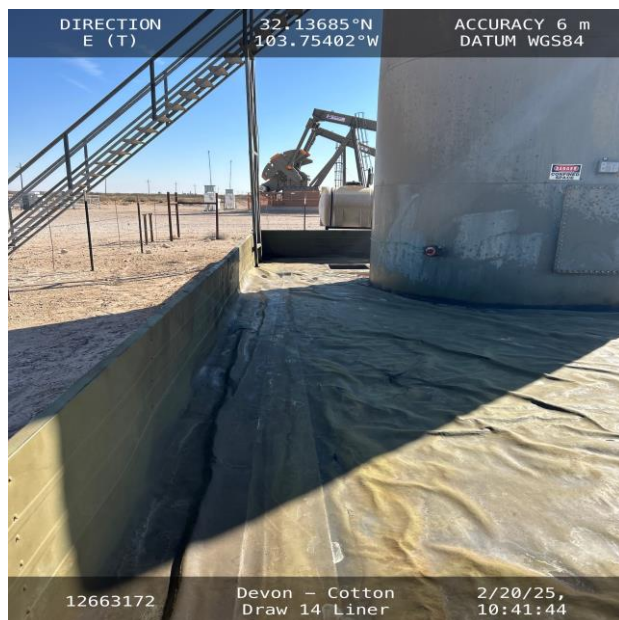
**Photo 21** View of northern side of secondary containment facing east.

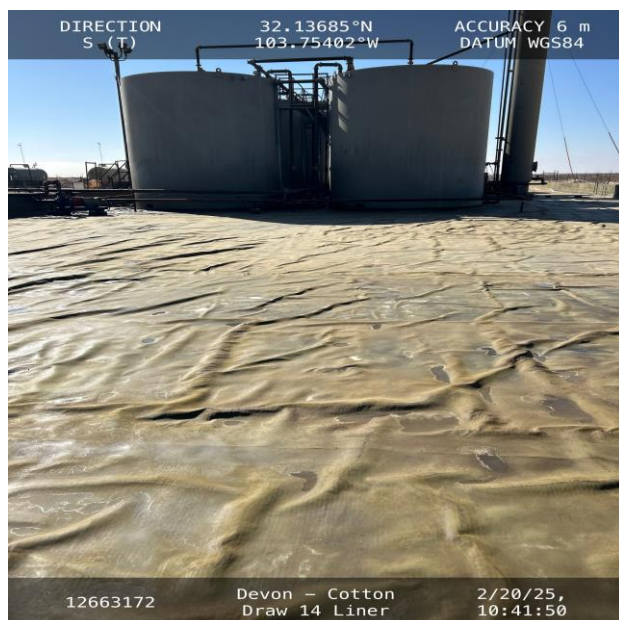
**Photo 23** View of central portion of secondary containment facing south.
