CLOSURE REQUEST REPORT

Devon Energy Production Company, LP

Snapping 12 CTB 2

Incident Number nAPP2501423105

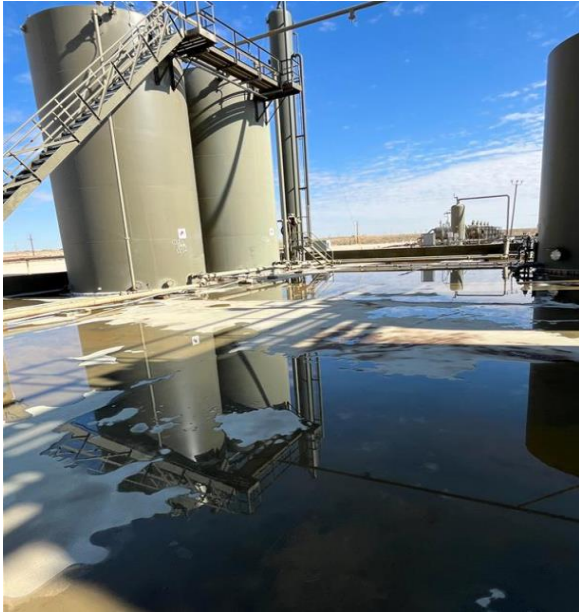
**Photograph 1****Date: 01/13/2025**

Description: Southwestern view of the eastern portion of the lined containment floor adjacent pad surface area before liner inspection activities.

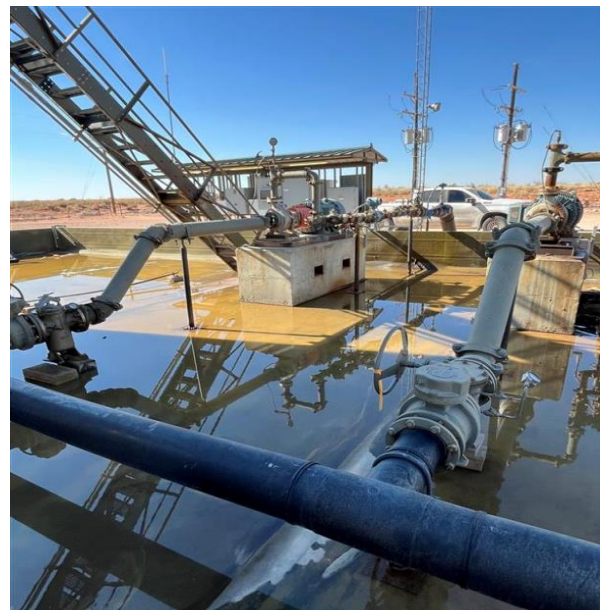
**Photograph 2****Date: 01/13/2025**

Description: Northeastern view of the eastern portion of the lined containment floor adjacent pad surface area before liner inspection activities.

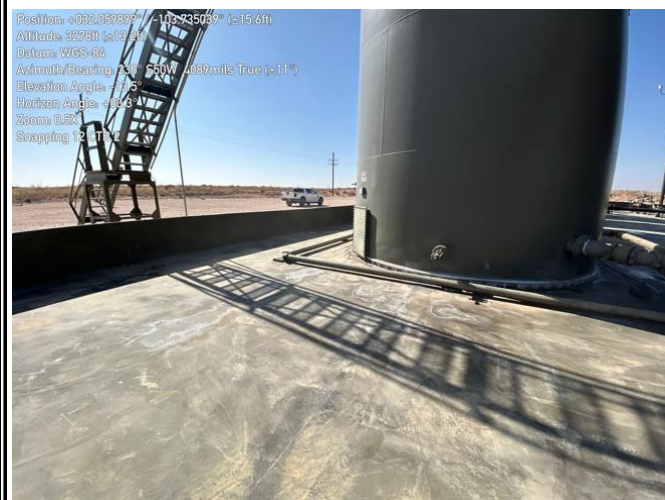
**Photograph 3****Date: 01/29/2025**

Description: Southwestern view of the eastern portion of the lined containment floor adjacent pad surface area during liner inspection activities.

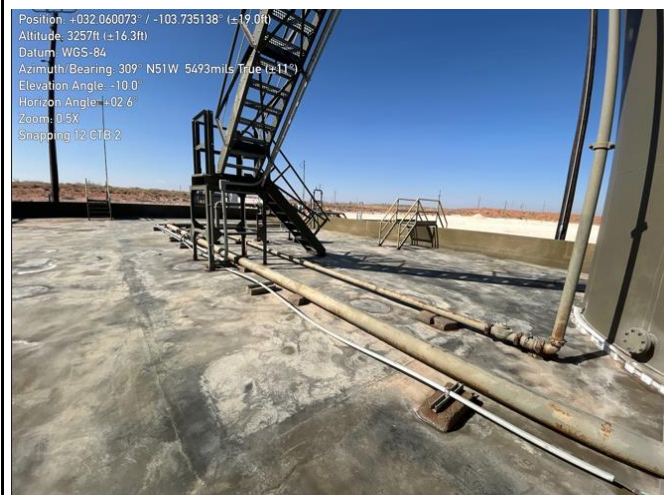
**Photograph 4****Date: 01/29/2025**

Description: Northwestern view of the eastern portion of the lined containment floor adjacent pad surface area during liner inspection activities.

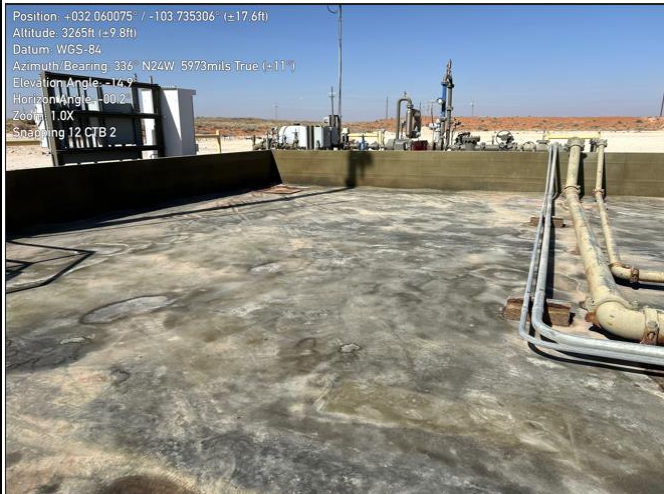
**Photograph 5****Date: 01/29/2025**

Description: Northwestern view of the Western portion of the lined containment floor adjacent pad surface area during liner inspection activities.

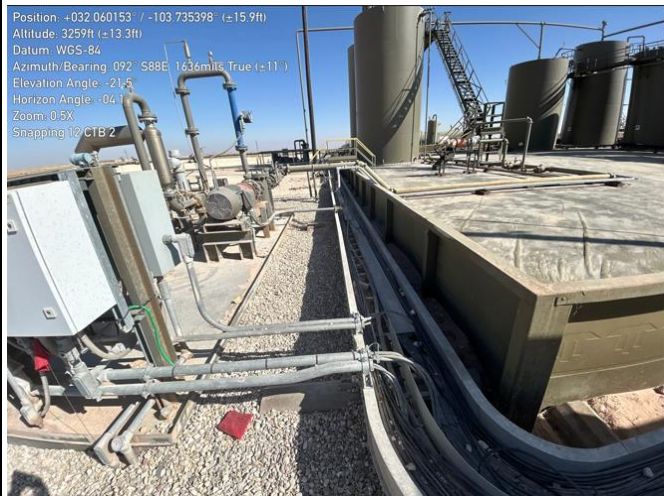
**Photograph 7****Date: 01/29/2025**

Description: Southeastern view of the western portion of the surrounding of the containment floor during liner inspection activities.

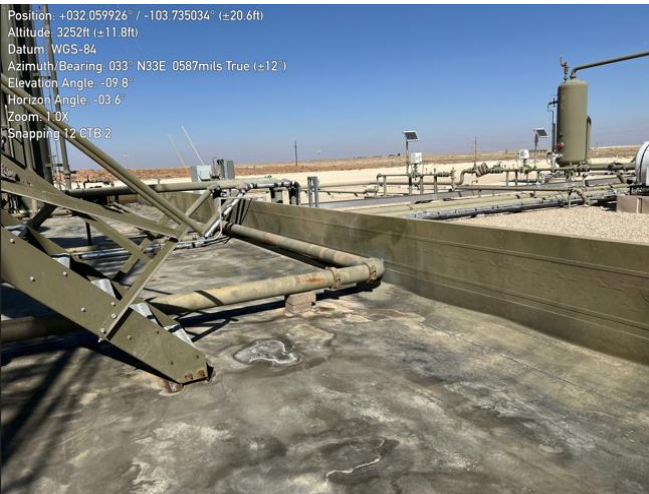
**Photograph 6****Date: 01/29/2025**

Description: Northeastern view of the eastern portion of the lined containment floor adjacent pad surface area during liner inspection activities.

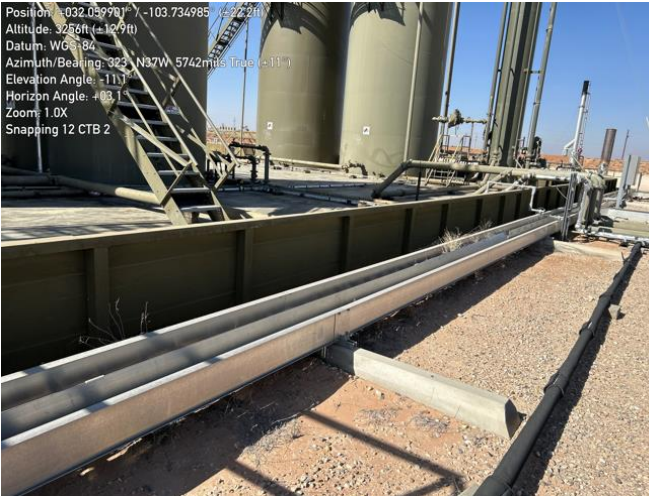
**Photograph 8****Date: 01/29/2025**

Description: Northwestern view of the eastern portion of the surrounding of the containment floor during liner inspection activities.
