SUBJECT: Liner Inspection and Closure Report for Aleutian 10 CTB 2 – April 23, 2025 Site Visit

Incident ID: nAPP2509923225
Facility ID (Name): fAPP2300331384 (ALEUTIAN 10 CTB 2)
Facility Location: Unit J, 10, T23S, R31E,
Facility GPS Coordinates: 32.315443, -103.762228
Eddy County, New Mexico

Environmental Liner Inspection Field Notes & Photolog Report

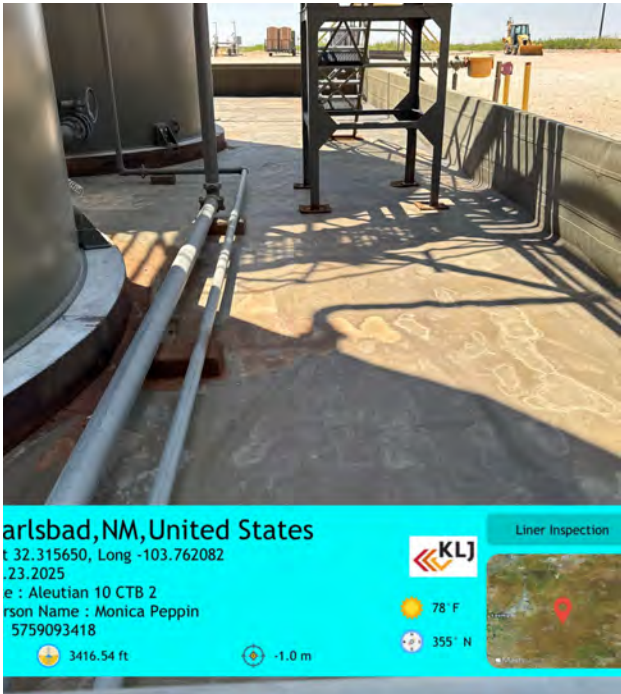
North end of containment facing west from east wall.

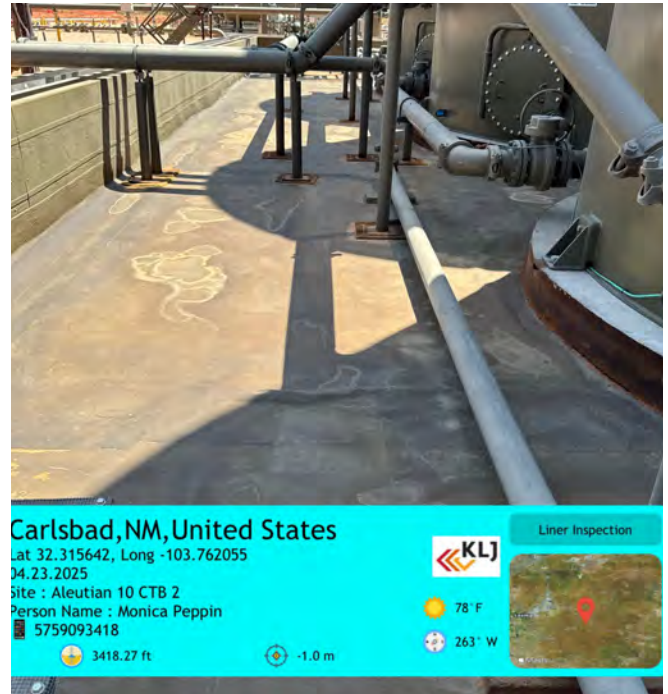
East side of containment from north wall looking south.

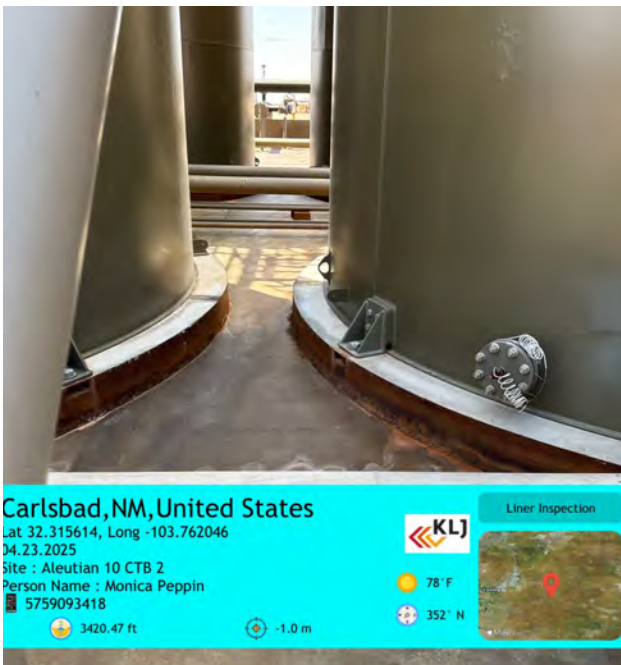
View of liner between tanks from east side on northern end of containment.

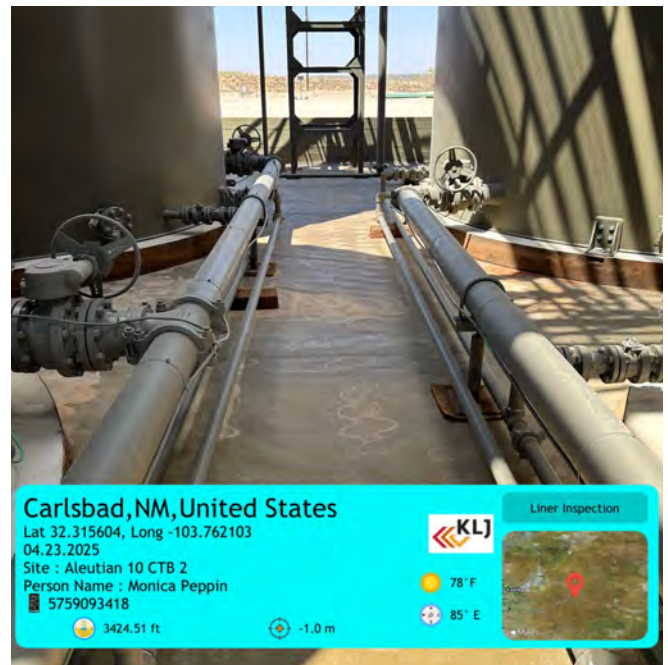
Facing north viewing liner between tanks from mid-area of containment.

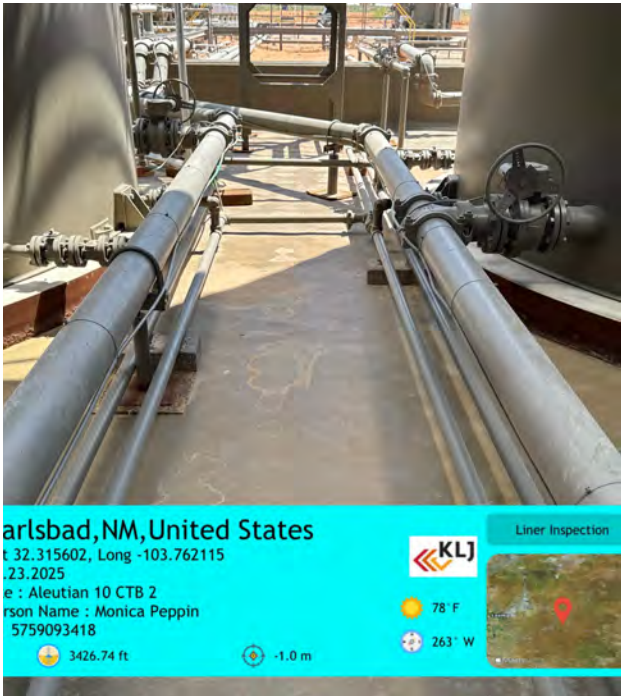
Liner between tanks from mid-area of containment facing south.

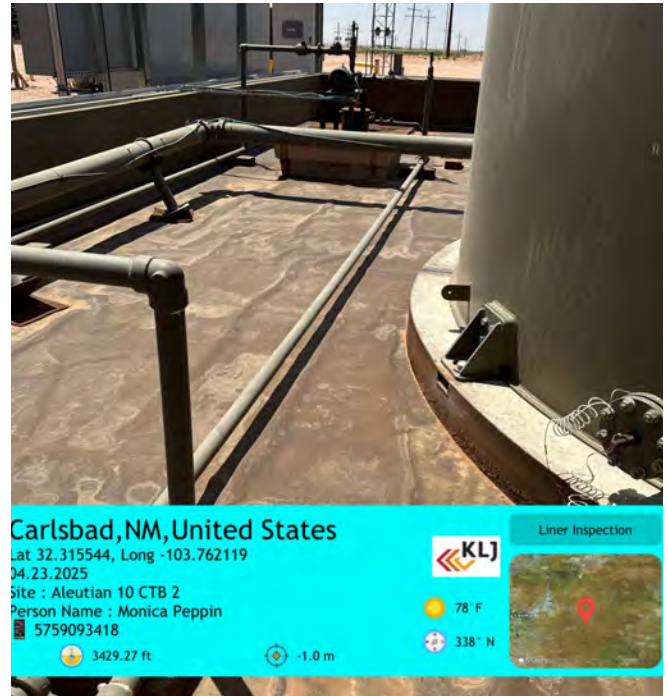
Liner area in northeast corner taken from mid-area by tanks.

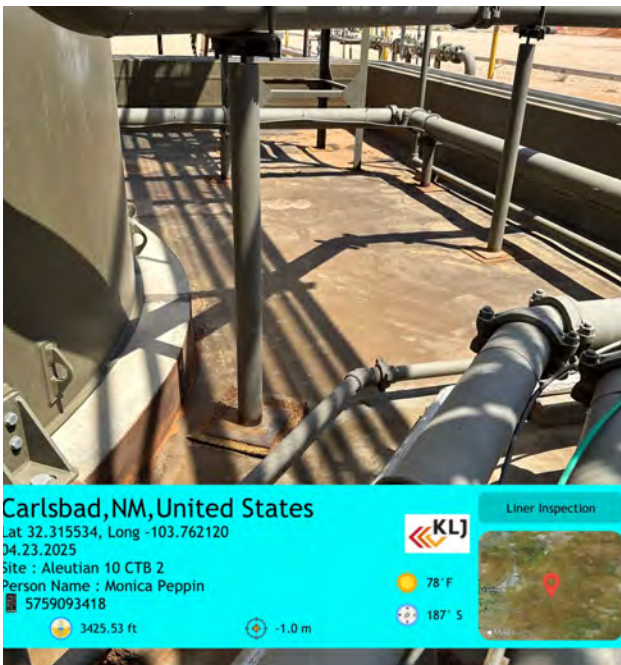
Liner on south end of containment looking southeast.

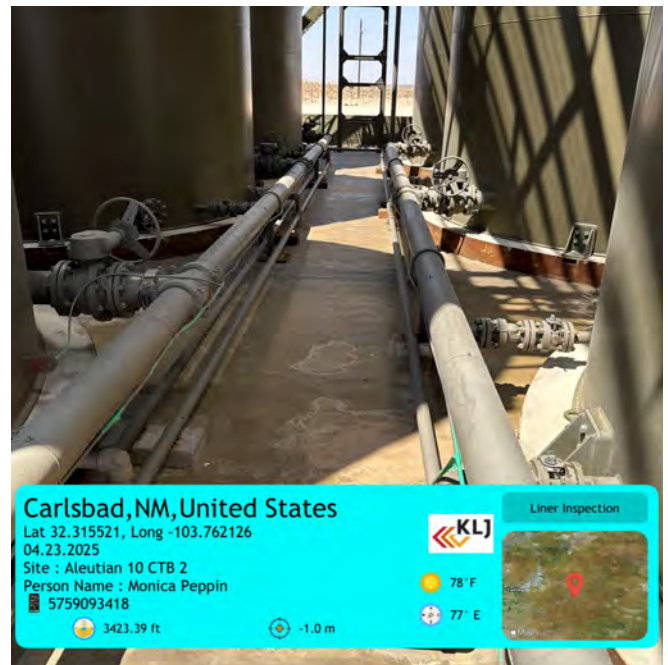
Looking north from south end of containment between tanks.

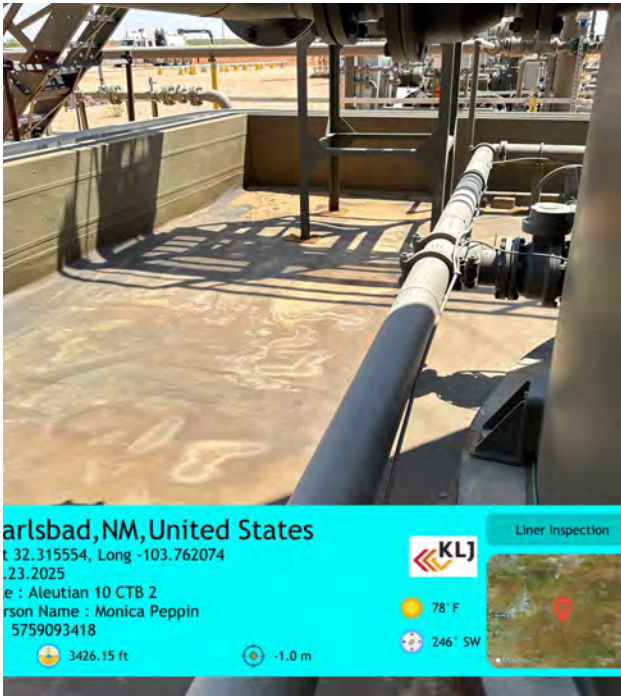
Liner in southwest corner of containment from near tanks.

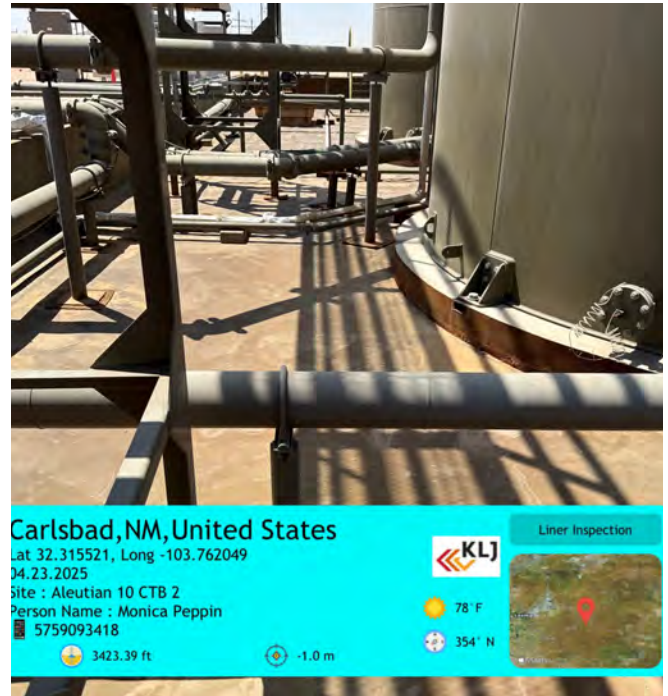
Liner on north end of containment looking east near piping and equipment.

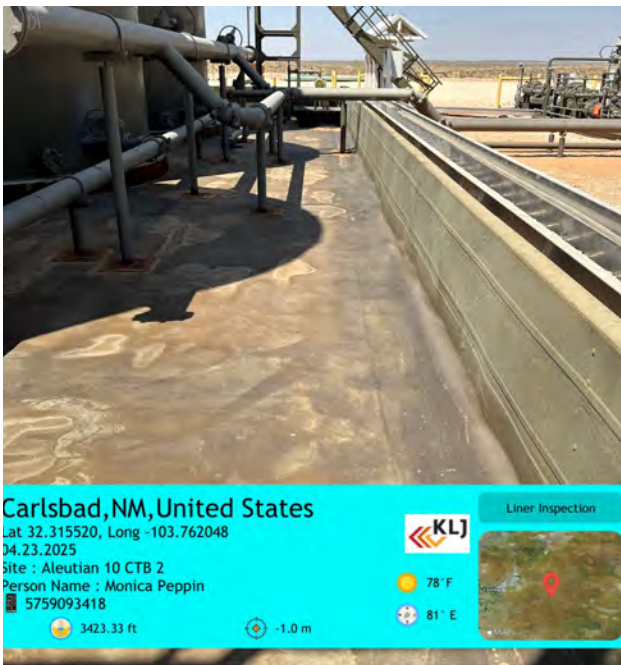
East wall of containment from south corner facing north.

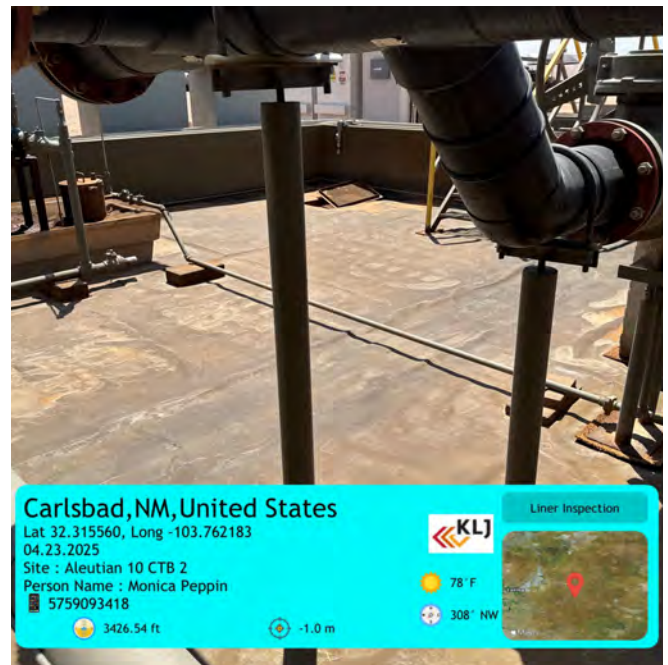
Liner area in southwest corner of containment view taken near tank.

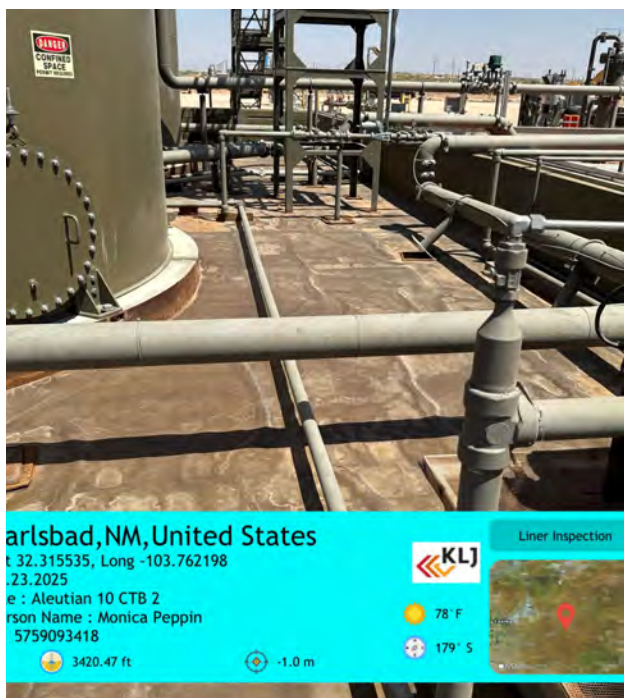
View of liner on south end from west wall facing east.

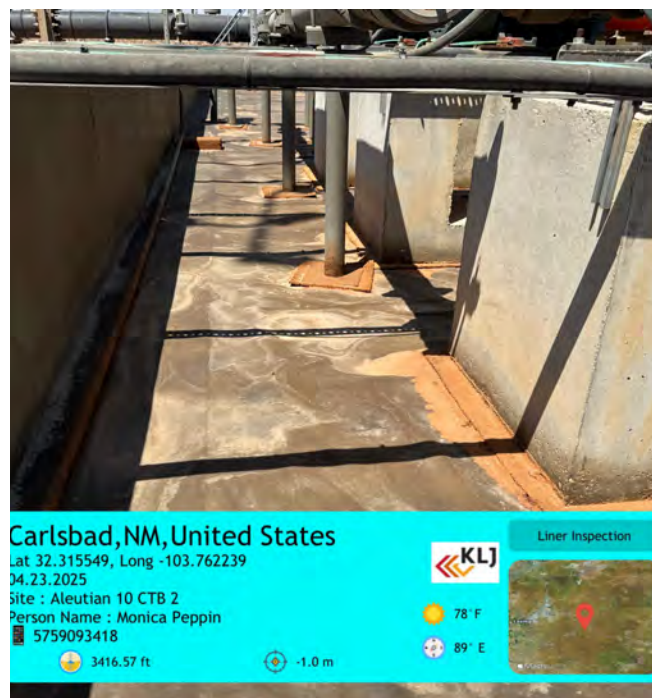
View of liner near pumps and west wall facing north.

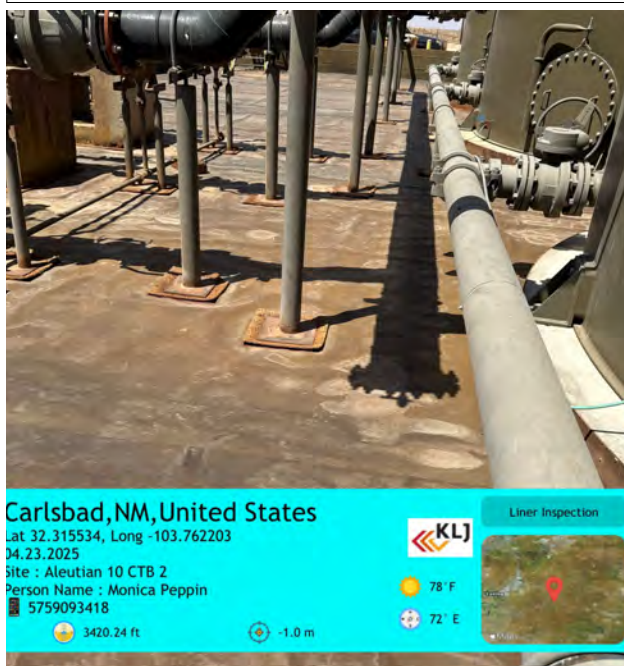
View of liner under piping and near equipment facing north.

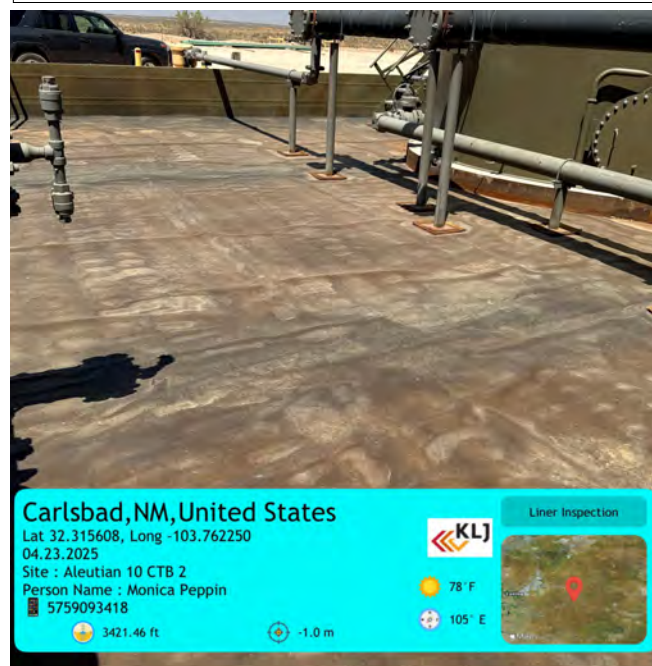
West side of containment viewing northwest corner of liner.

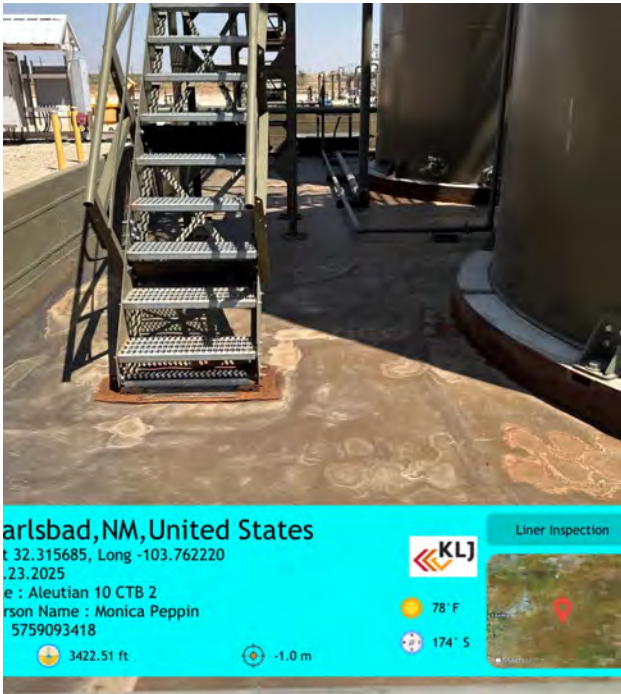
North wall area from west side
facing east.

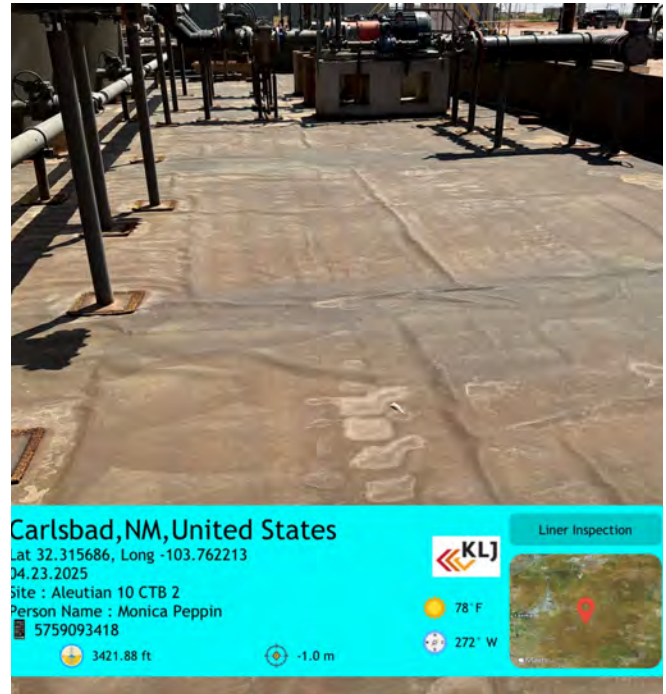
West wall area from north end
facing south.

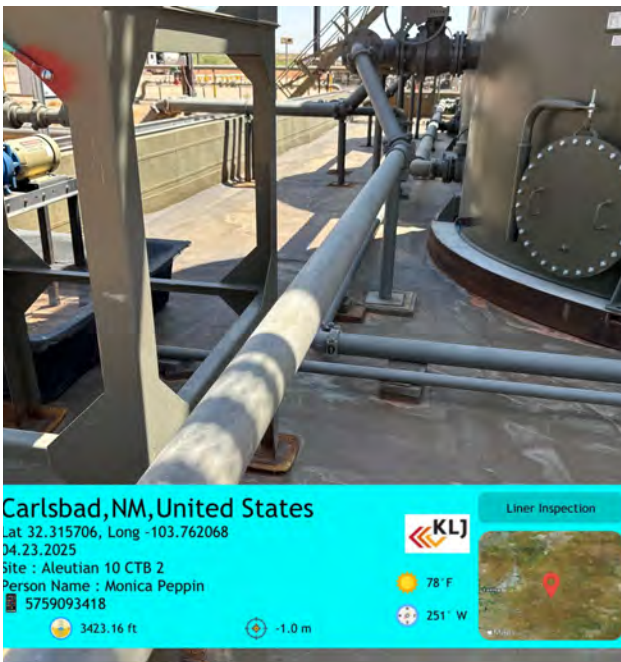
View of south end of containment
from east wall facing west.

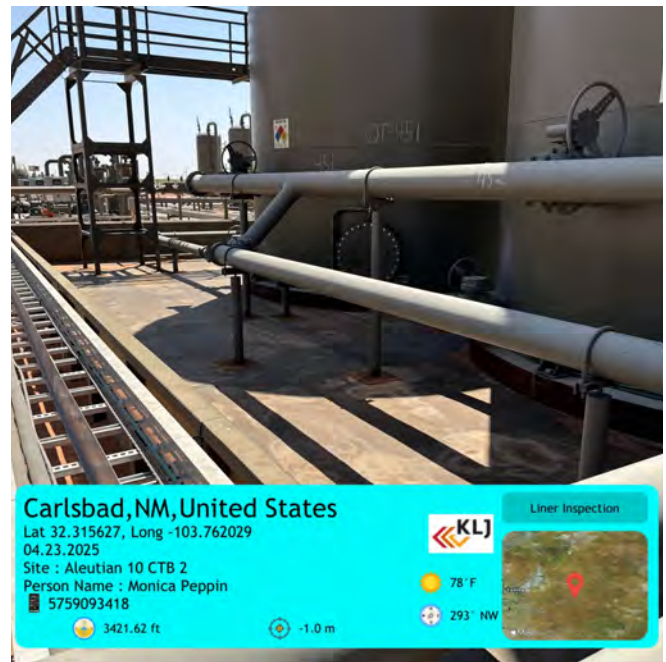
View of east area of containment
from northern side facing south
southwest.

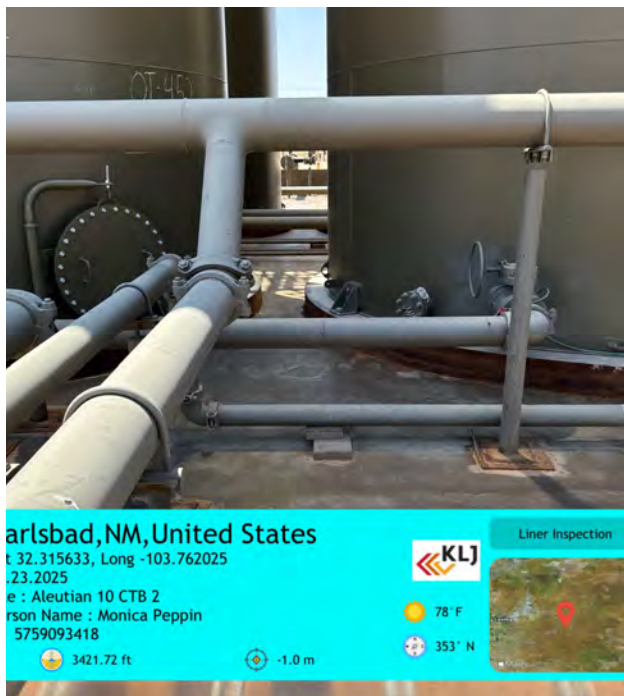
View of liner between tanks from west side facing east.

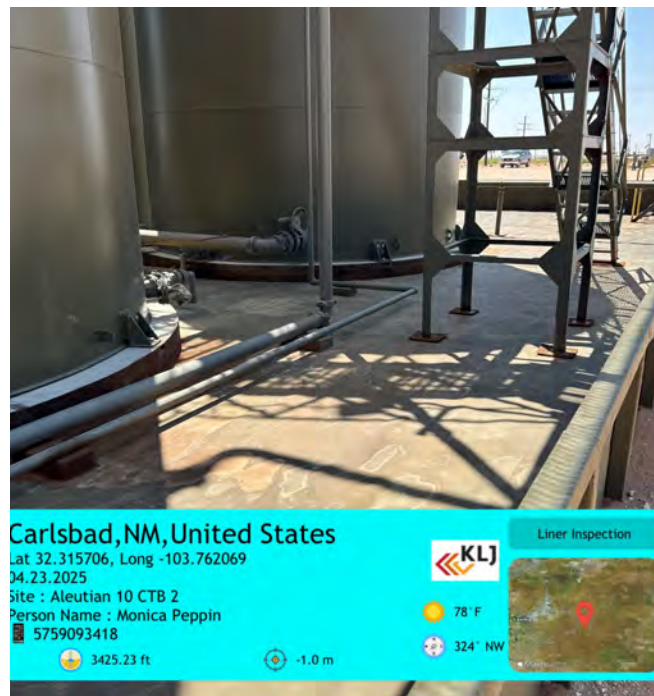
View of liner near equipment of north end facing west.

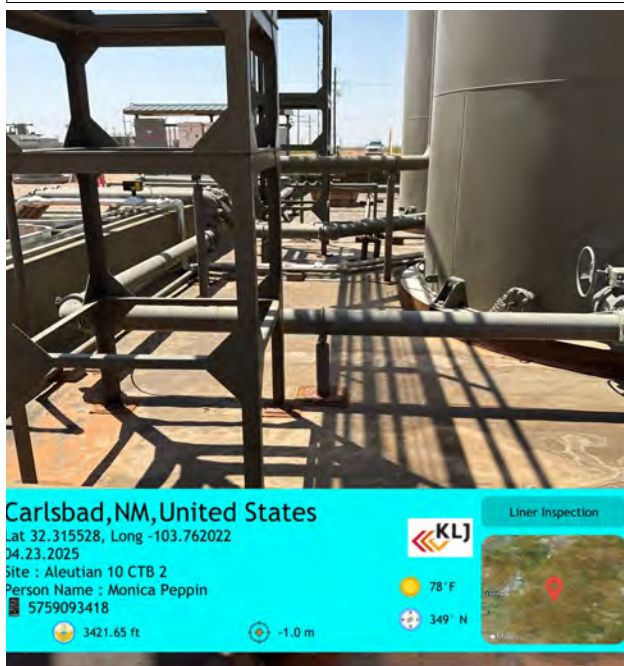
View of liner near tanks on north end facing west from east side.

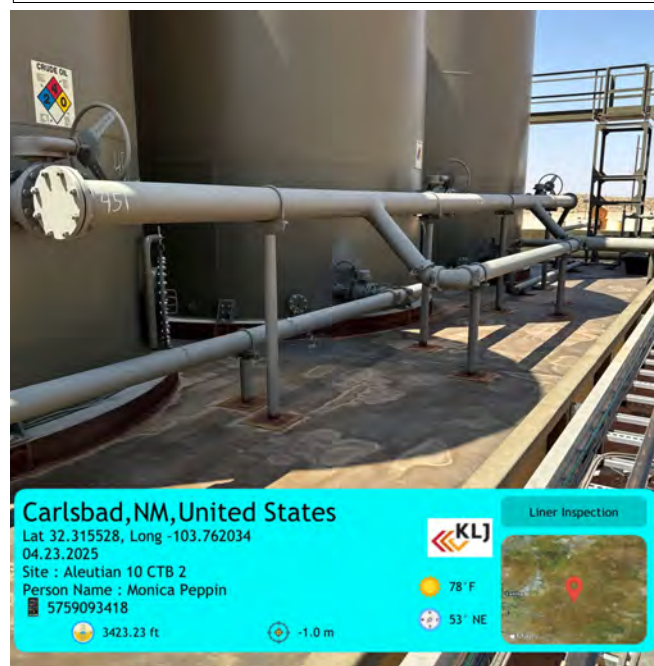
View of liner from southeast corner facing north northwest.
