Our Ref.: 12670289-NMOCD-1

June 04, 2025

Closure Report  
Devon Energy Production Company, LP  
Flagler 8 CTB 3  
Unit Letter O, Section 8, T25S, R33E  
GPS: 32.140726, -103.590823  
Lea County, New Mexico

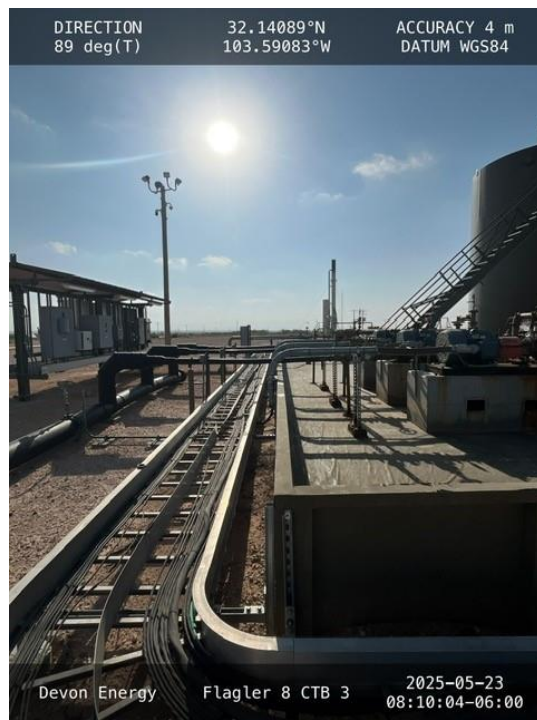
The liner inspection notice was provided on May 20, 2025. A liner integrity inspection was completed on May 23, 2025. The liner was visually inspected and no rips, tears, holes, or damages in the liner was observed. The liner was determined to be intact with no integrity issues. Photographic documentation of the liner inspection completed on May 23, 2025, is presented in **Attachment C**.

Photo 2 View of northern portion of containment facing east.

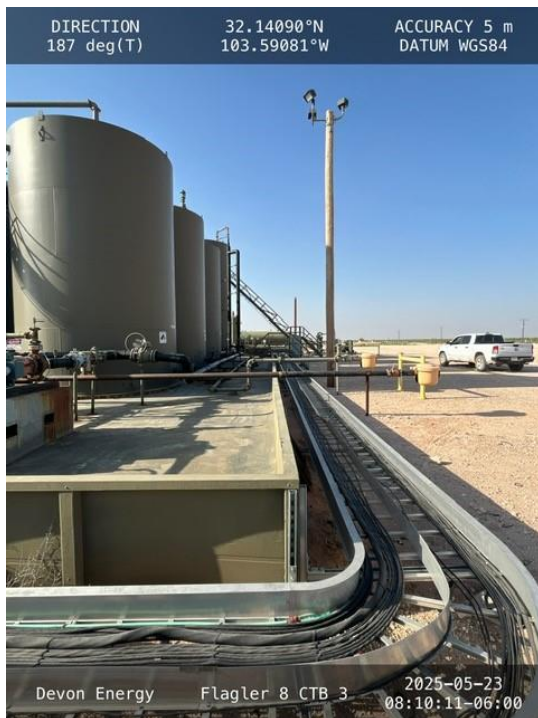
Photo 3 View of west side containment facing south.

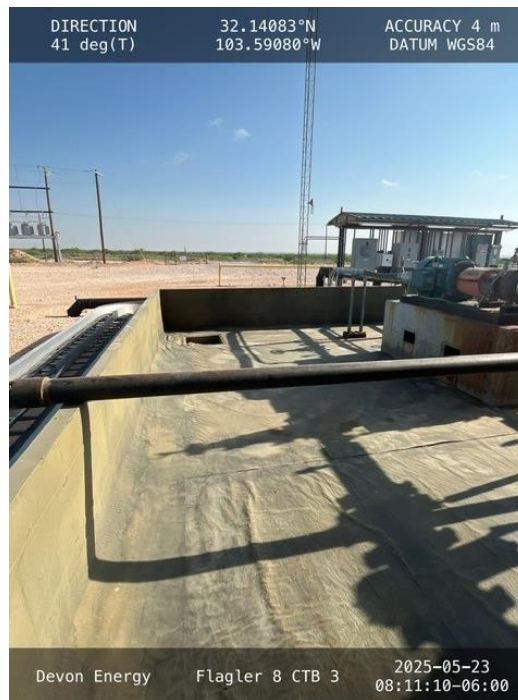
Photo 4 View of northwest corner of containment.

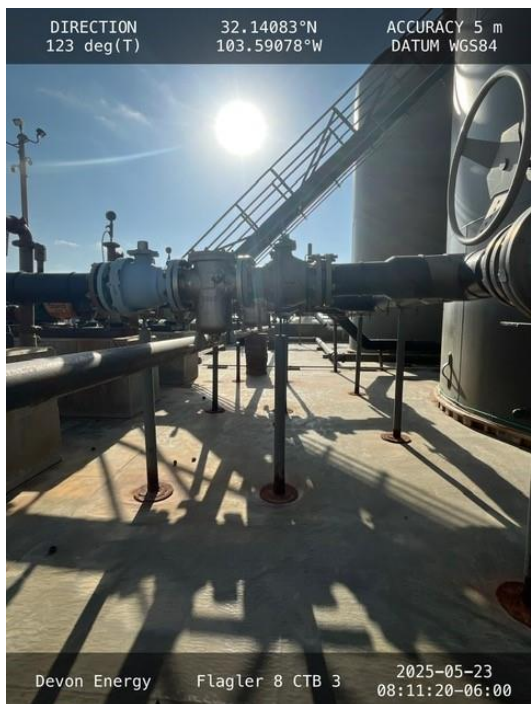
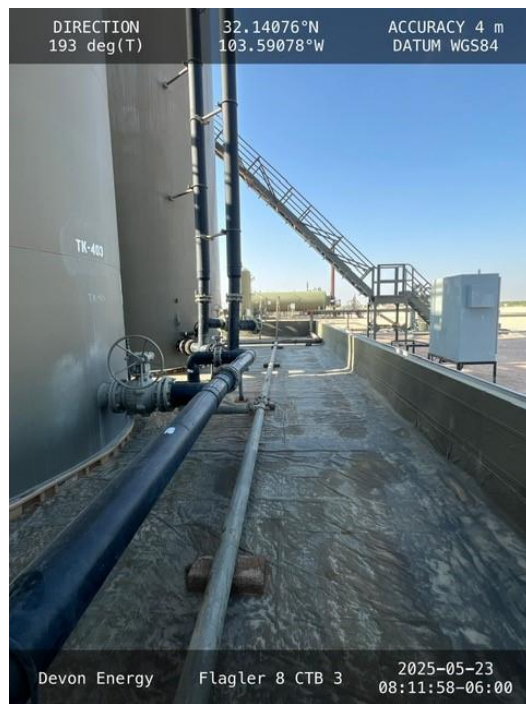
Photo 5 View of north side of containment towards east. Photo 6 View of west side containment facing south.

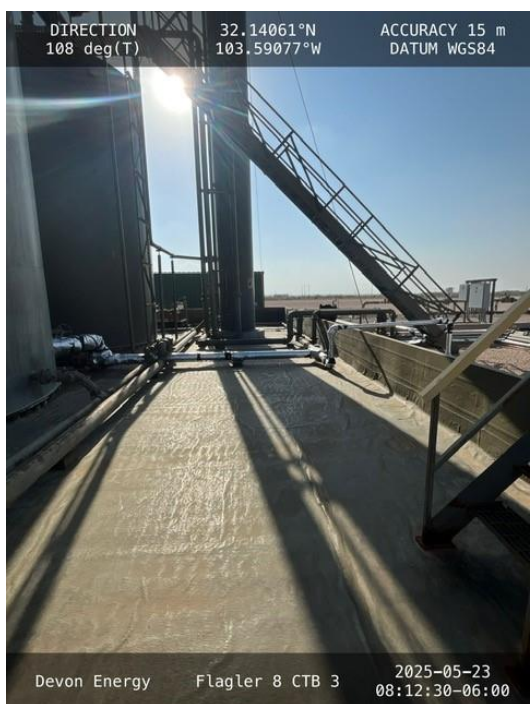
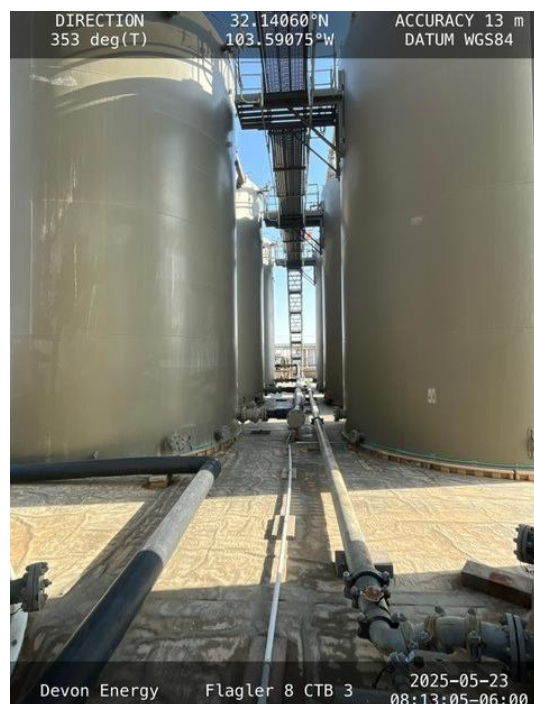
Photo 7 View of south side of containment facing east. Photo 8 View of central portion of secondary containment facing south.

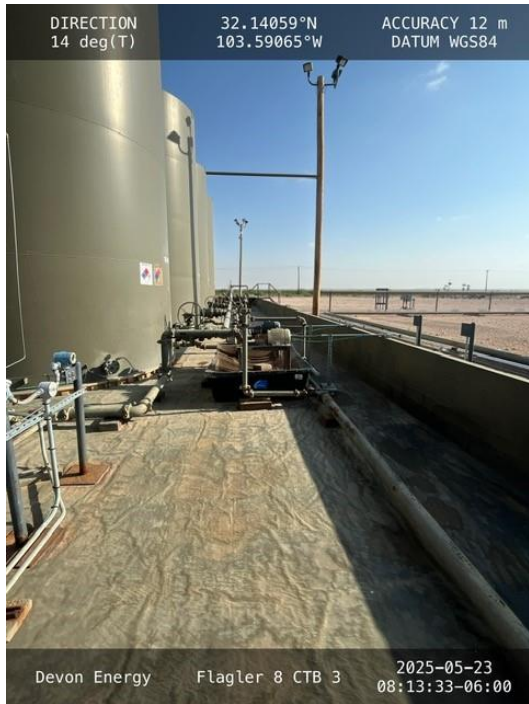
Photo 9      View of east side portion of secondary containment towards north.

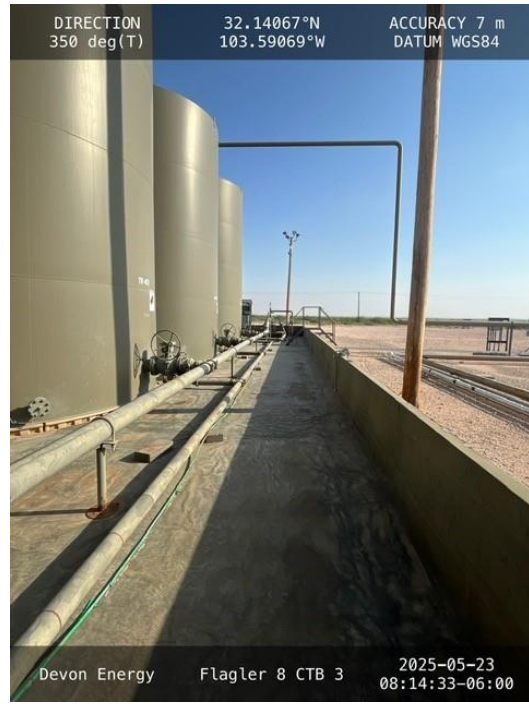
Photo 10      View of east side portion of secondary containment towards north.

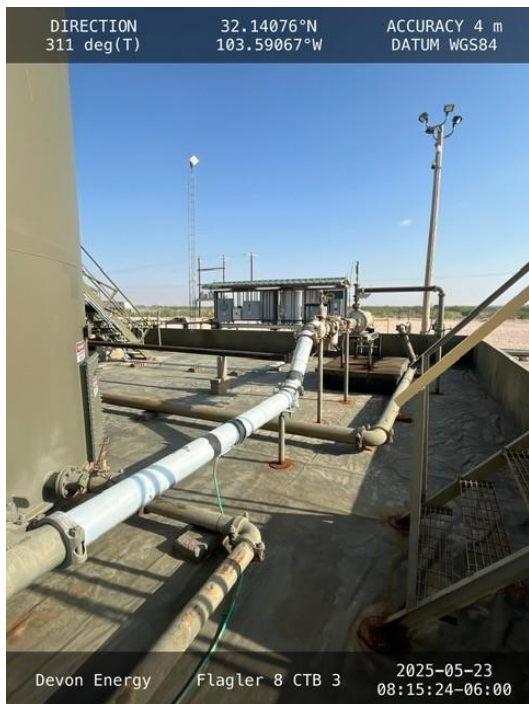
Photo 11      View of north side of secondary containment.

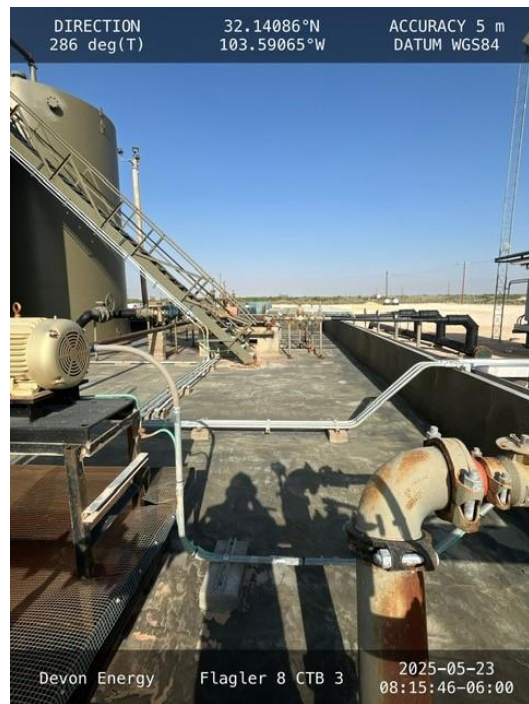
Photo 12      View of north side of secondary containment facing west.

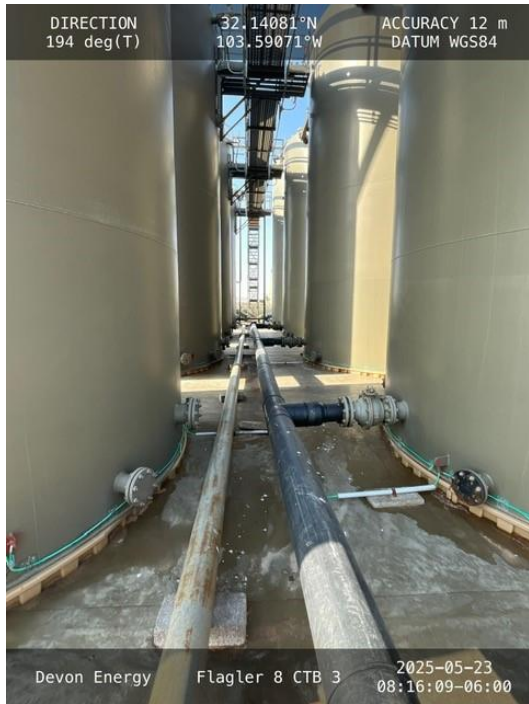
**Photo 13** View of central portion of secondary containment.

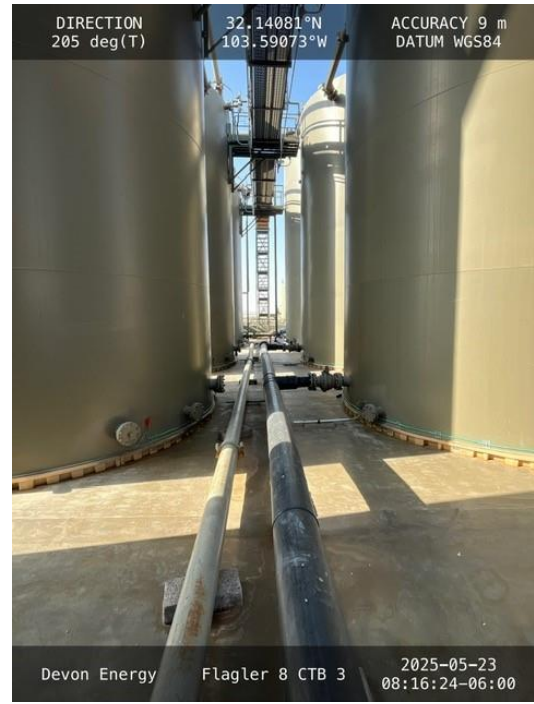
**Photo 14** View of central portion of secondary containment.
