Taylor D 3 Battery  
Incident ID nAPP2523834603

## Liner Inspection and Closure Report

September 14, 2025

**RE: Liner Inspection and Closure Report**  
**Taylor D 3 TB**  
**API No. N/A**  
**GPS: Latitude 32.850400001 Longitude -103.76800001**  
**UL- G, Section 09, Township 17S, Range 32E**  
**NMOCD Reference No. nAPP2523834603**

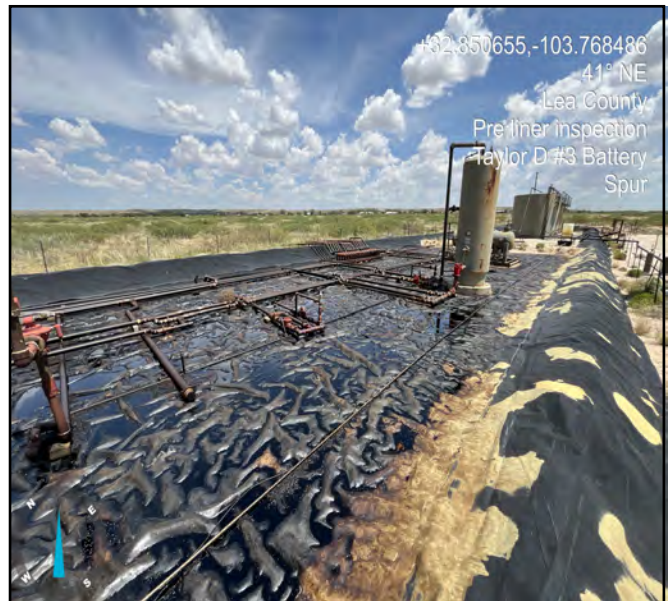
Photo of liner taken during initial liner inspection facing east.

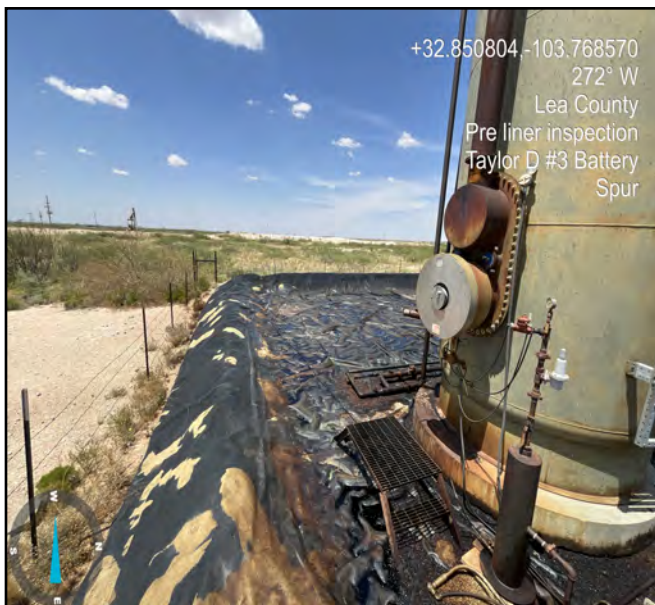
Photo of liner taken during initial liner inspection facing west.

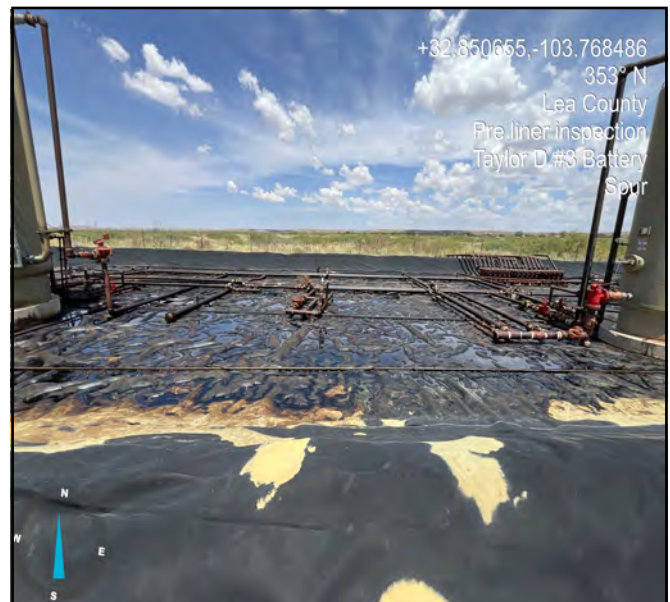
Photo of liner taken during initial liner inspection facing north.

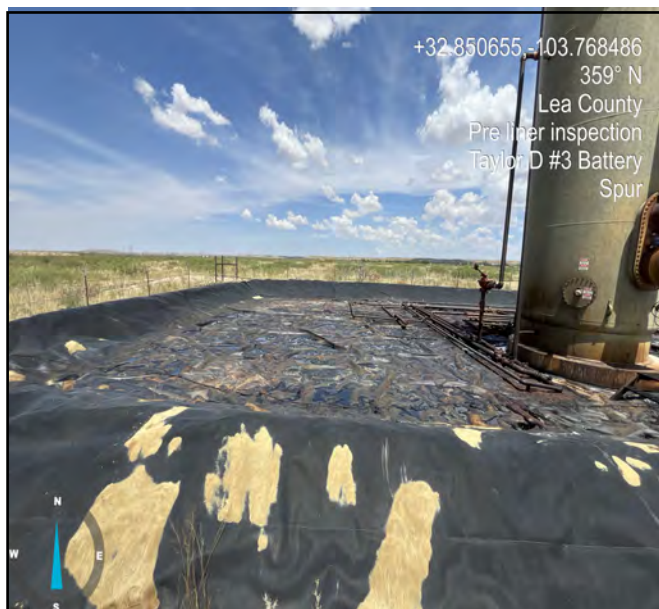
Photo of liner taken during initial liner inspection facing north.

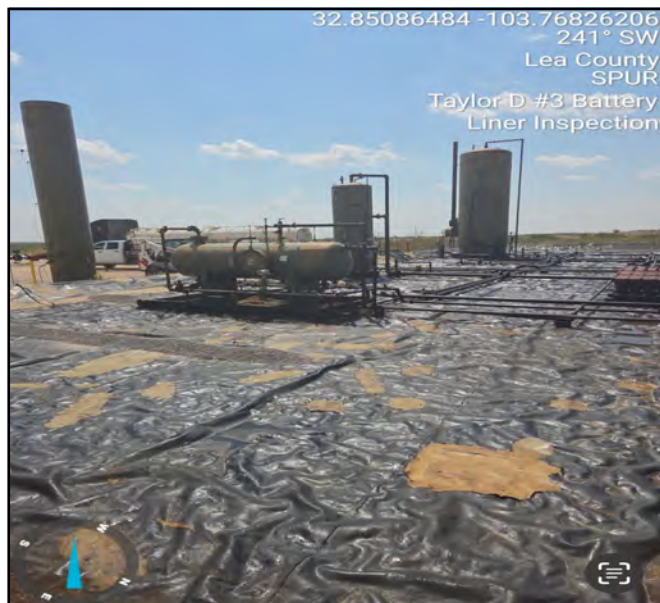
Photo of location taken post power wash facing southwest.

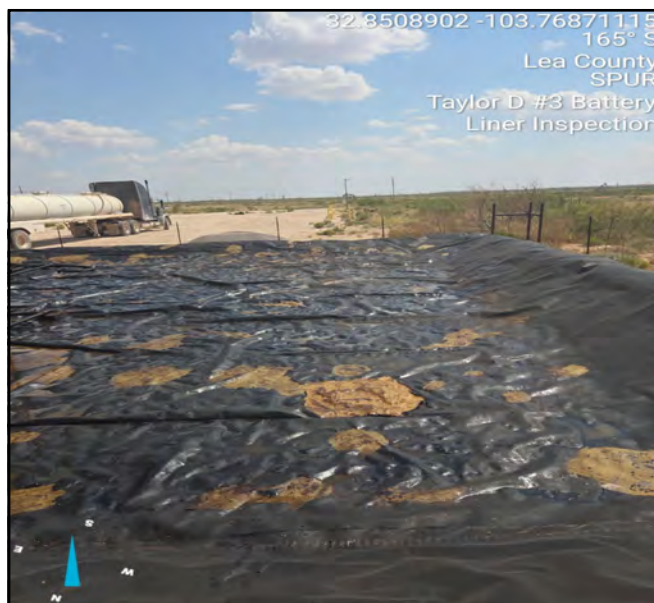
Photo of location taken post power wash facing southwest.

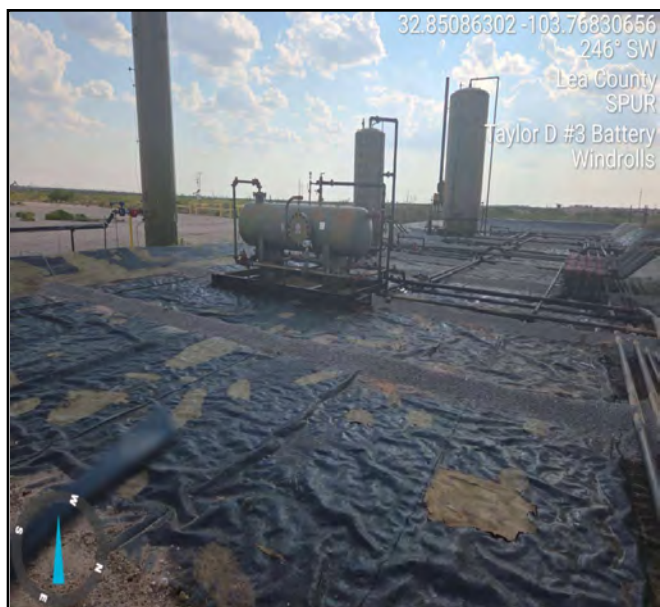
Photo of location taken after windrolls were laid facing southwest.

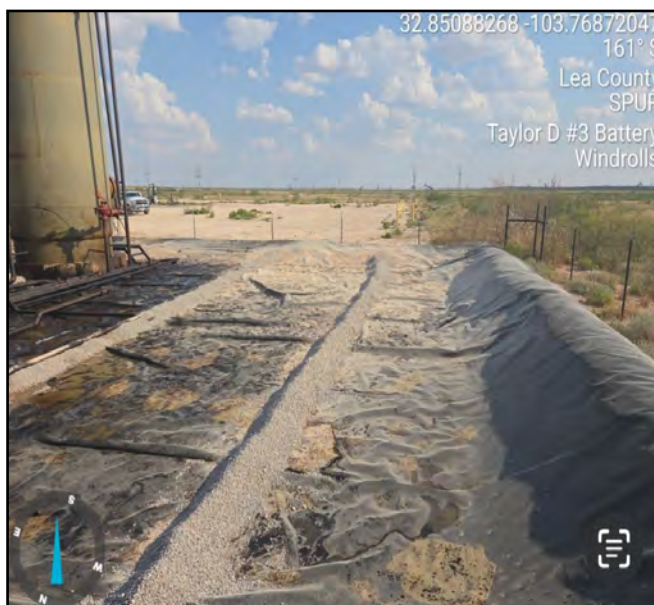
Photo of location taken after windrolls were laid facing south.

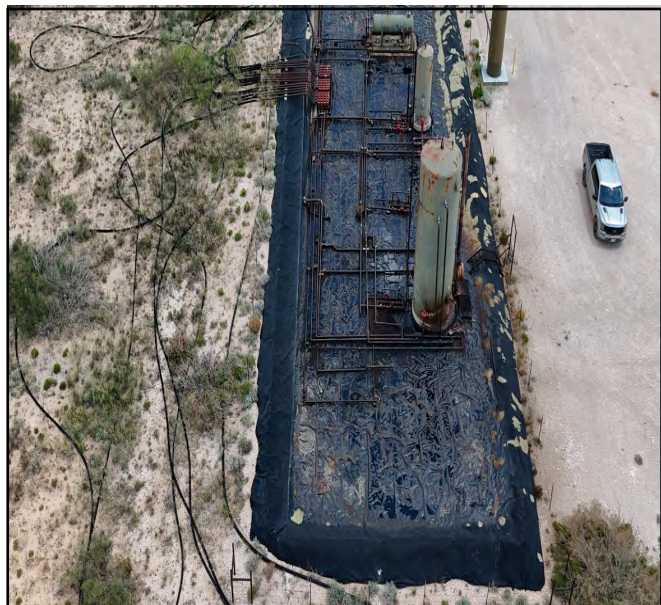
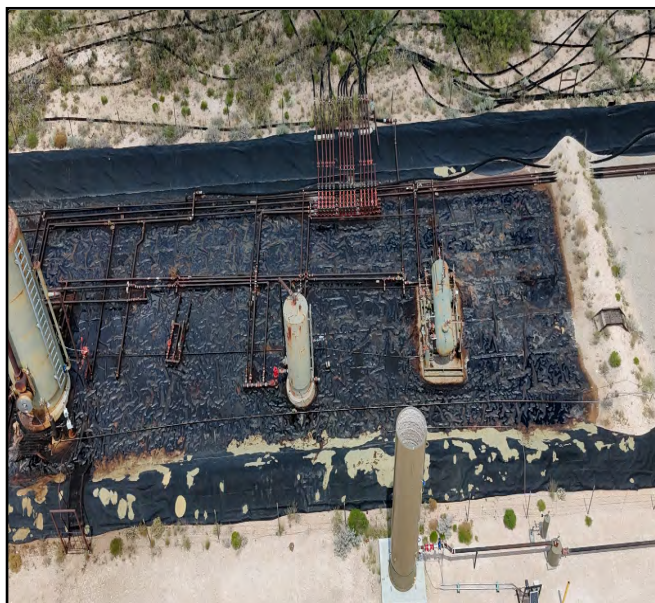
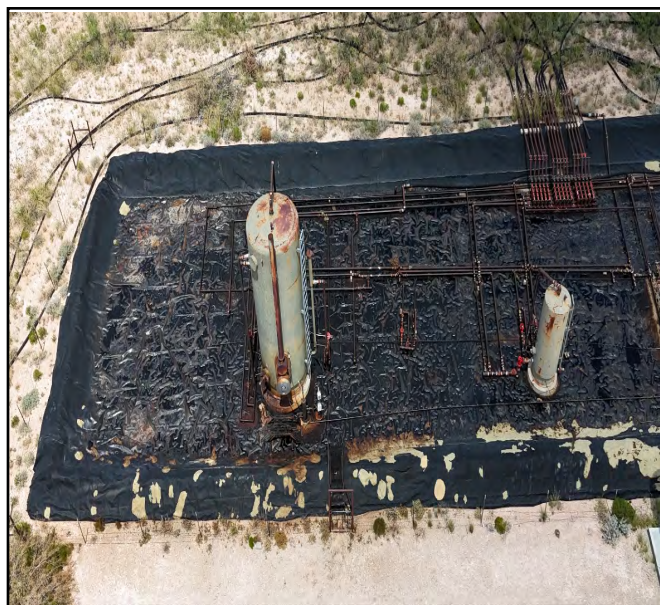
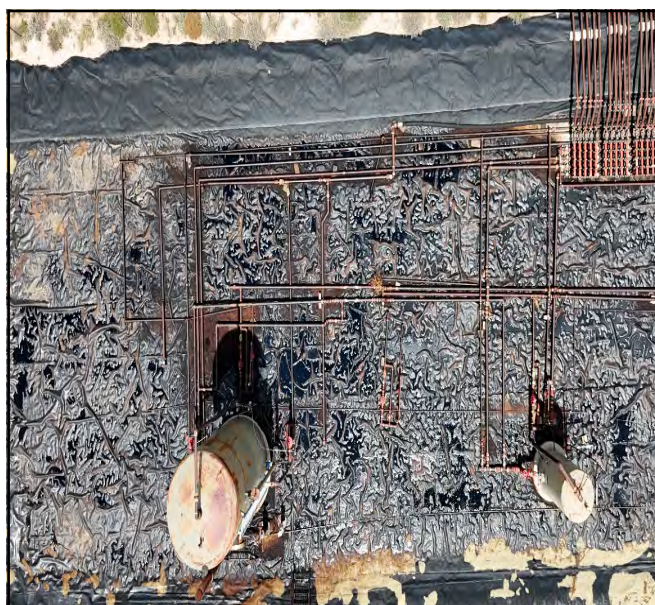
Aerial photos taken pre power wash.
