Our ref: 12676588-NMOCD-1

October 13, 2025

Closure Report  
Devon Energy Production Company, LP  
Tomahawk 13 CTB 1  
Unit Letter H, Section 13, T22S, R27E  
GPS: 32.393068, -104.138015  
Eddy County, New Mexico

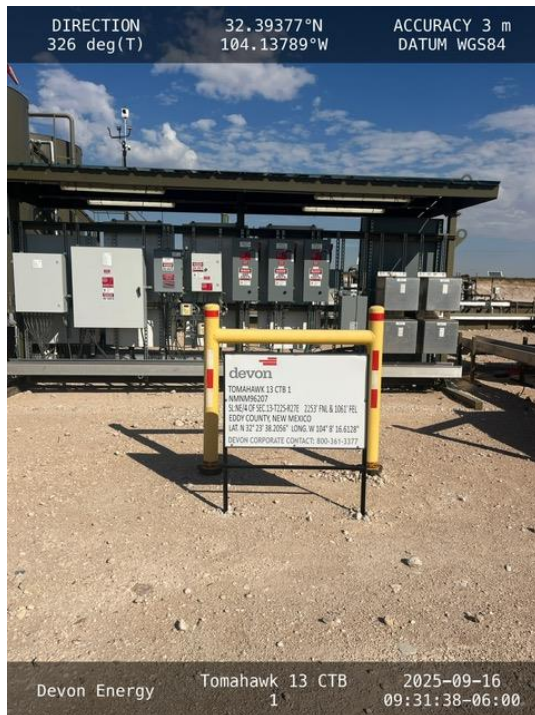
Photo 1 View of Site location.

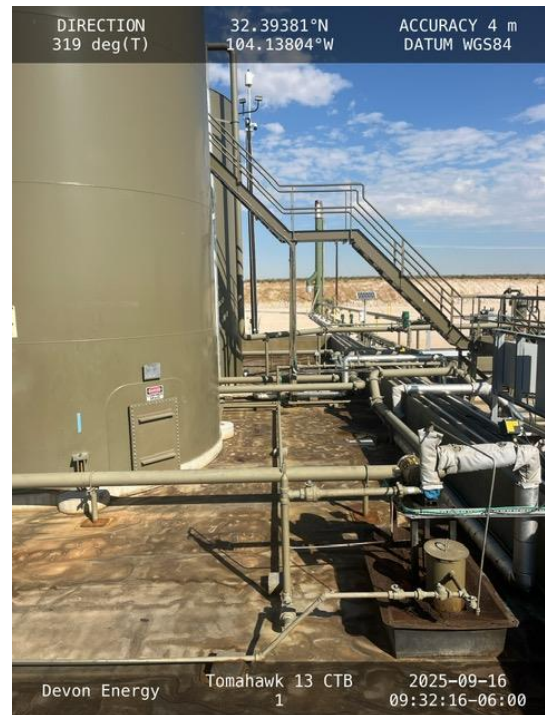
Photo 2 View of containment towards northwest.

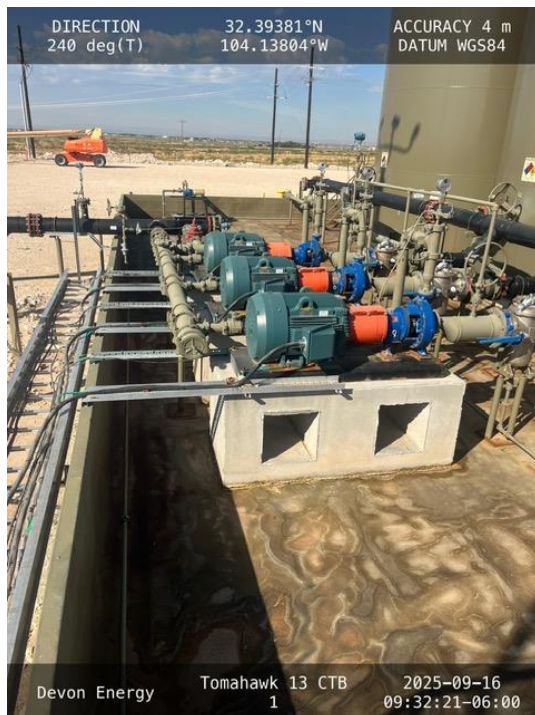
Photo 1 View of containment towards Southwest.

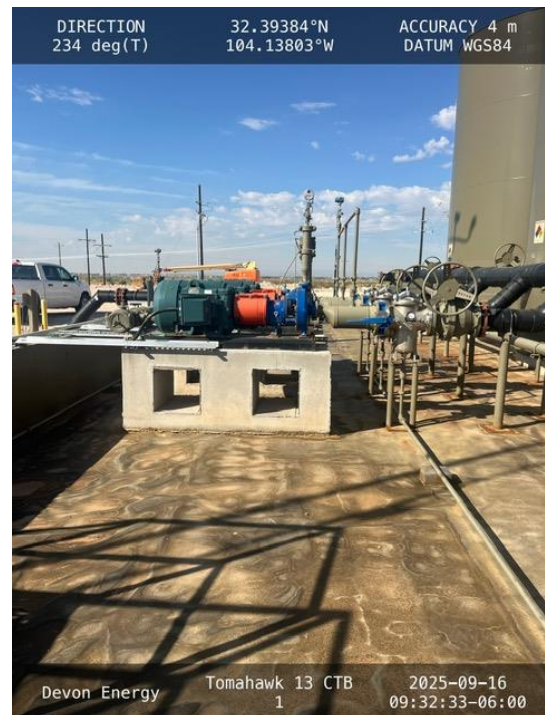
Photo 2 View of containment towards Southwest.

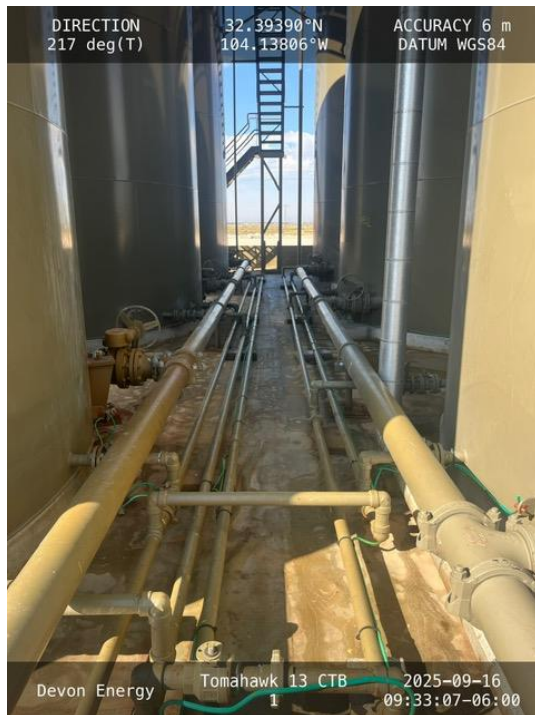
Photo 5 View of containment towards South.

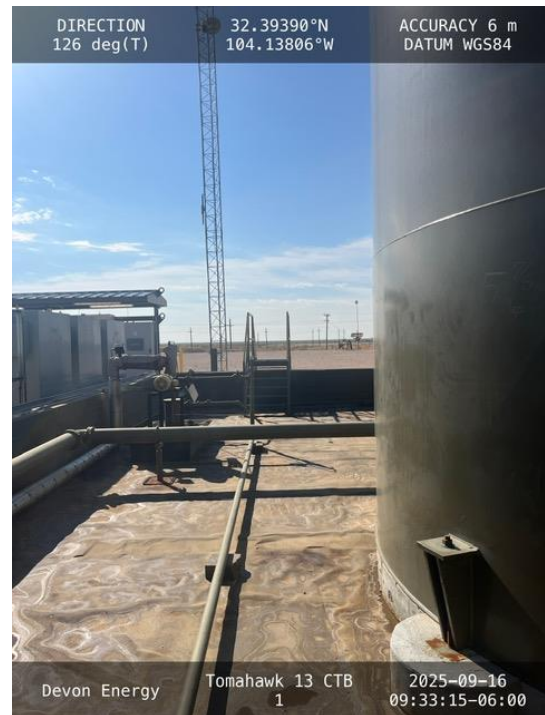
Photo 6 View of Southeast corner of containment.

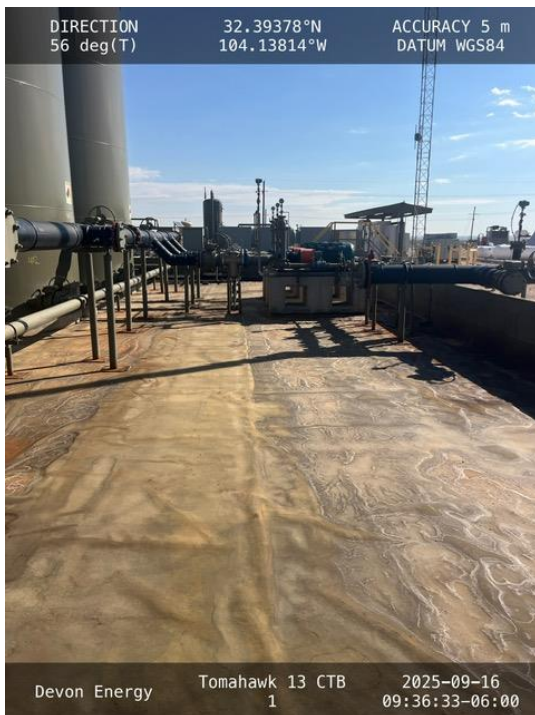
Photo 7 View of containment towards East

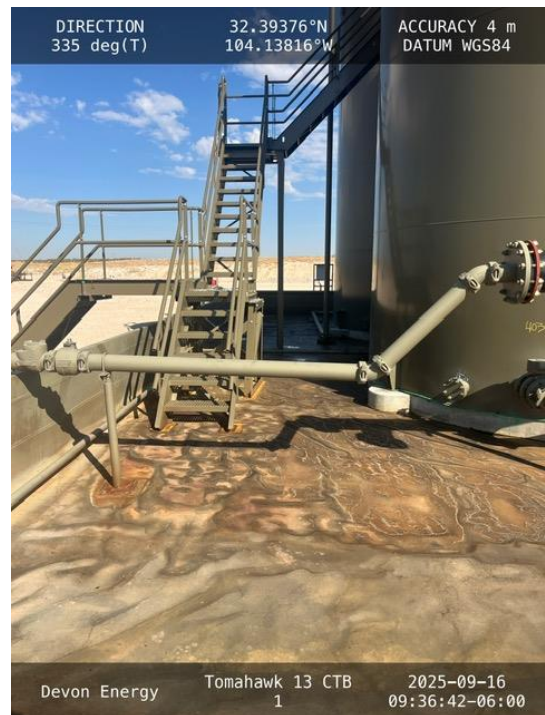
Photo 8 View of containment towards Northwest.

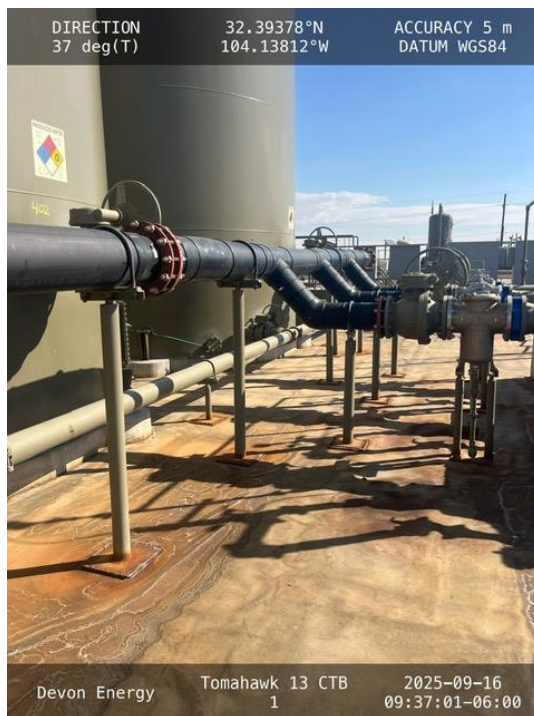
Photo 9 View of containment towards Northeast.

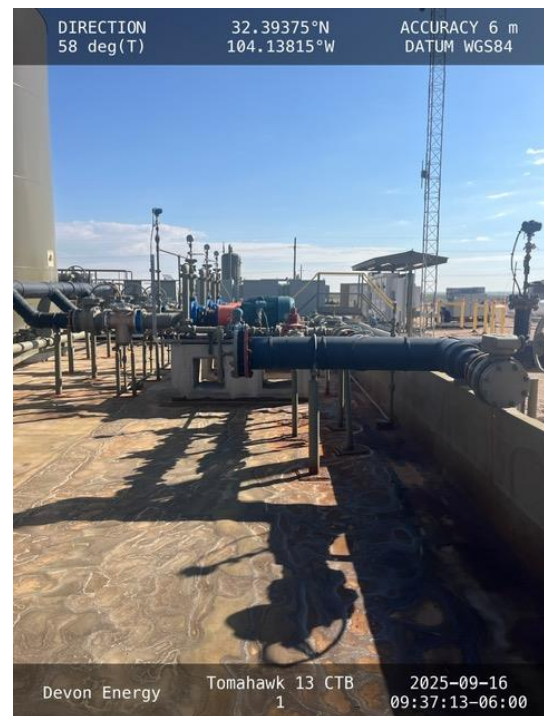
Photo 10 View of containment towards East.

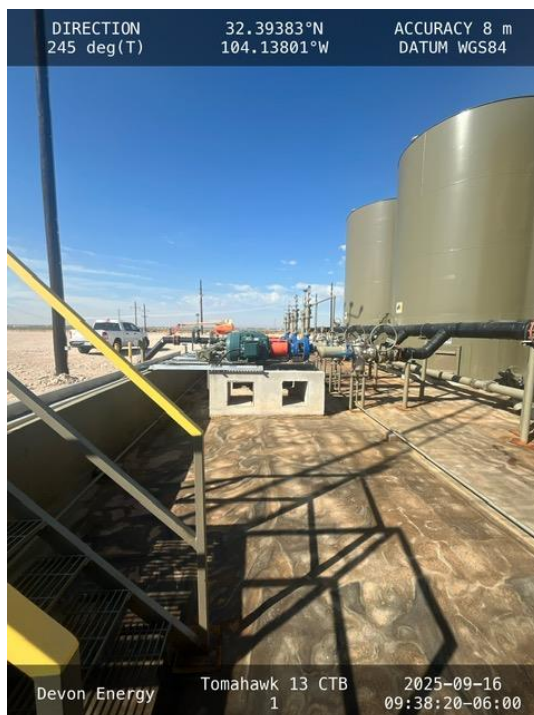
Photo 11 View of containment towards Southwest

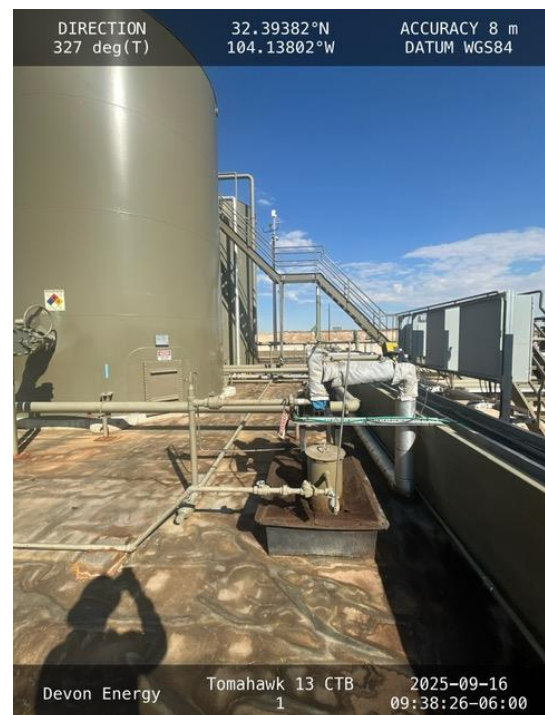
Photo 12 View of containment towards Northwest.

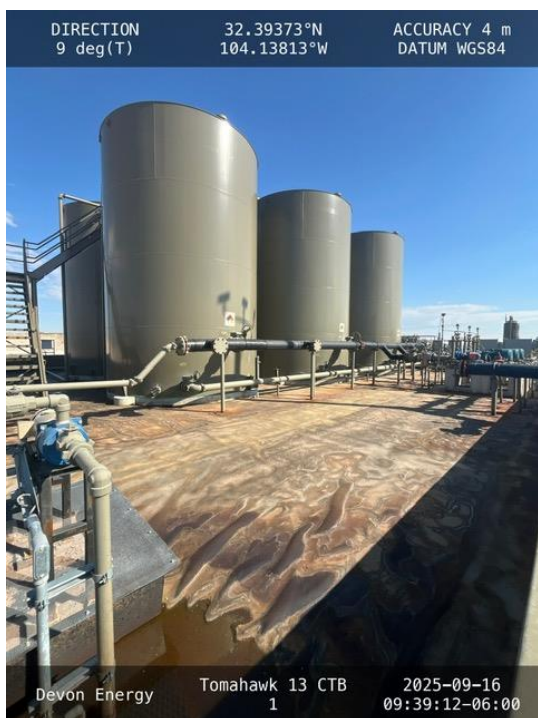
Photo 13 View of containment towards North.

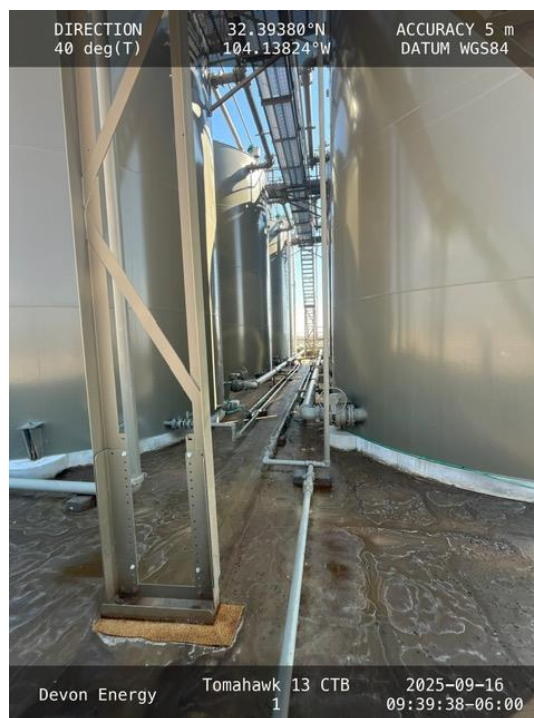
Photo 14 View of containment towards East
