CLOSURE REQUEST REPORT

*Devon Energy Production Company, LP.
5315 Buena Vista Dr.
Carlsbad, NM 88220*

Flagler 8 CTB 1

Incident Number nAPP2530126751

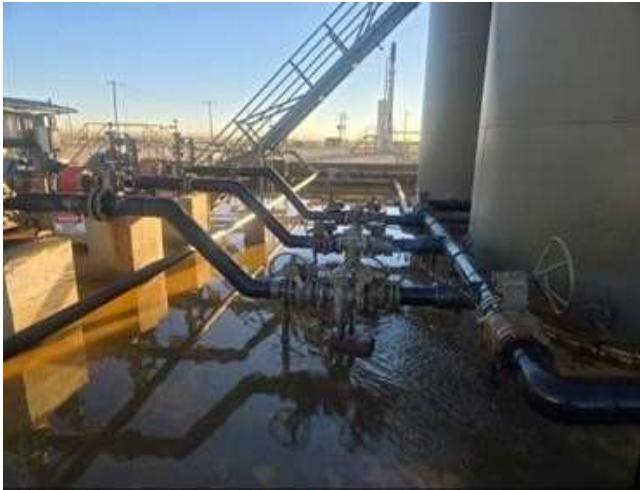
Photograph 1

Description: Northern view of southern portion of the lined containment floor before liner inspection activities.

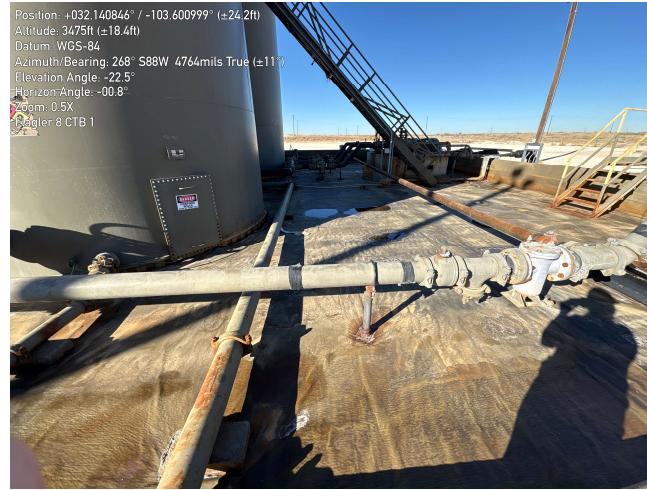
Photograph 2

Description: Western view of northern portion of lined containment during liner inspection activities.

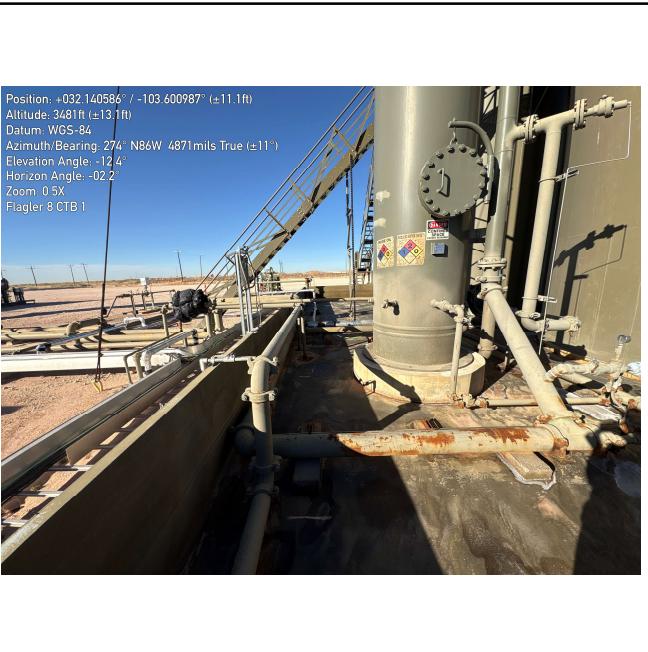
Photograph 3

Description: Western view of southern portion of lined containment during liner inspection activities.

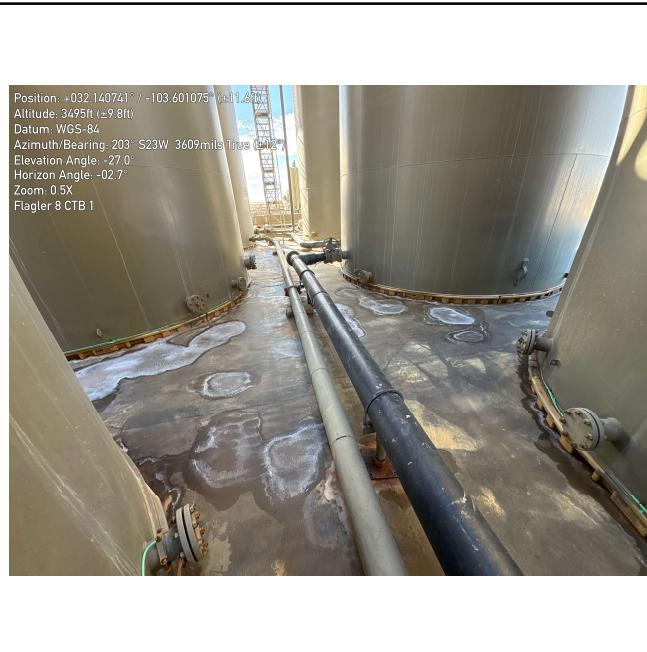
Photograph 4

Description: Southwestern view of center of lined containment during liner inspection activities.

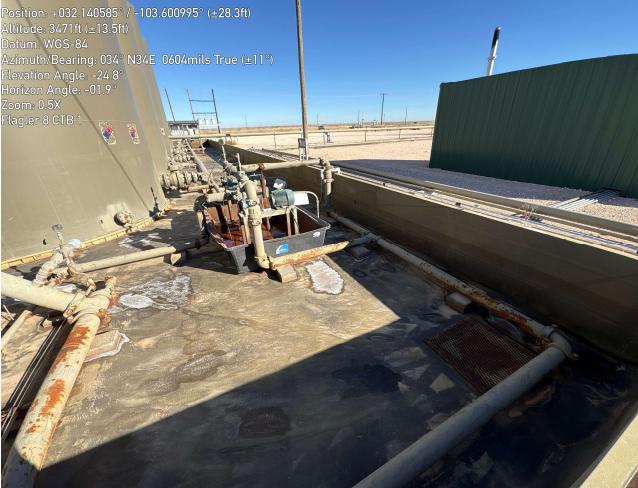
**Photograph 5****Date: 12/26/2025**

Description: Northeastern view of southern portion of the lined containment during liner inspection activities.

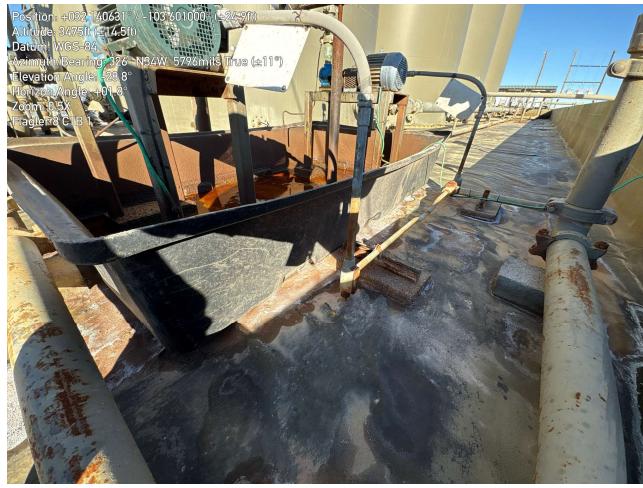
**Photograph 6****Date: 12/26/2025**

Description: Northwestern view of southern portion of lined containment during liner inspection activities.

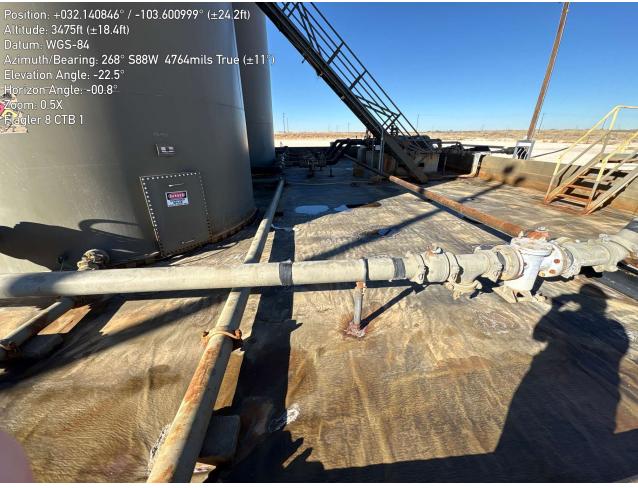
**Photograph 7****Date: 12/26/2025**

Description: Southwestern view of southern portion of lined containment during liner inspection activities.

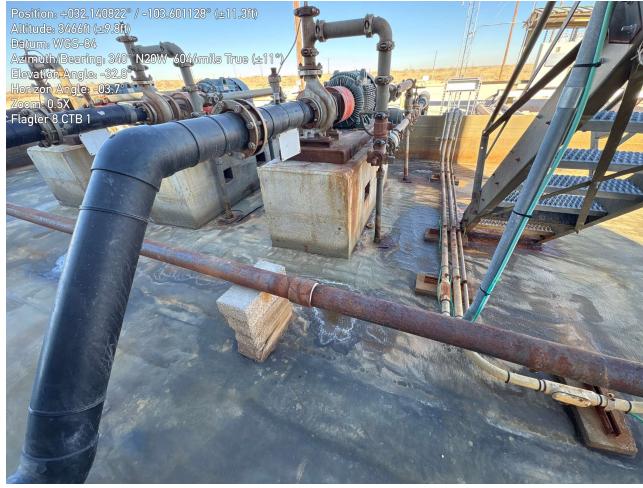
**Photograph 8****Date: 12/26/2025**

Description: Northwestern view of northern portion of lined containment during liner inspection activities.
