**Closure Report
Prairie Fire 30 Facility 1 (1.12.2026)
Incident ID: nAPP2601329132
Eddy County, New Mexico
Unit L, S30, T20S, R30E
32.5386881°, -104.0172097°**

Produced Water Release

Re: **Closure Report**
Prairie Fire 30 Facility 1 (01.12.2026)
Incident ID: nAPP2601329132
Devon Energy Production Company
Site Location: Unit L, S30, T20S, R30E
32.5386881°, -104.0172097°
Eddy County, New Mexico

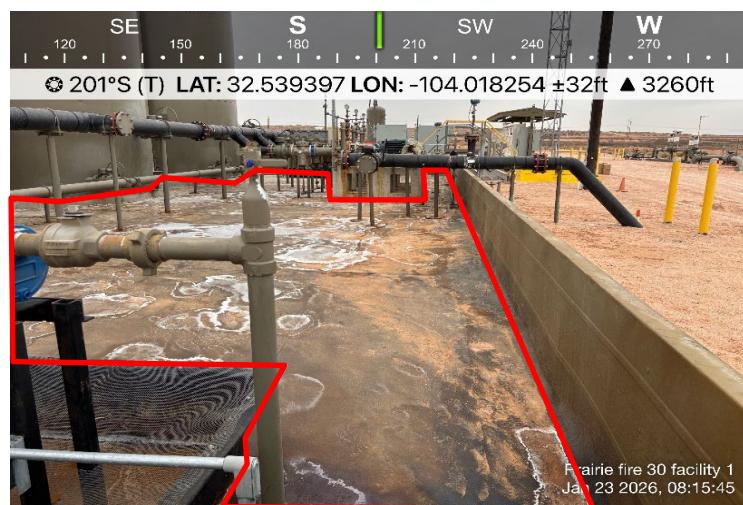
Photograph No. 1

View South of exposed liner. The red outline is the area of the liner inspection.

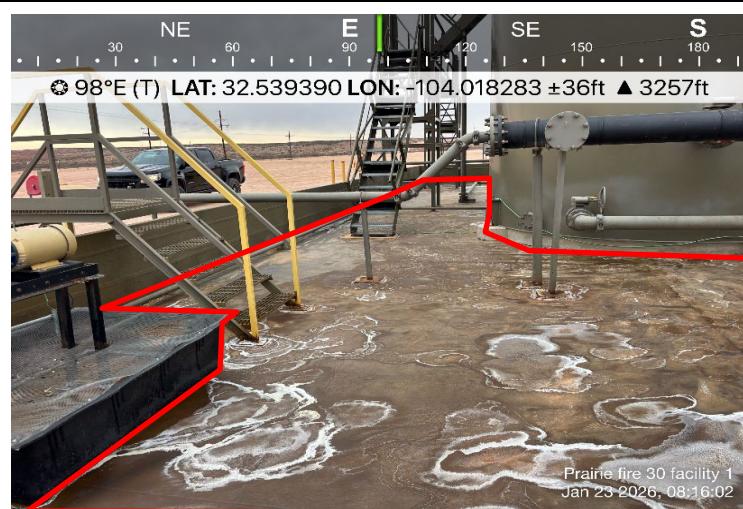
Photograph No. 2

View East of exposed liner. The red outline is the area of the liner inspection.

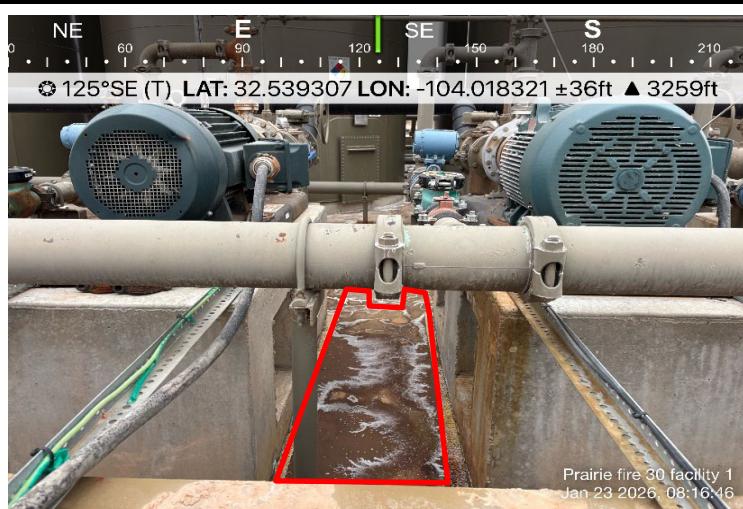
Photograph No. 3

View Southeast of exposed liner. The red outline is the area of the liner inspection.

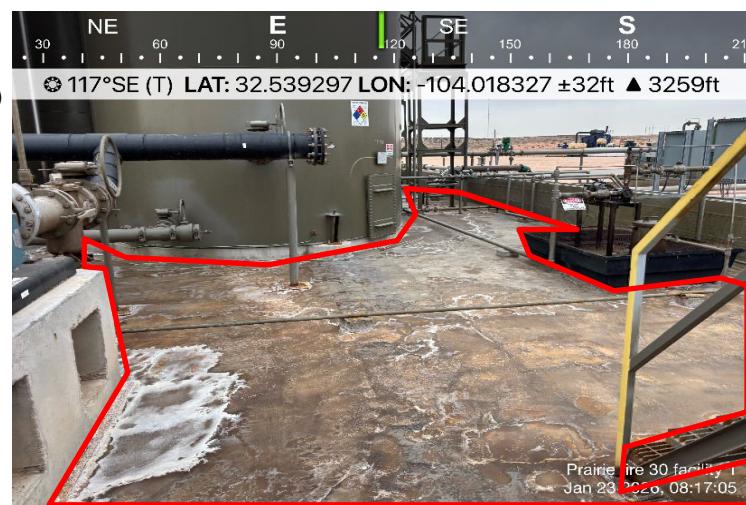
Photograph No. 4

View Southeast of exposed liner. The red outline is the area of the liner inspection.

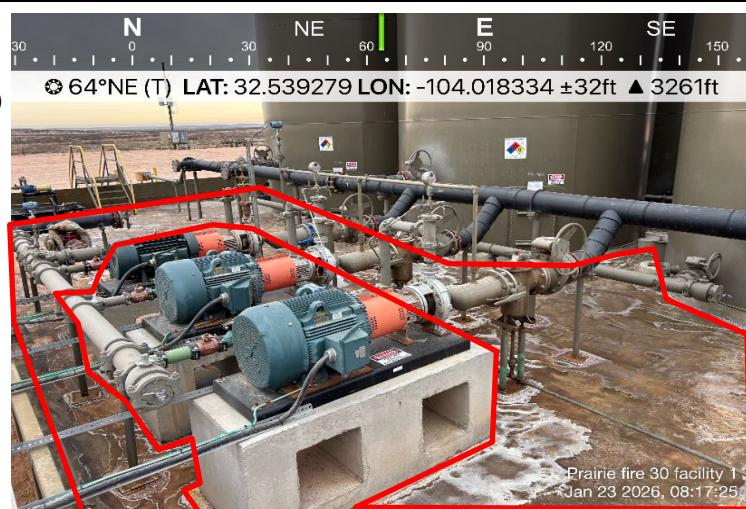
Photograph No. 5

View Northeast of exposed liner. The red outline is the area of the liner inspection.

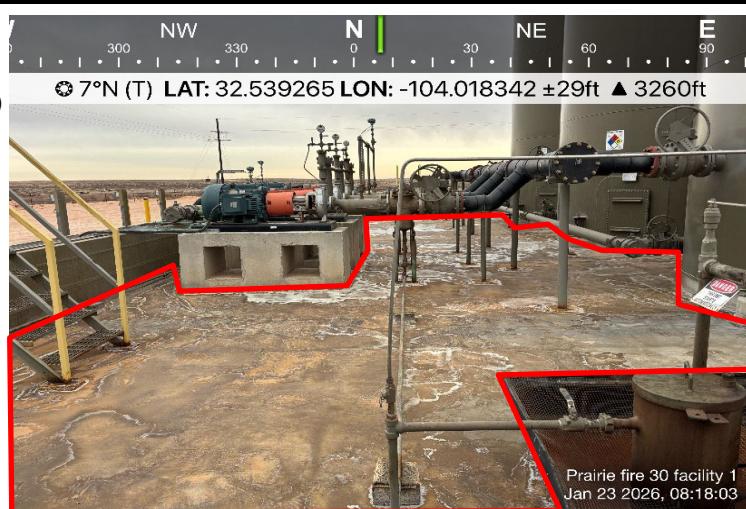
Photograph No. 6

View North of exposed liner. The red outline is the area of the liner inspection.

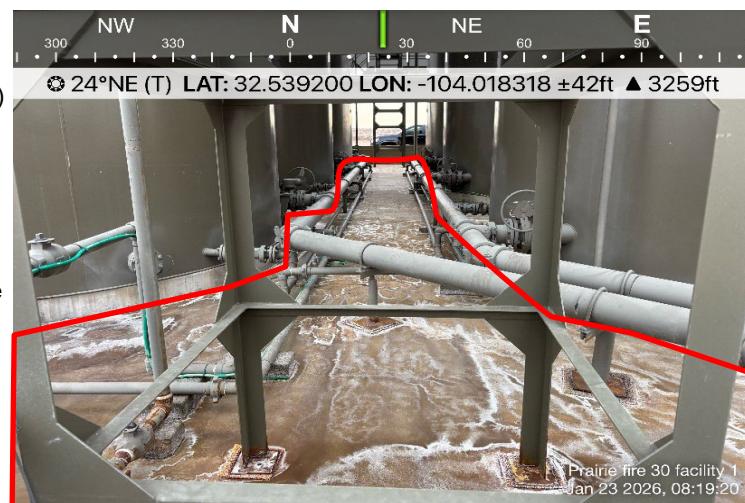
Photograph No. 7

View Northeast of exposed liner. The red outline is the area of the liner inspection.

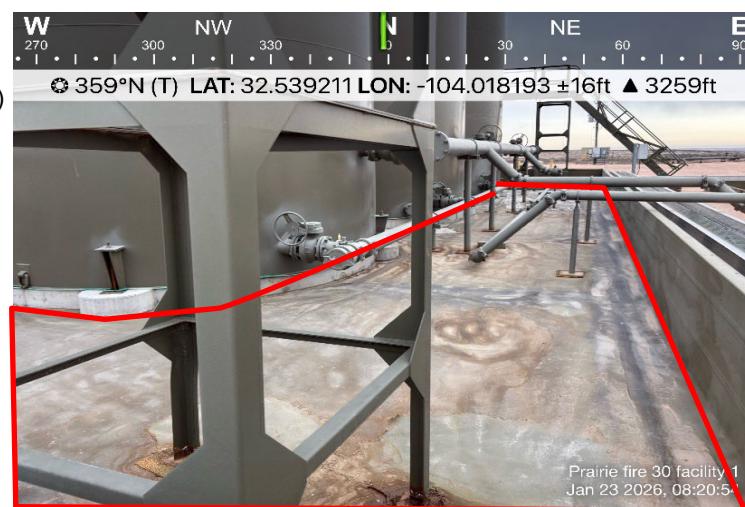
Photograph No. 8

View North of exposed liner. The red outline is the area of the liner inspection.

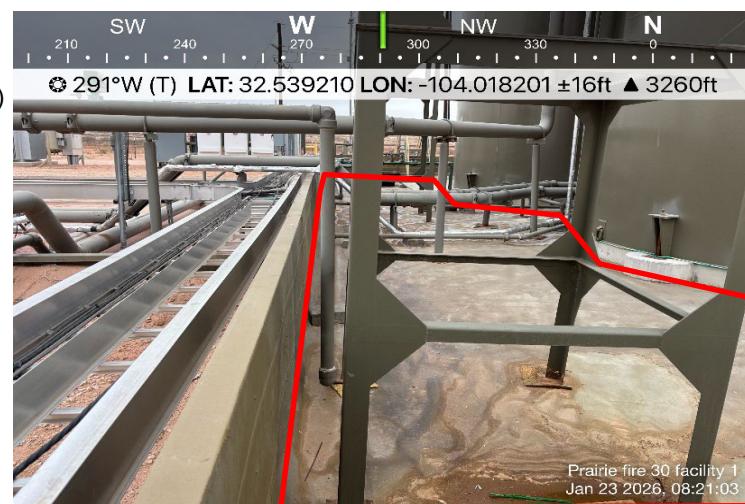
Photograph No. 9

View West of exposed liner. The red outline is the area of the liner inspection.

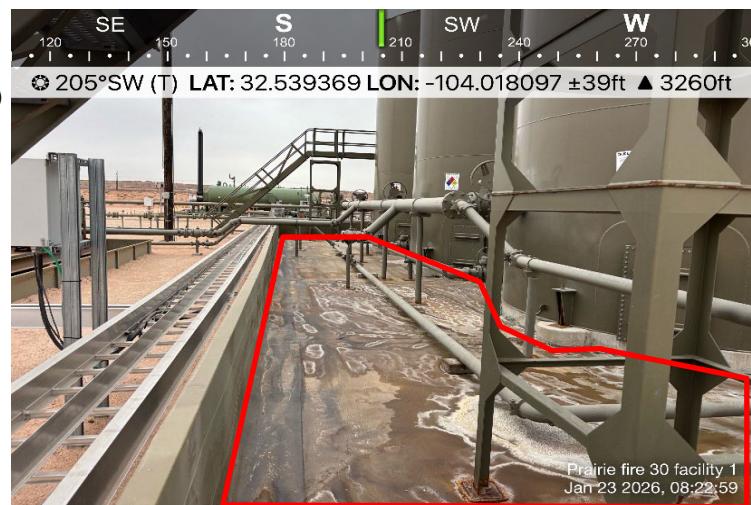
Photograph No. 10

View Southwest of exposed liner. The red outline is the area of the liner inspection.

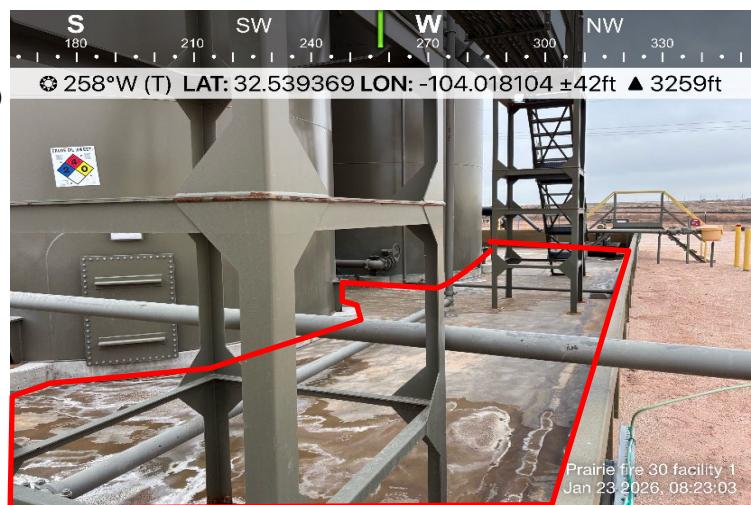
Photograph No.11

View West of exposed liner. The red outline is the area of the liner inspection.
