Our ref.: 12684334-NMOCD-1

February 2, 2026

Closure Report
Devon Energy Production Company, LP
Galapagos 14 CTB 2
Unit Letter D, Section 14, T23S, R31E
GPS: 32.308521, -103.748562
Eddy County, New Mexico

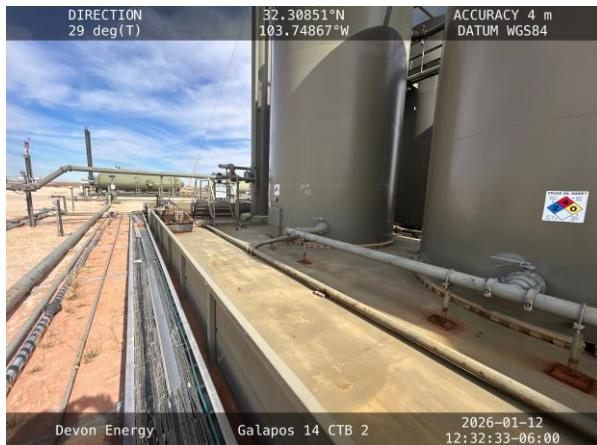
The liner inspection notice was provided on January 8, 2026. A liner integrity inspection was scheduled on January 12, 2026. The liner was visually inspected and no rips, tears, holes, or damage in the liner was observed. The liner was determined to be intact with no integrity issues. Photographic documentation of the liner inspection completed on January 12, is presented in **Attachment C**.

Photo 1 View of west side of containment towards north.

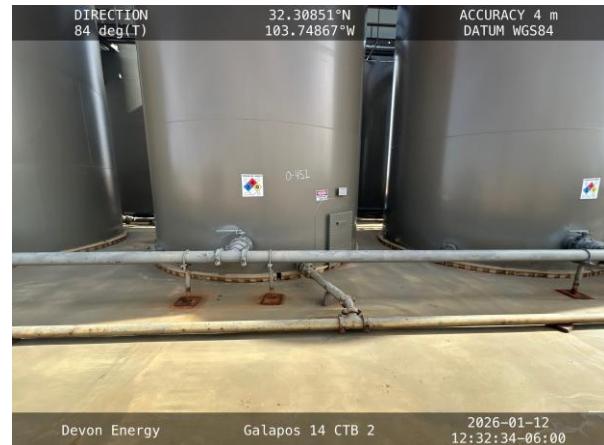
Photo 2 View of west side of containment.

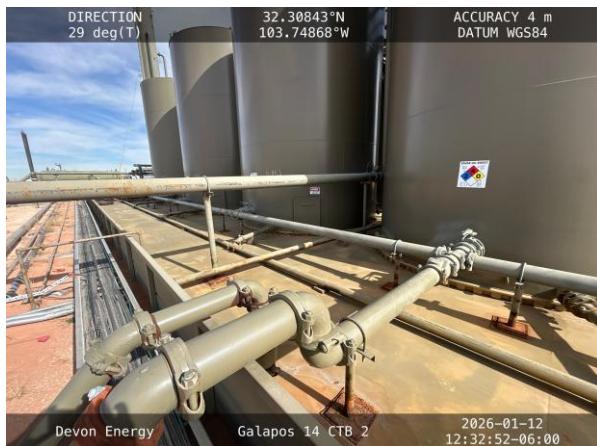
Photo 3 View of west side of containment towards north.

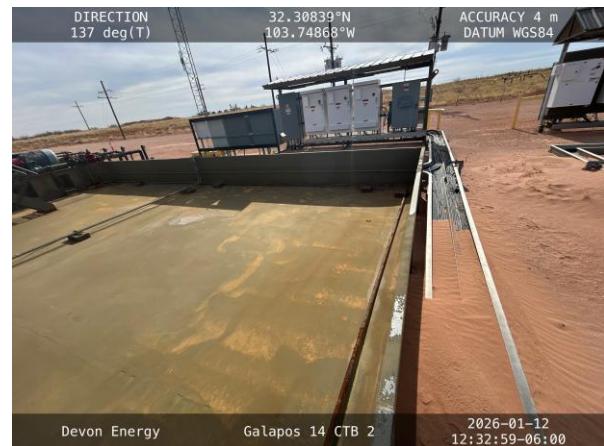
Photo 4 View of west side of containment towards south.

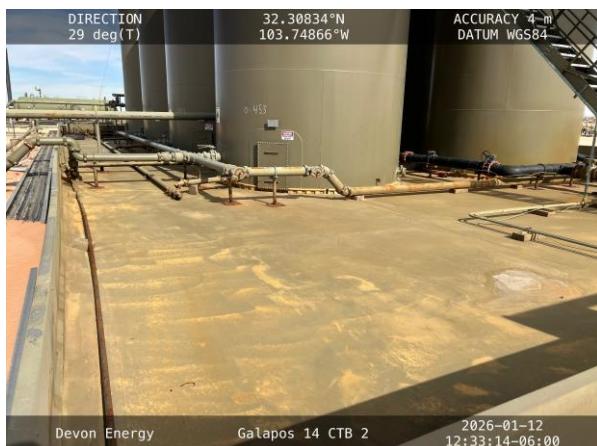
Photo 5 View of southwest corner of containment.

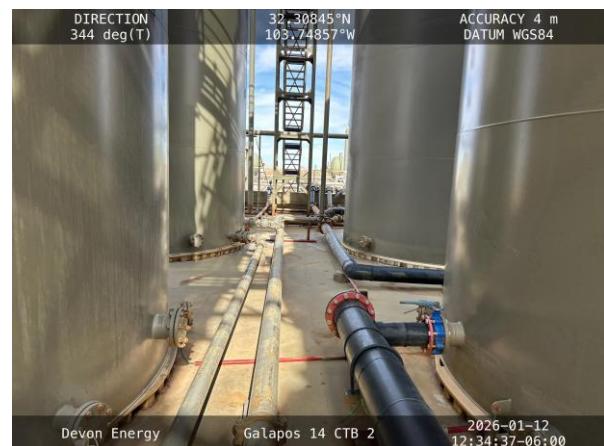
Photo 6 View of central portion of containment towards north.
