Liner Inspection and Closure Request

**Devon Energy Production Company, LP
Cotton Draw Unit 26 CTB 2 Liner
Lea County, New Mexico**

**Unit Letter "C", Section 26, Township 24 South, Range 31 East
Latitude 32.192712 North, Longitude 103.748725 West
NMOCD Incident # NAPP2525233161**

December 2025

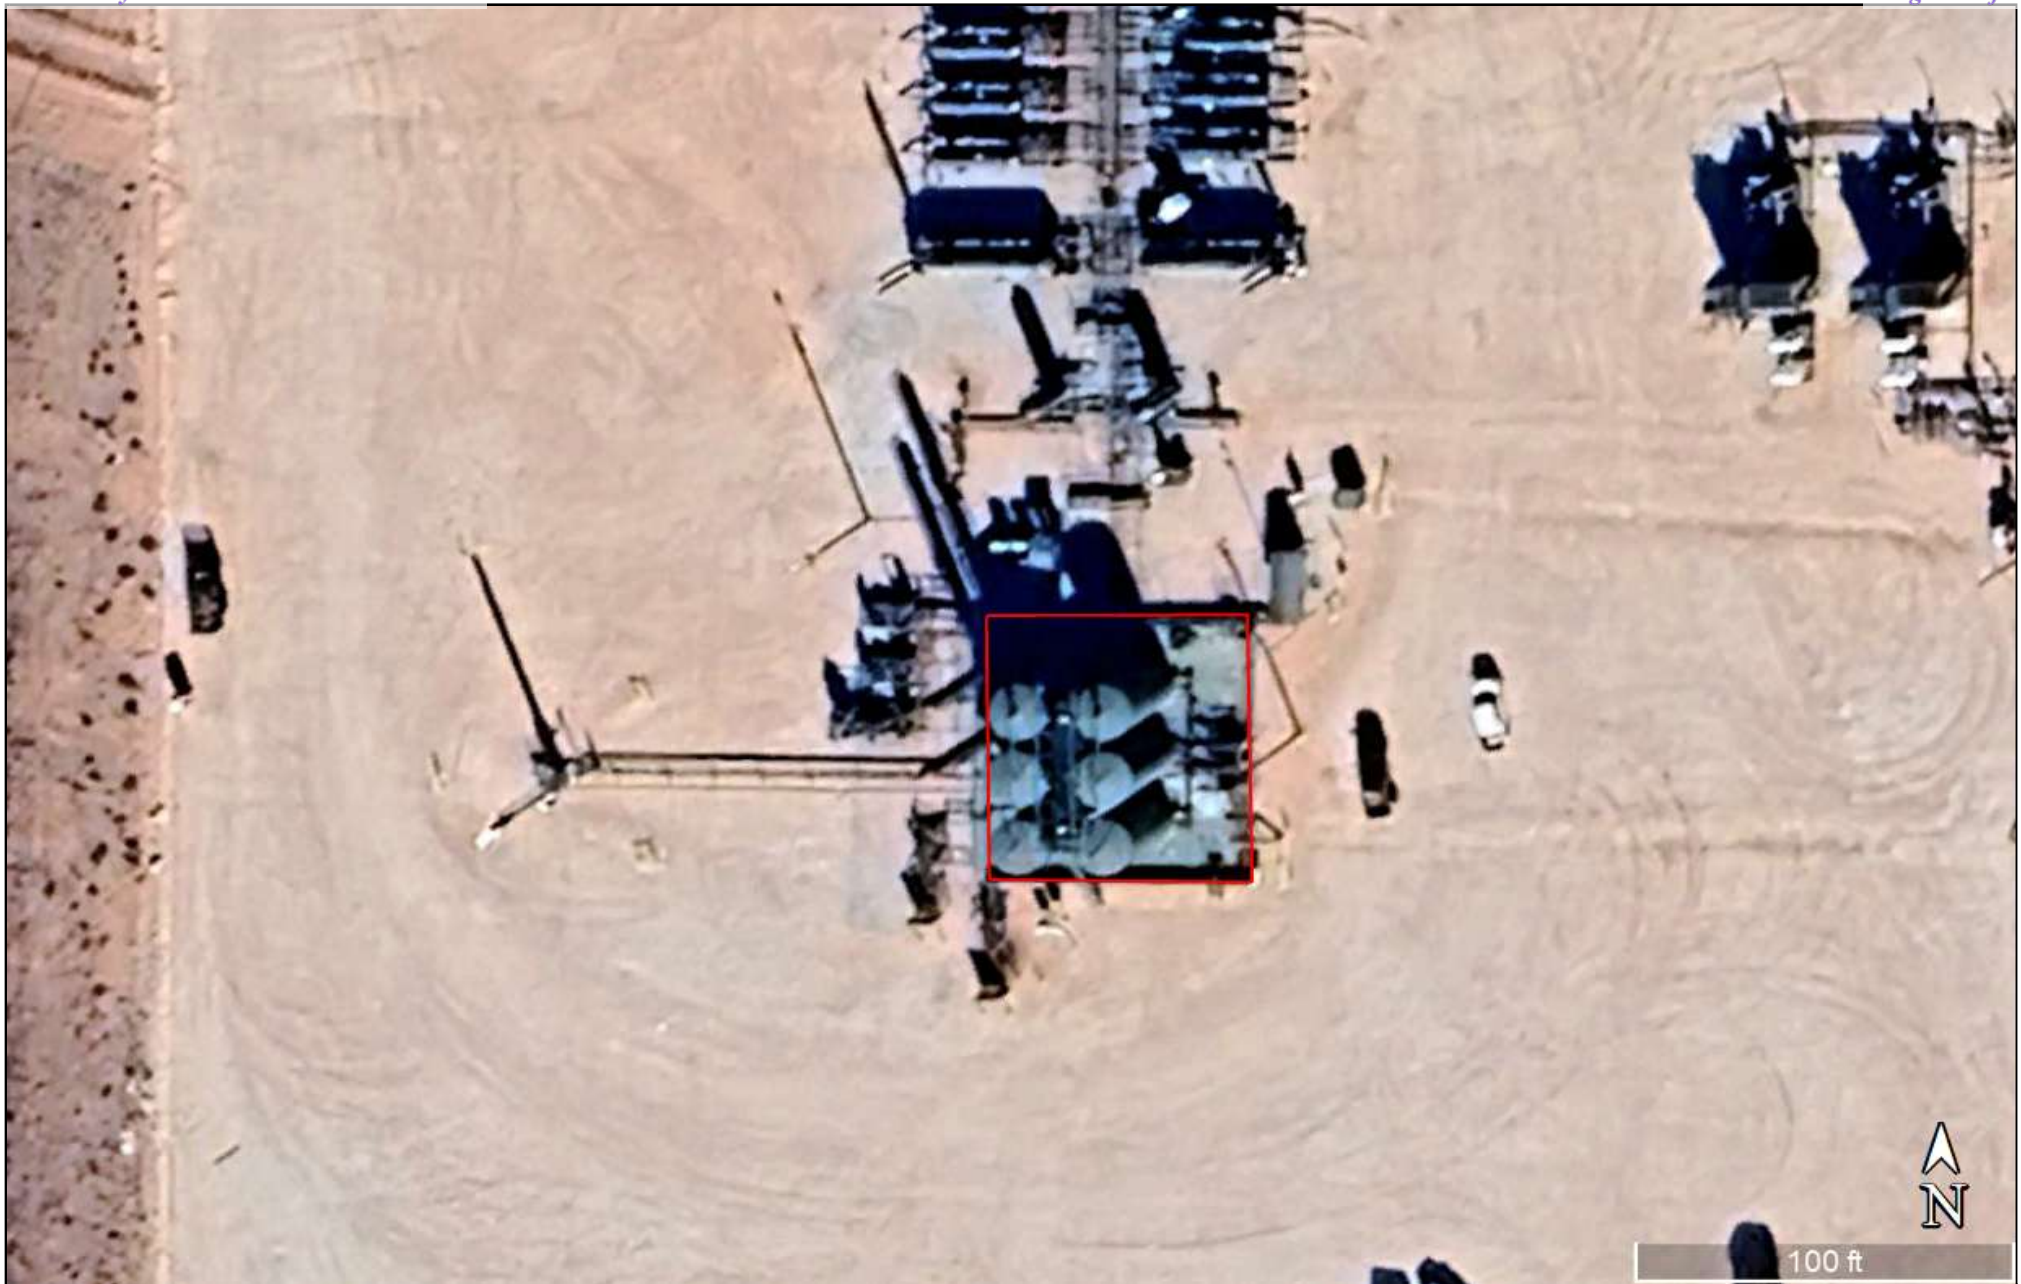
Figure 4

Liner Inspection Map
Devon Energy Production Company, LP
Cotton Draw Unit 26 CTB 2
GPS: 32.192712, -103.748725
Eddy County

Release Area within Lined Containment

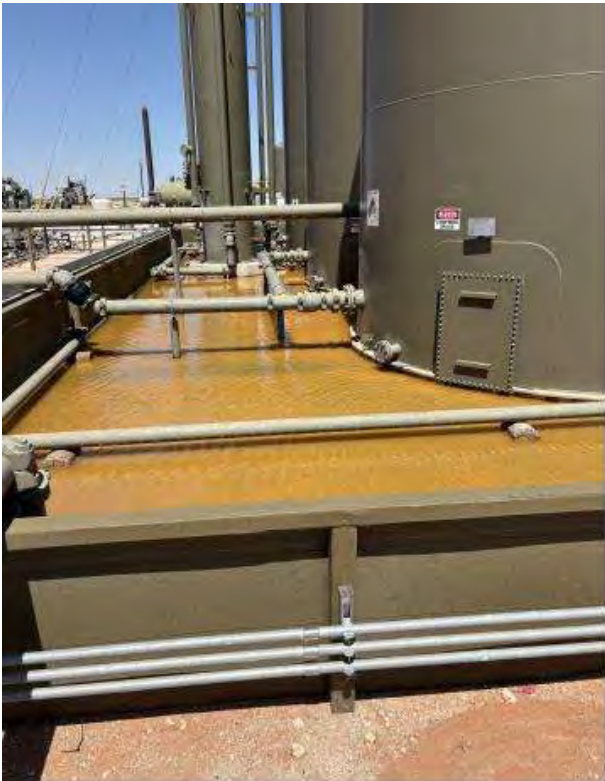
Photo: 1	Description: Day of Release

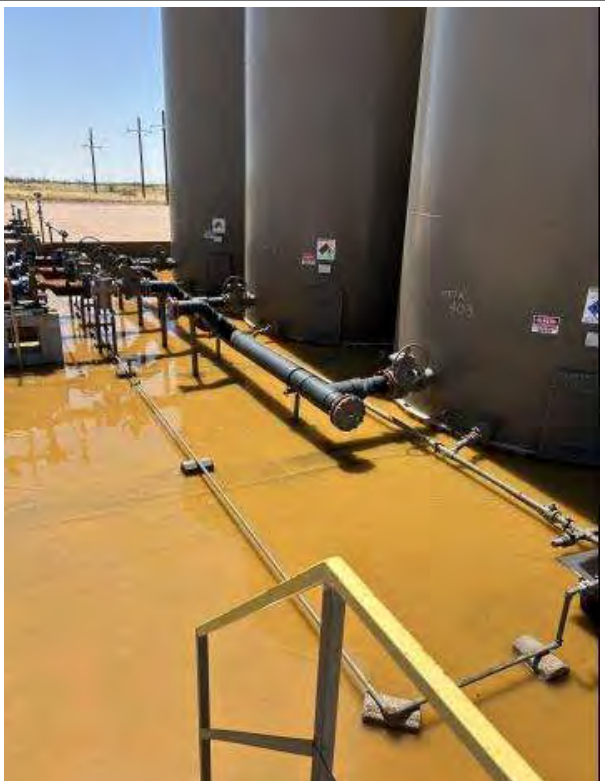
Photo: 2	Description: Day of Release
