Sherman 4 Fee 6H TB

Incident ID NAPP2601229026

PREPARED BY:
PIMA ENVIRONMENTAL SERVICES, LLC

Liner Inspection and Closure Report

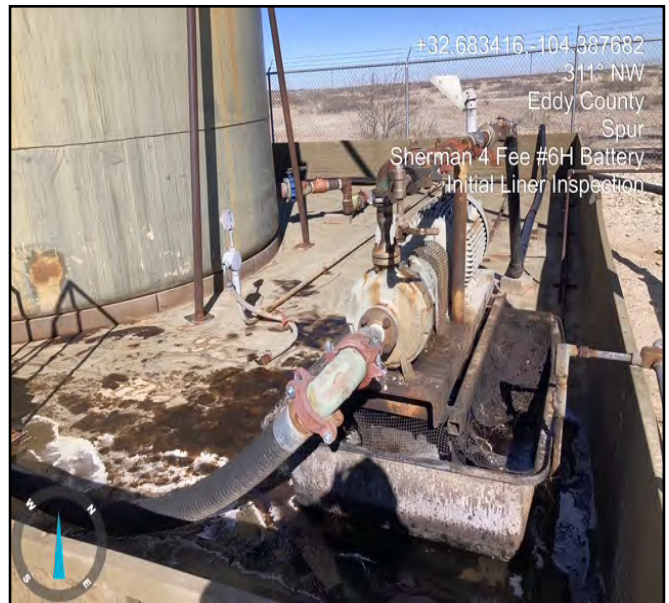
Photo of liner taken during initial liner inspection facing northwest.

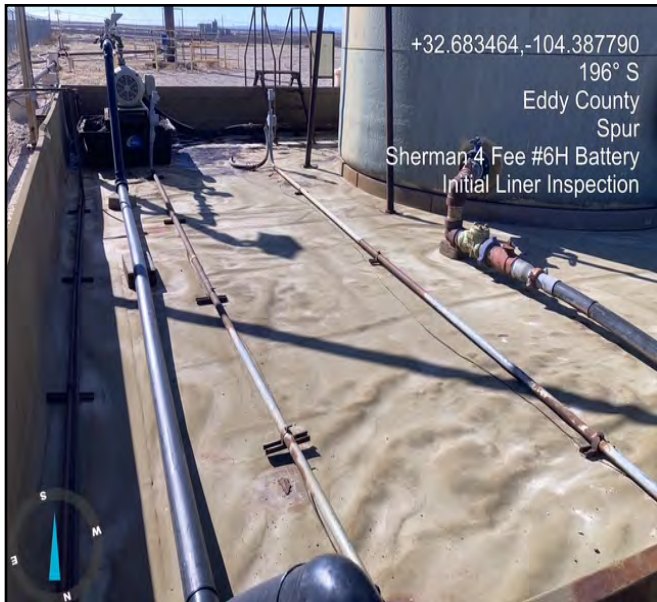
Photo of liner taken during initial liner inspection facing south.

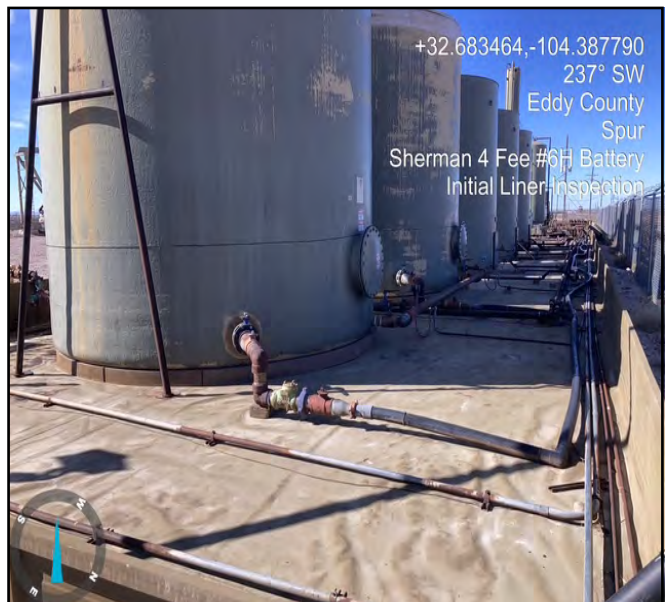
Photo of liner taken during initial liner inspection facing southwest.

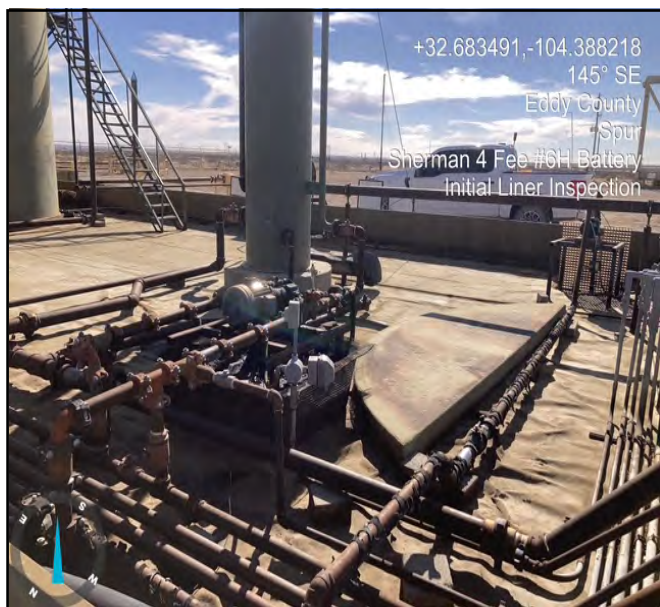
Photo of liner taken during initial liner inspection facing southeast.

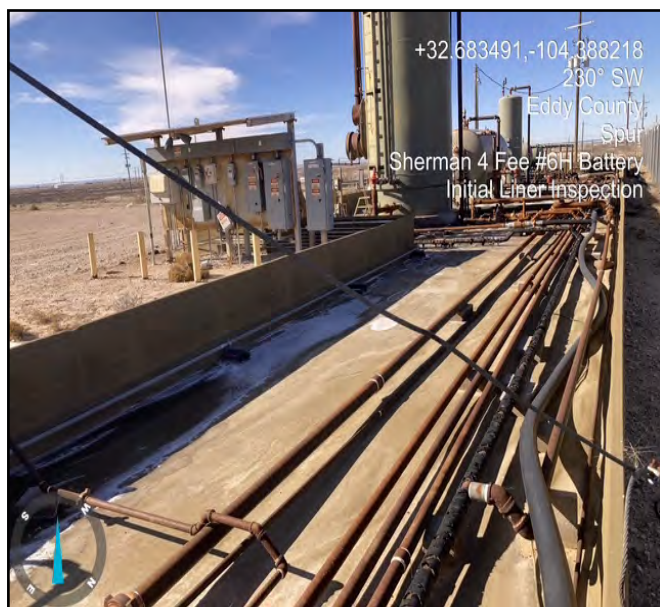
Photo of liner taken during initial liner inspection facing southwest.

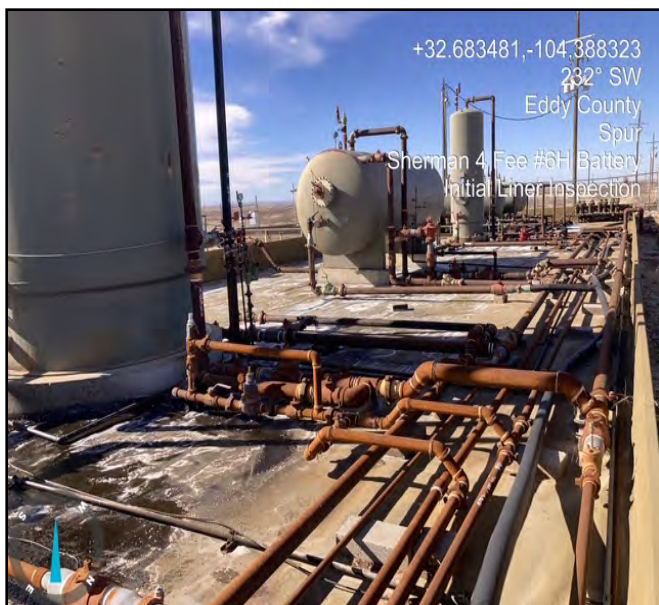
Photo of liner taken during initial liner inspection facing southwest.

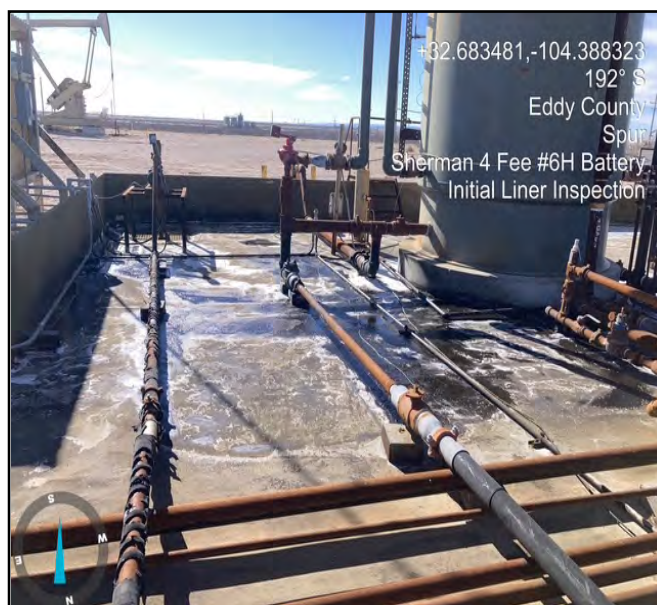
Photo of liner taken during initial liner inspection facing south.

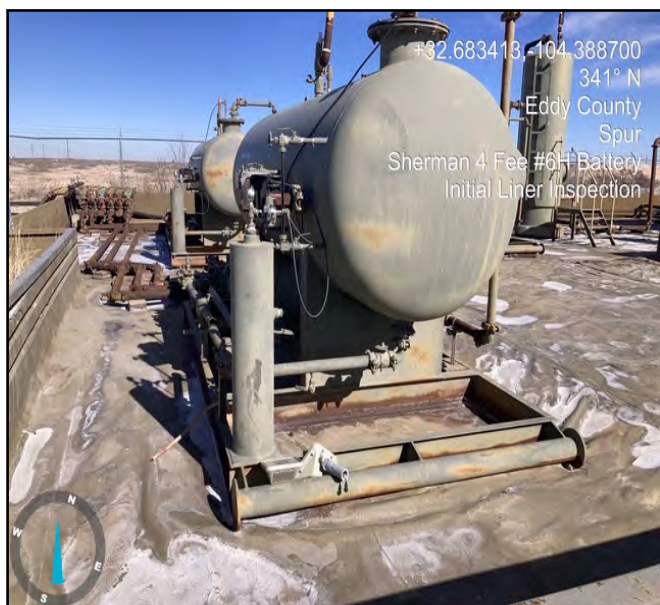
Photo of liner taken during initial liner inspection facing north.

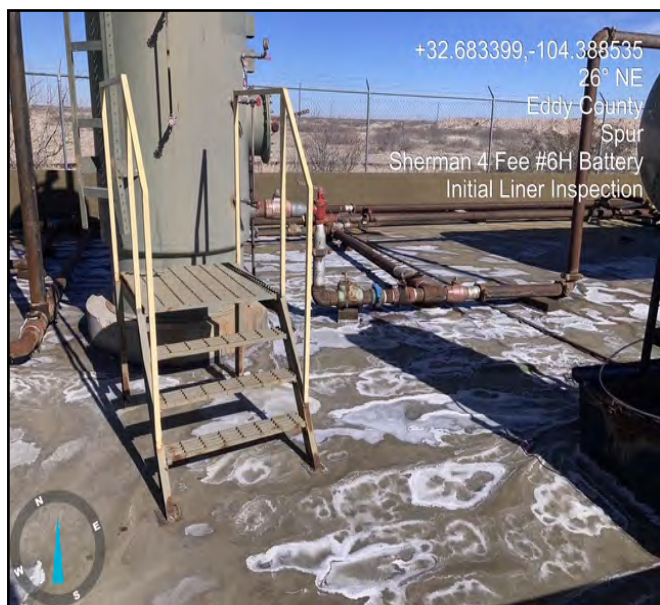
Photo of liner taken during initial liner inspection facing northeast.

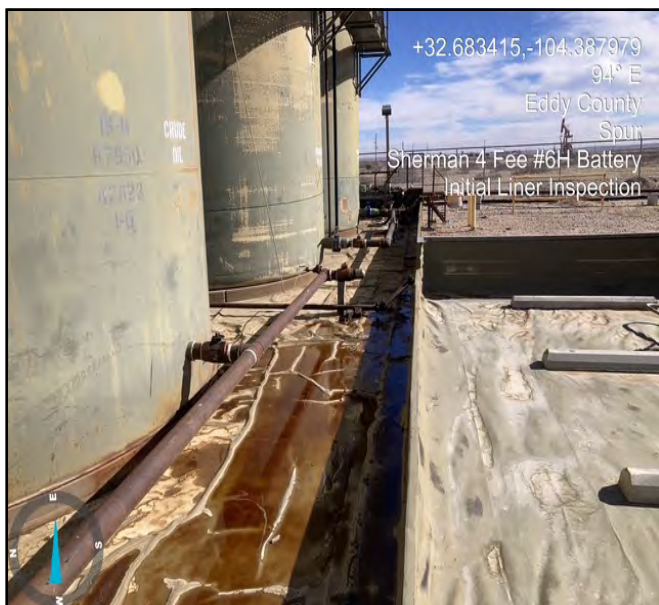
Photo of liner taken during initial liner inspection facing east.

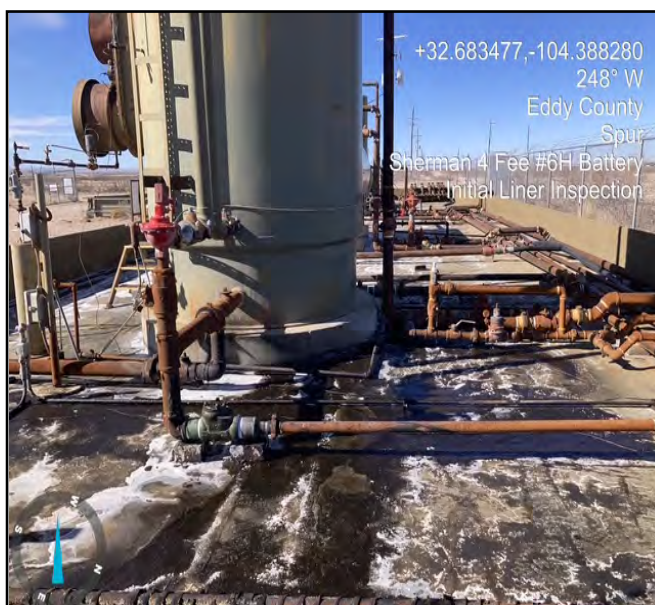
Photo of liner taken during initial liner inspection facing west.

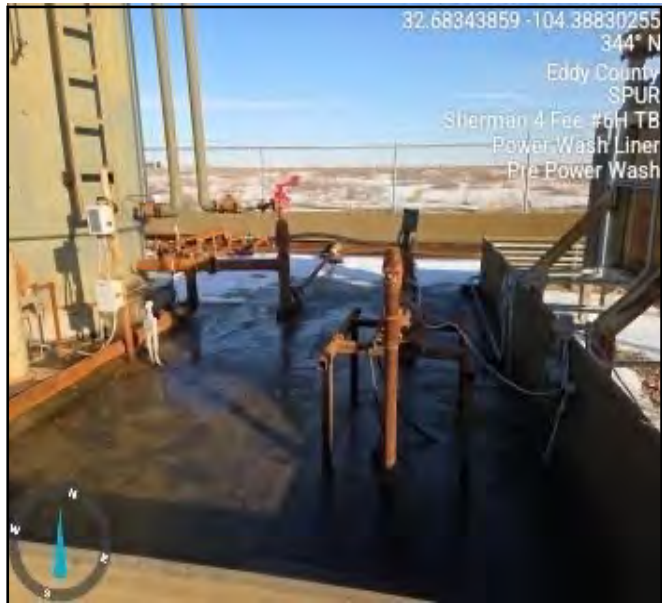
Photograph taken pre- powerwash process facing north.

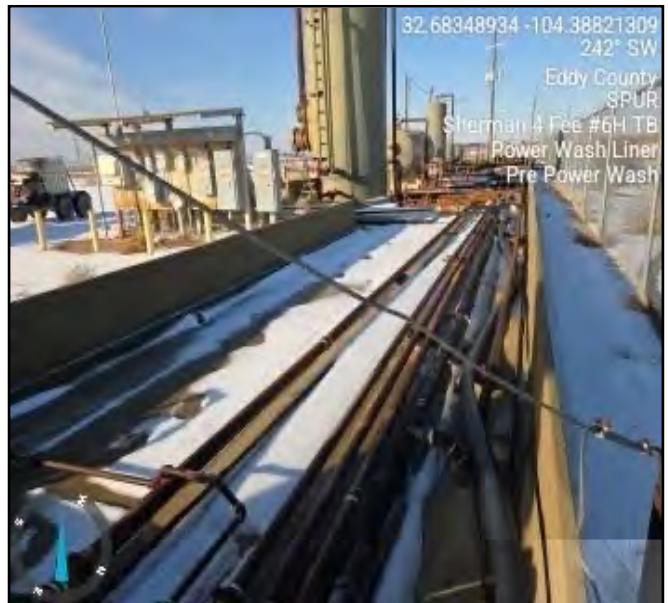
Photograph taken pre- powerwash process facing southwest.

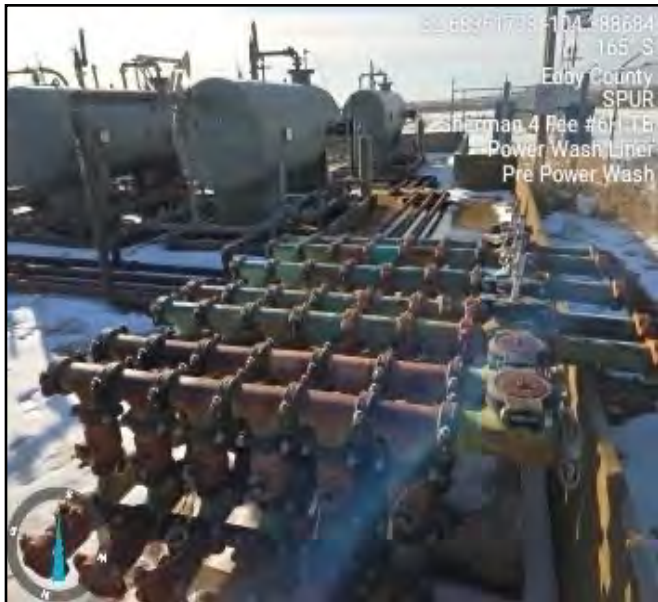
Photograph taken pre- powerwash process facing south.

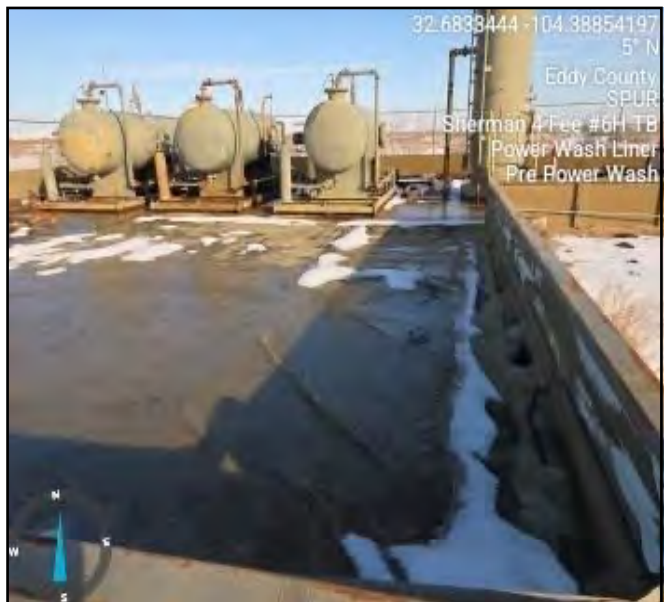
Photograph taken pre- powerwash process facing north.

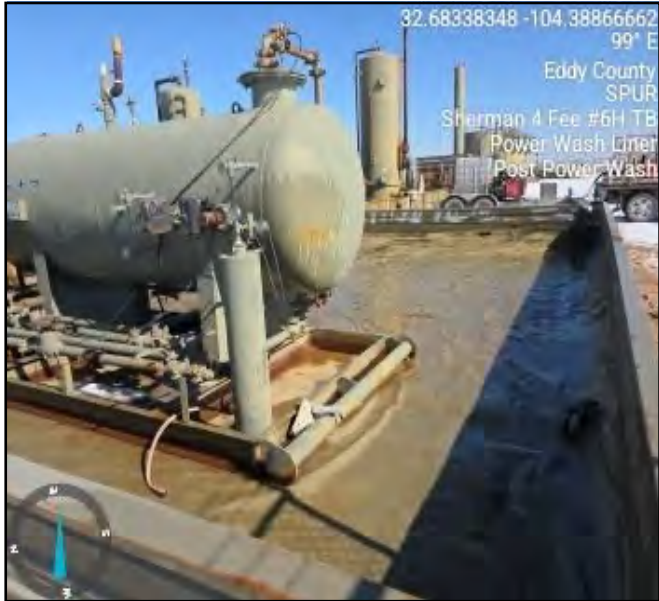
Photo of location taken post power wash facing east.

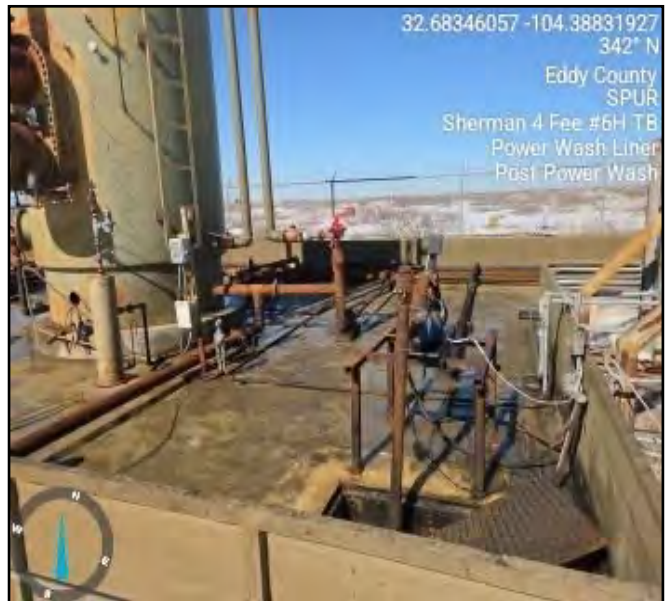
Photo of location taken post power wash facing north.

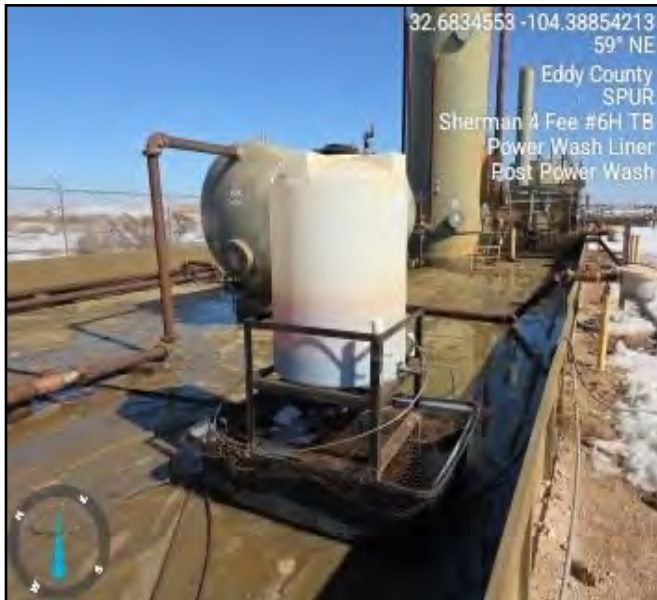
Photo of location taken post power wash facing northeast.

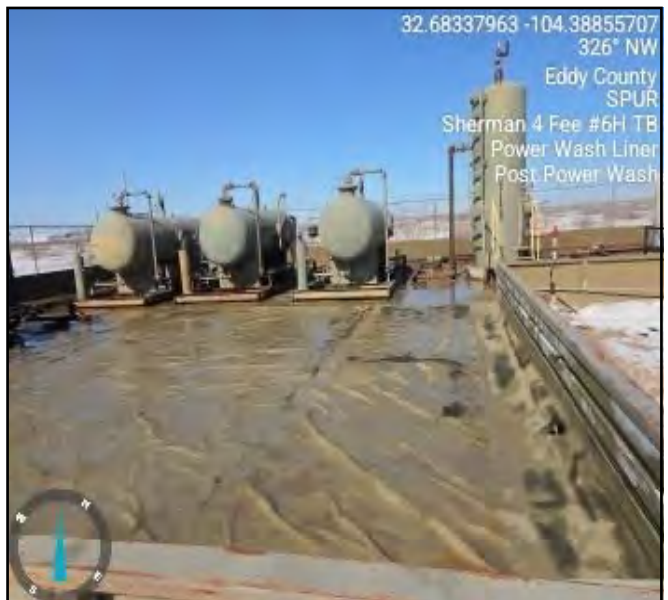
Photo of location taken post power wash facing northwest.

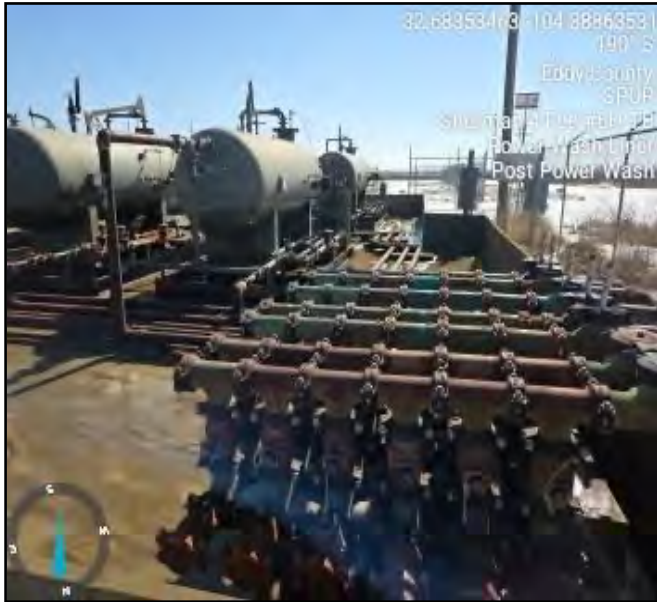
Photo of location taken post power wash facing south.

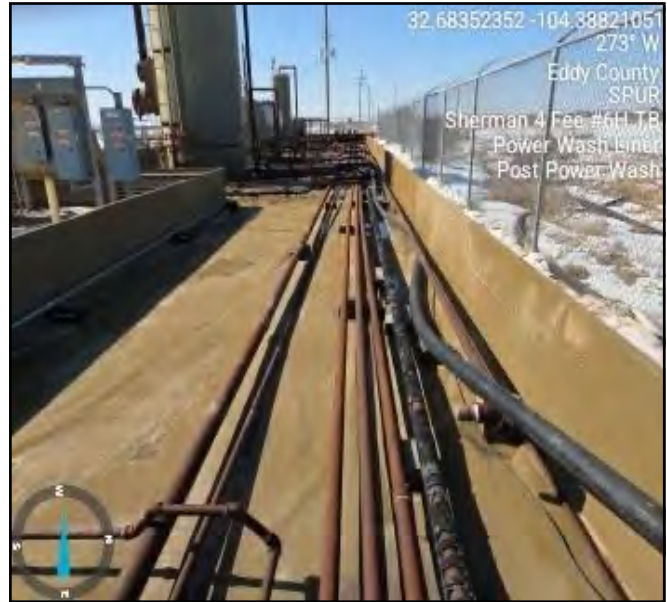
Photo of location taken post power wash facing west.

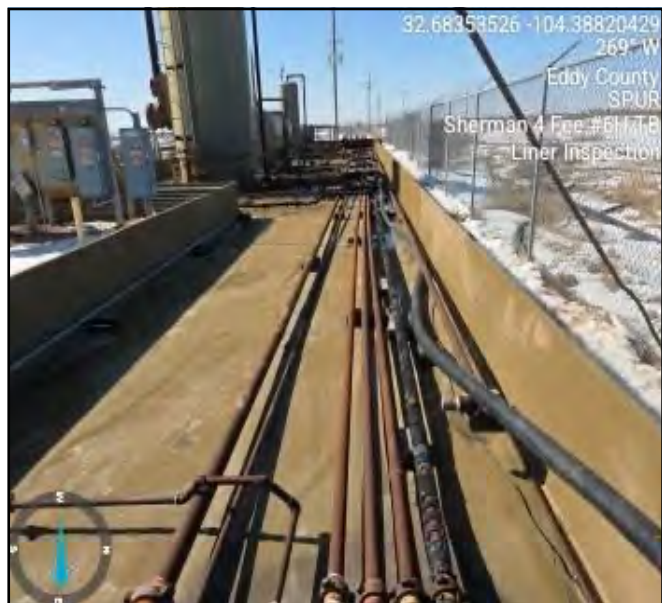
Visualization	Yes	No	Comments
Is there a tear in the liner?		X	
Are there holes in the liner?		X	
Is the liner retaining any fluids?	X		Standing fluid is visible inside the lined containment due to power washing efforts.
Does the liner have integrity to contain a leak?	X

Photograph taken during liner inspection facing west.

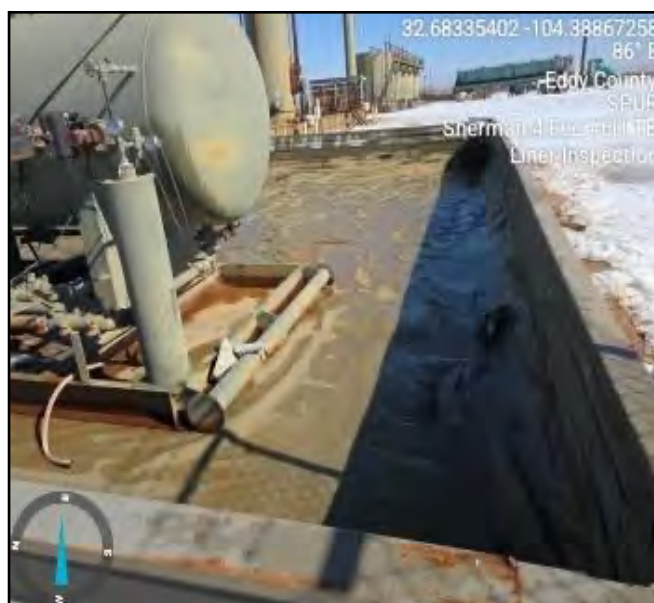
Photograph taken during liner inspection facing east.

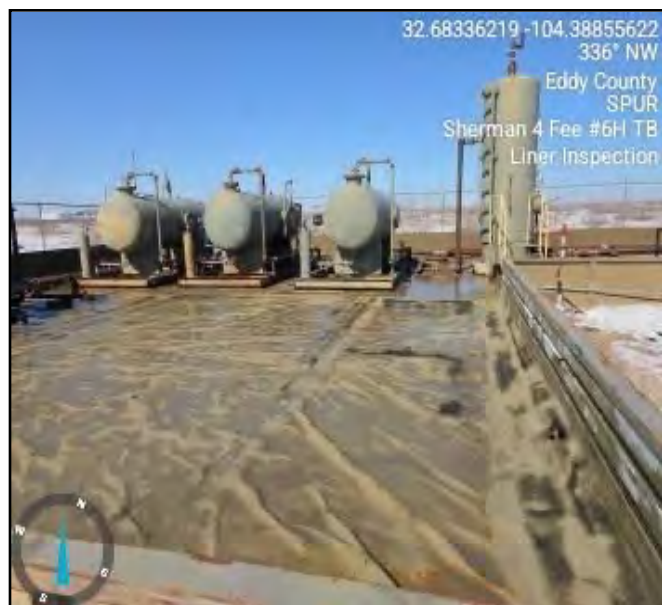
Photograph taken during liner inspection facing northwest.

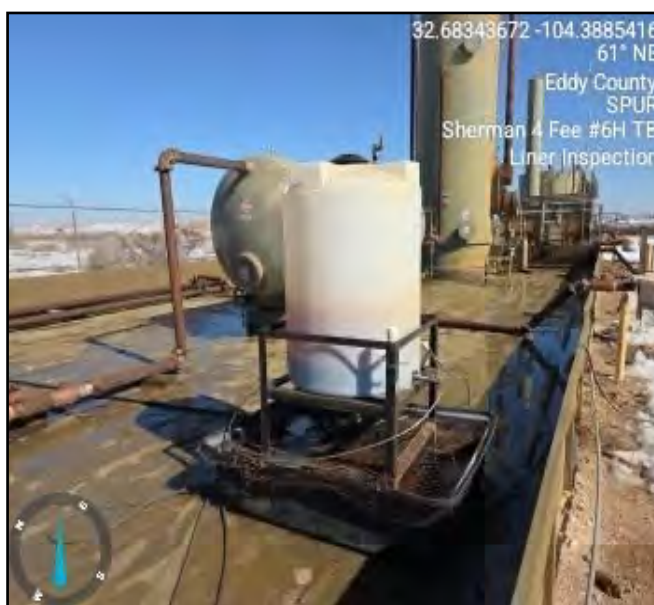
Photograph taken during liner inspection facing northeast.

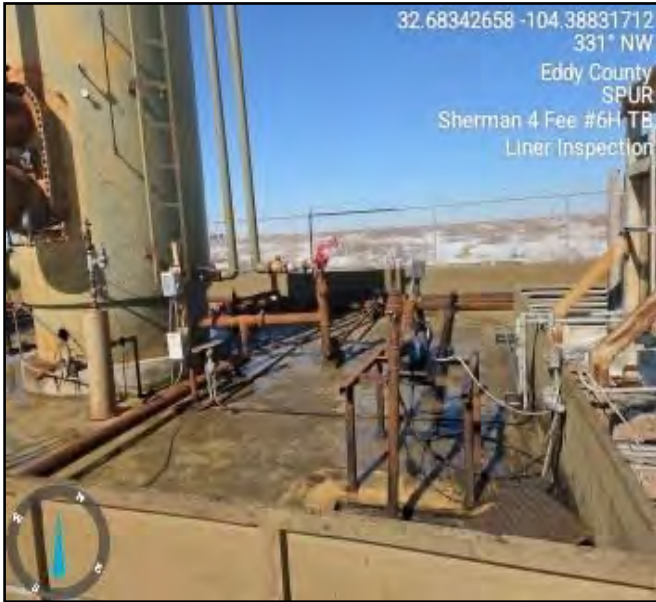
Photograph taken during liner inspection facing northwest.

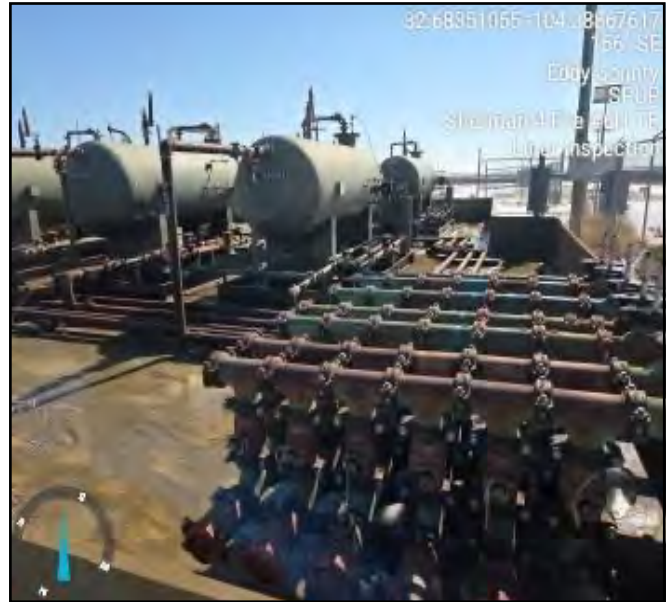
Photograph taken during liner inspection facing southeast.
