Our Ref.: 12679377 – NMOCD – 2

April 15, 2026

Closure Report
Devon Energy Production Company, LP
Exmoor 15 CTB 2
Unit Letter A, Section 15, TS25, R31E
GPS: 32.134225, -103.757538
Eddy County, New Mexico

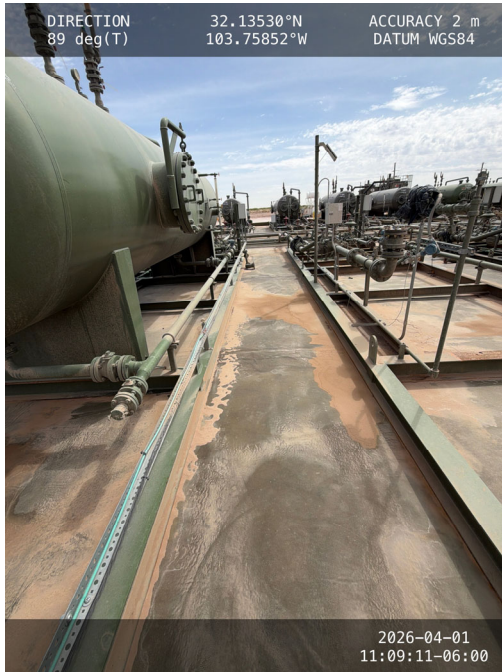
Photo 5 Photo of containment towards west.

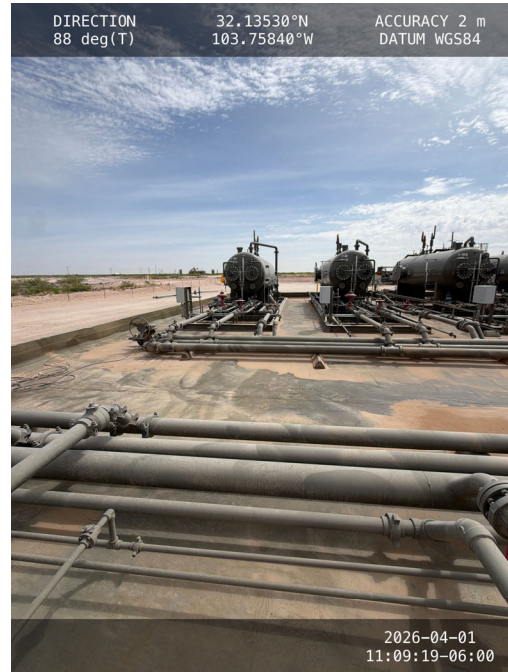
Photo 6 Photo of containment towards west.

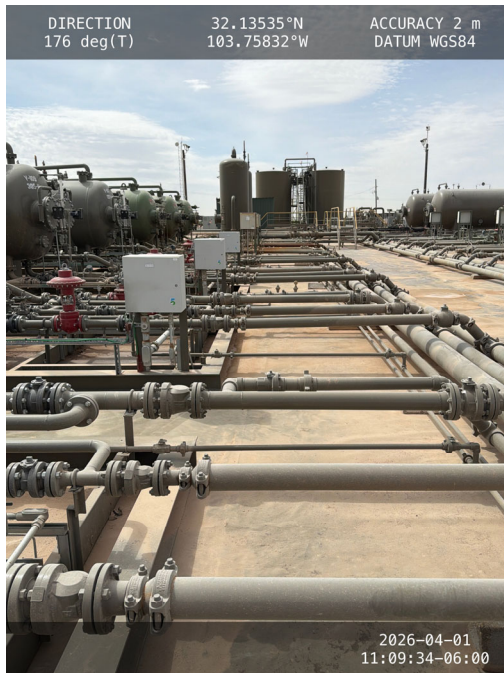
Photo 7 Photo of containment towards south.

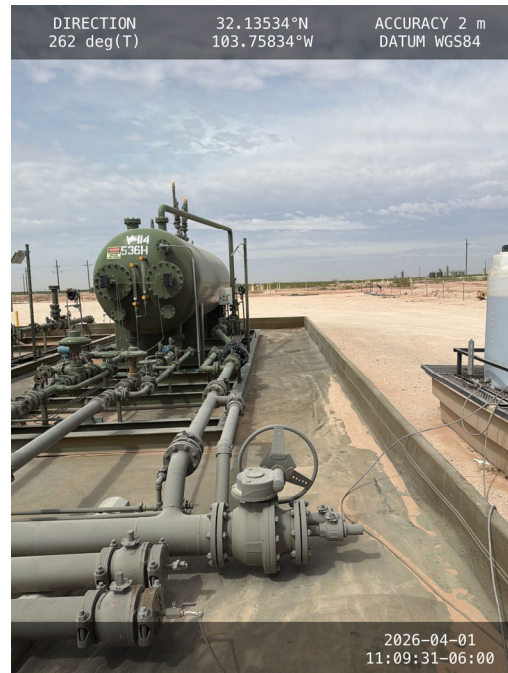
Photo 8 Photo of containment towards west.

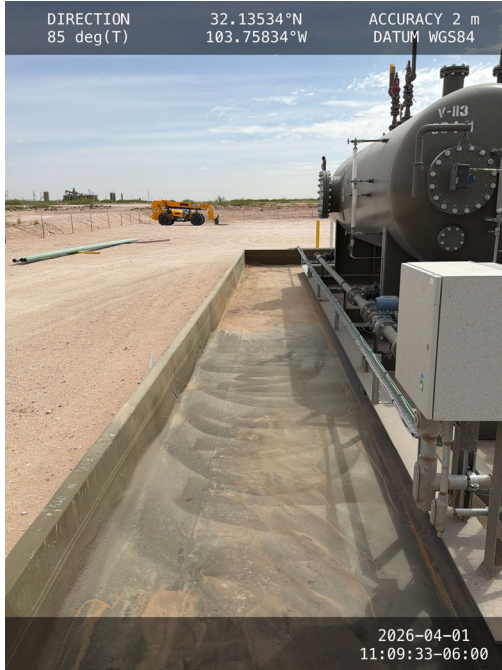
Photo 9 Photo of containment towards east.

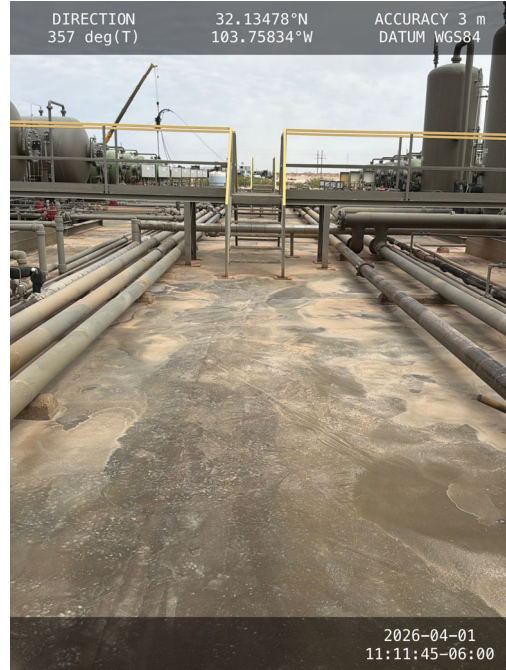
Photo 10 Photo of containment towards north.
