Our Ref.: 12679377 – NMOCD – 2

April 15, 2026

Closure Report
Devon Energy Production Company, LP
Exmoor 15 CTB 2
Unit Letter A, Section 15, TS25, R31E
GPS: 32.134225, -103.757538
Eddy County, New Mexico

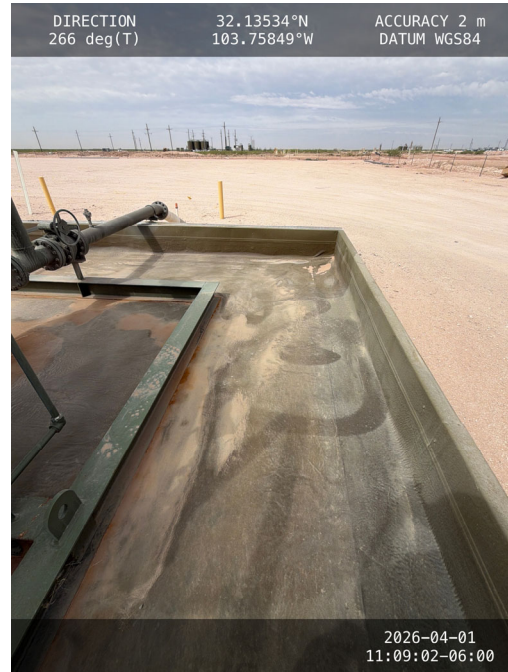
Photo 2 Photo of southwest corner of containment.

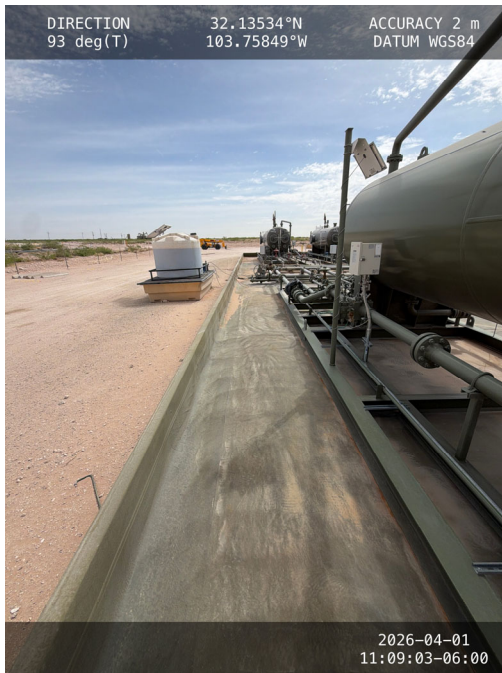
Photo 3 Photo of containment towards east.

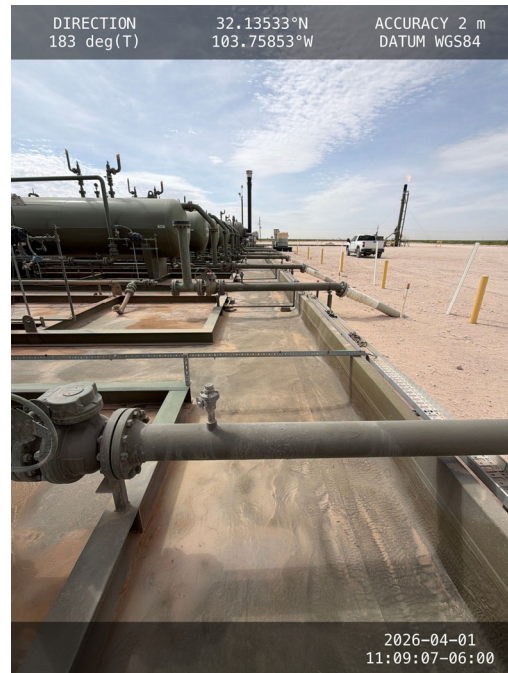
Photo 4 Photo of containment towards south.

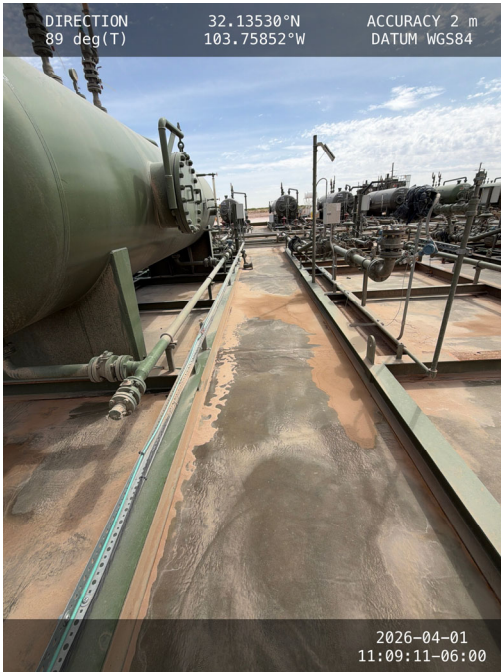
Photo 5 Photo of containment towards west.

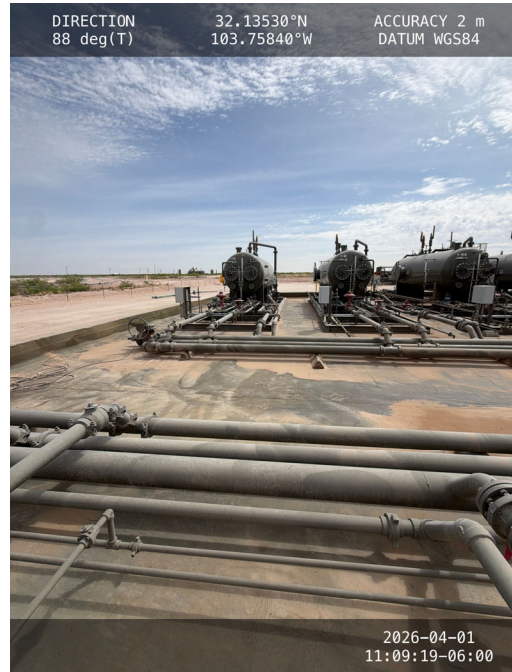
Photo 6 Photo of containment towards west.

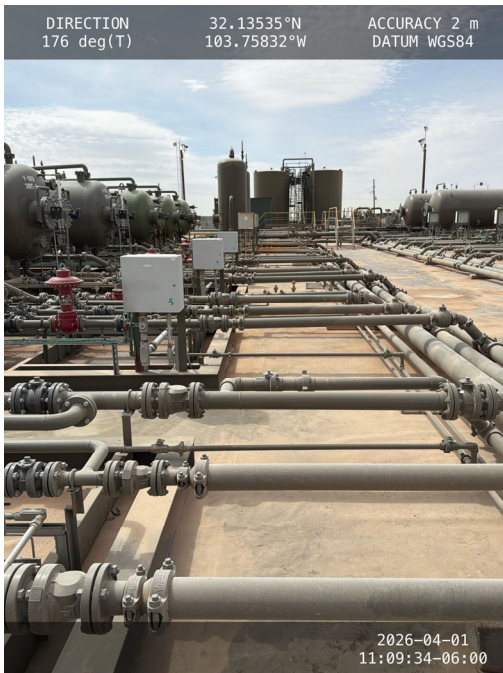
Photo 7 Photo of containment towards south.

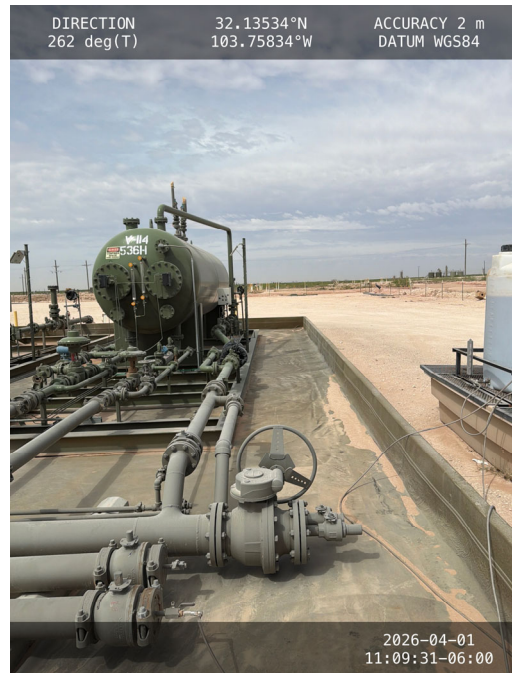
Photo 8 Photo of containment towards west.

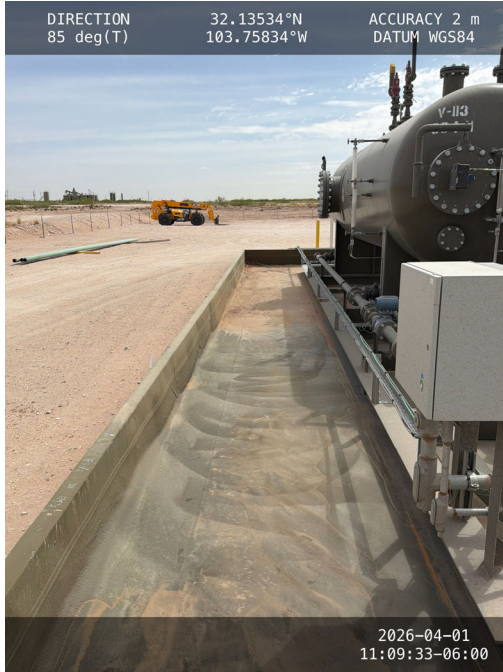
Photo 9 Photo of containment towards east.

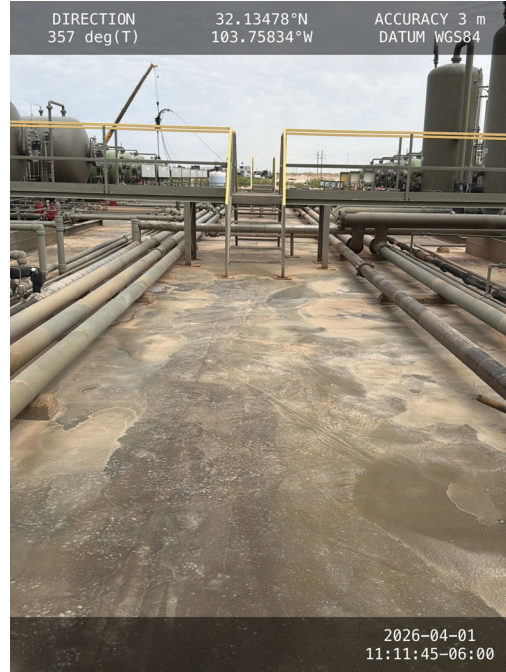
Photo 10 Photo of containment towards north.
