Welch A 28 CTB

Incident ID NAPP2533535010

PREPARED FOR:
Spur Energy

Liner Inspection and Closure Report

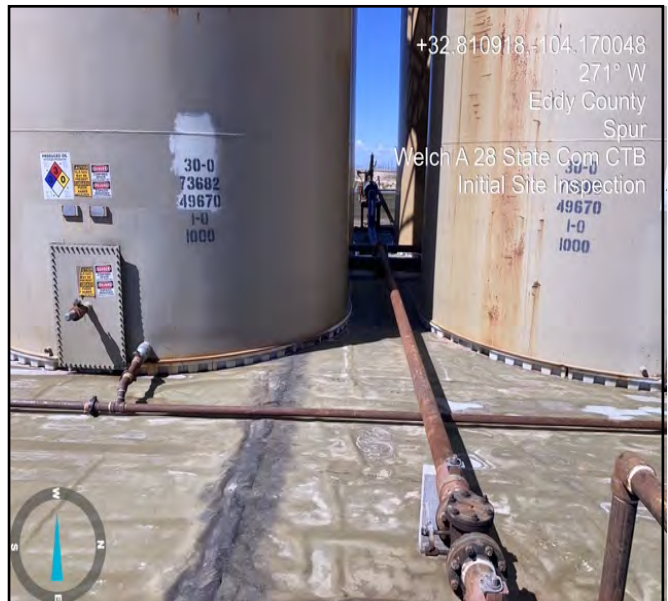
Photo of liner taken during initial liner inspection facing west.

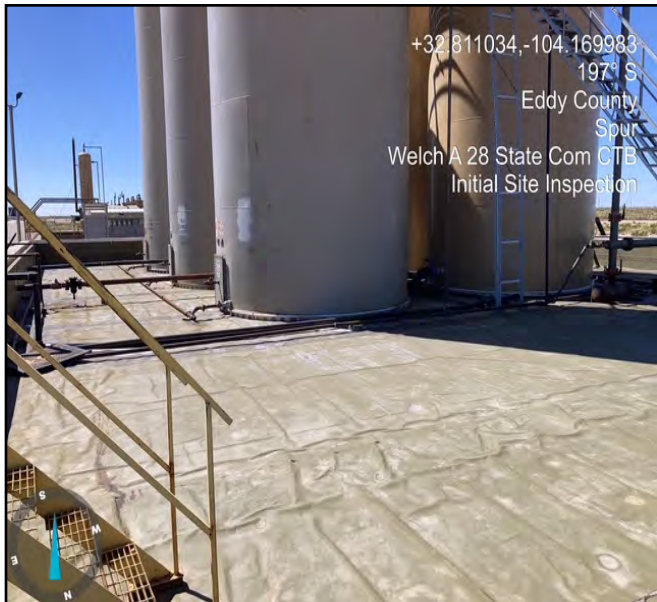
Photo of liner taken during initial liner inspection facing south.

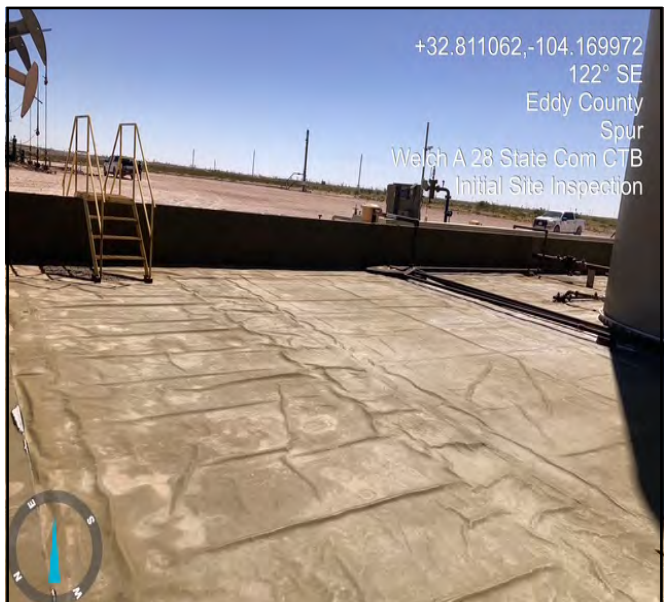
Photo of liner taken during initial liner inspection facing southeast.

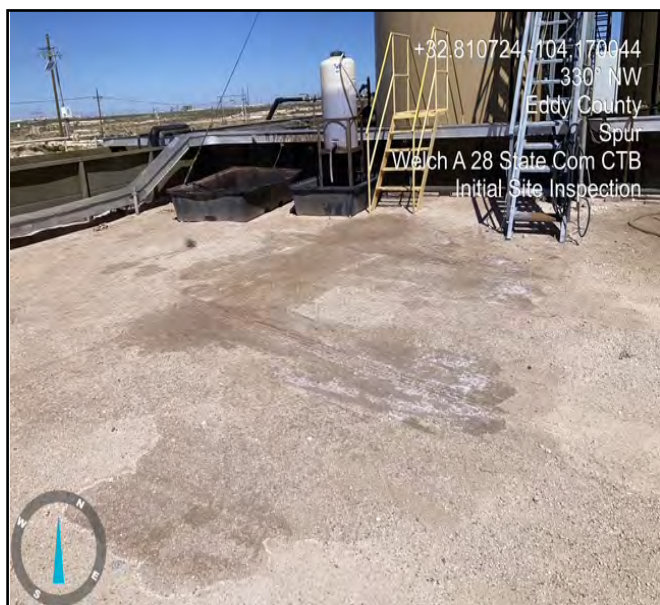
Photo of liner taken during initial liner inspection facing northwest.

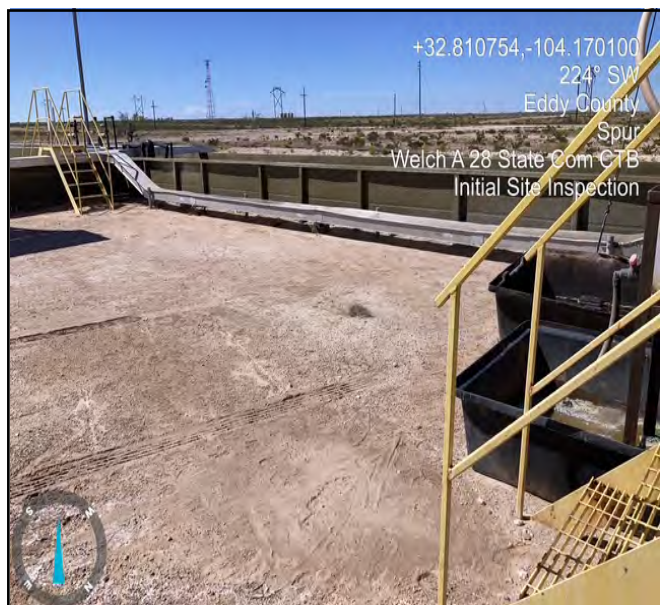
Photo of liner taken during initial liner inspection facing southwest.

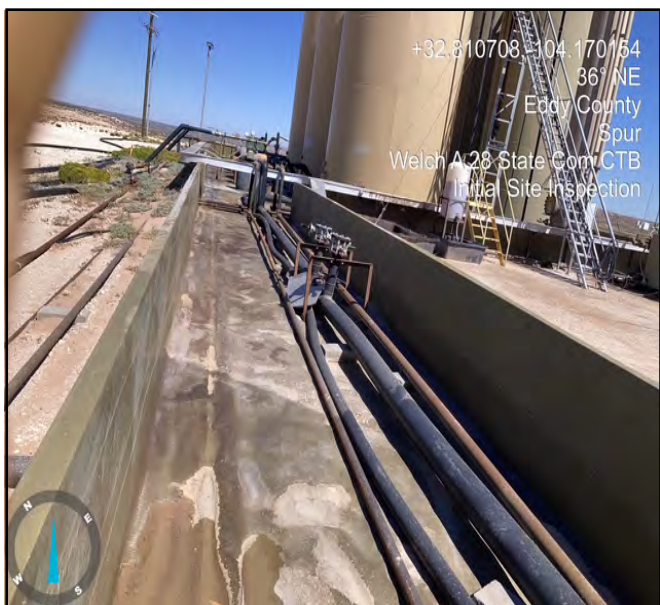
Photo of liner taken during initial liner inspection facing northeast.

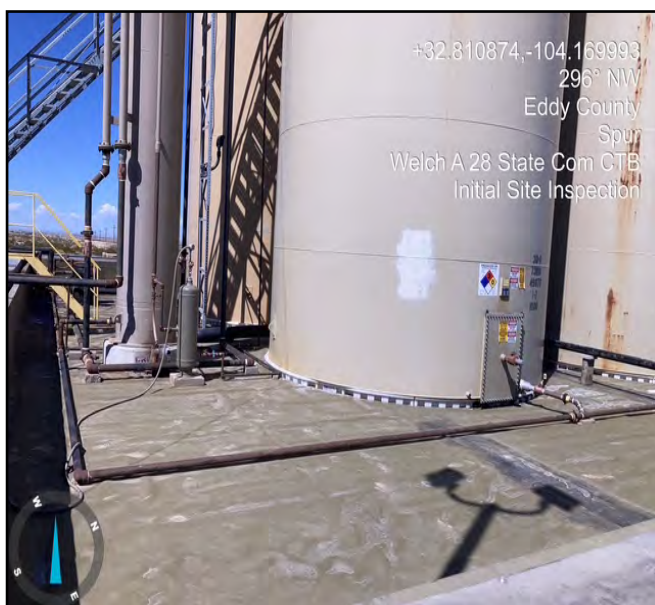
Photo of liner taken during initial liner inspection facing northwest.

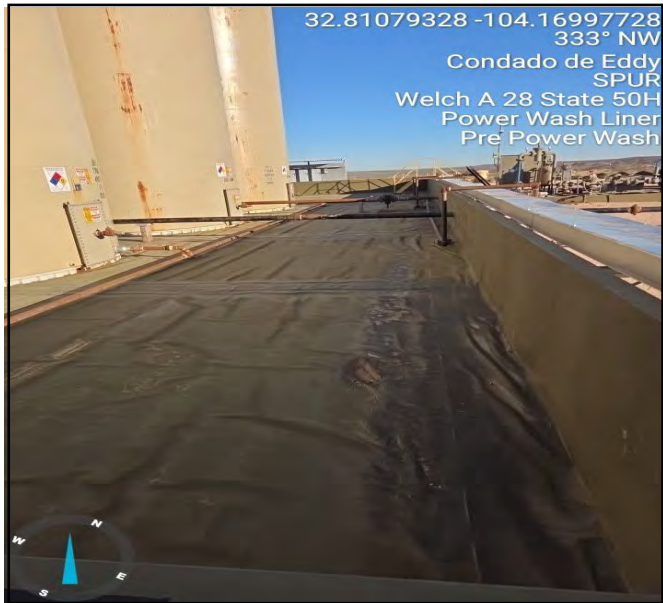
Photograph taken pre power-wash process facing northwest.

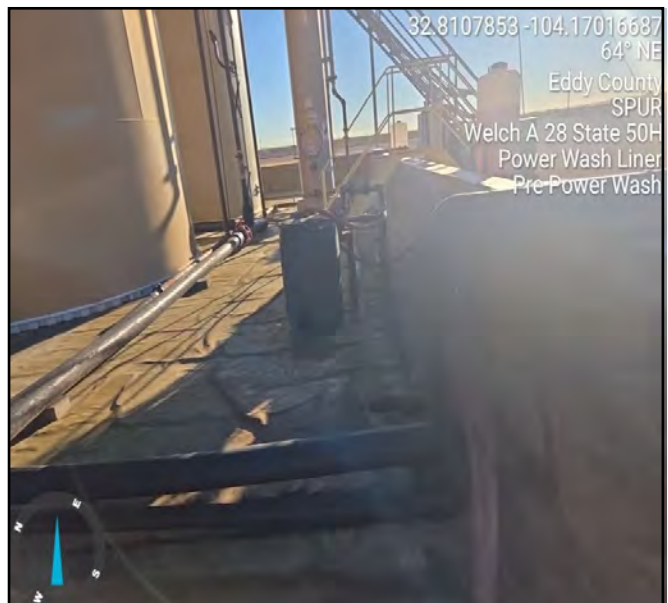
Photograph taken pre power-wash process facing northeast.

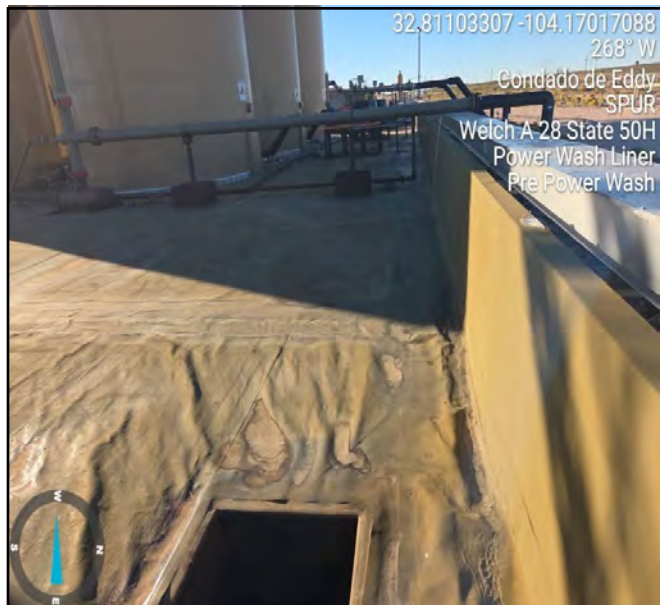
Photograph taken pre power-wash process facing west.

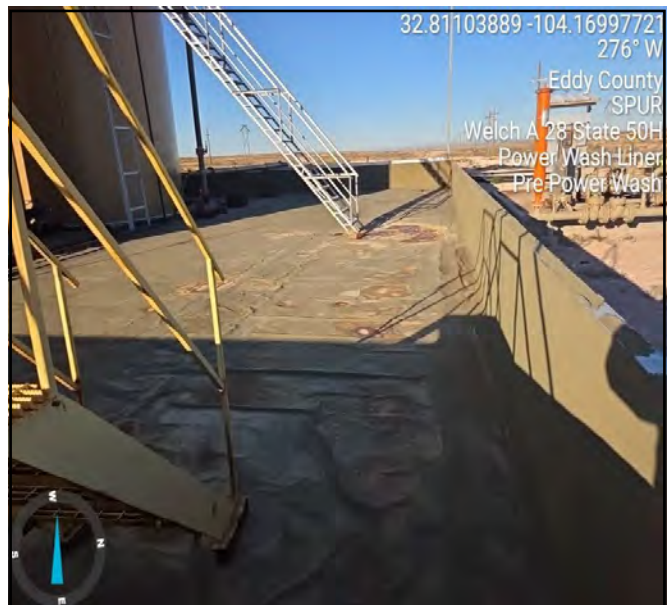
Photograph taken pre power-wash process facing west.

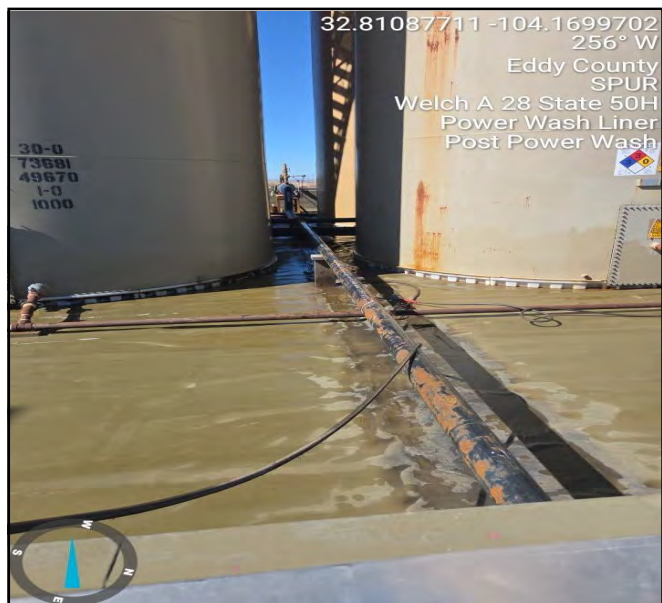
Photo of location taken post power wash facing west.

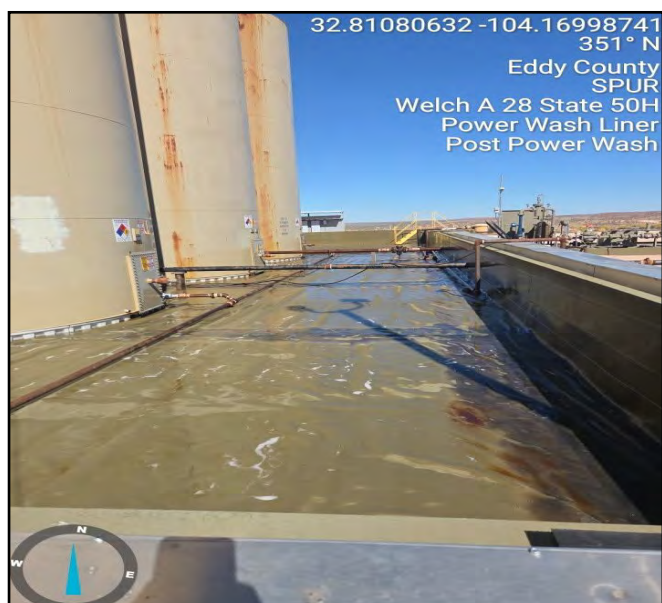
Photo of location taken post power wash facing north.

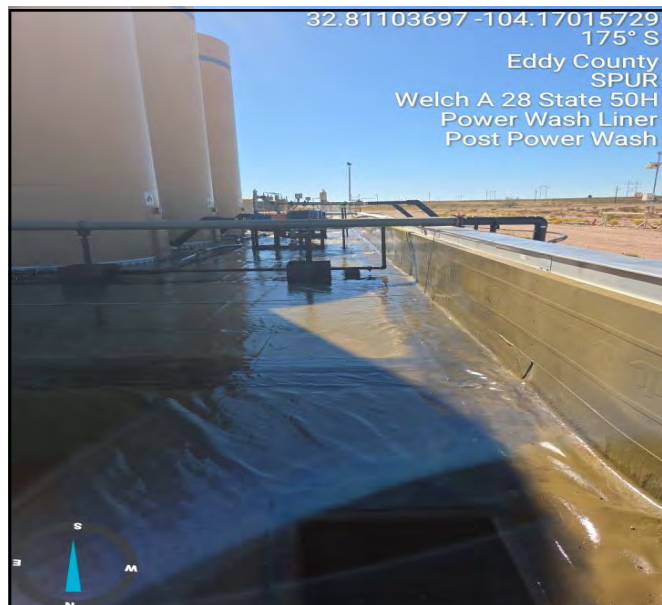
Photo of location taken post power wash facing south.

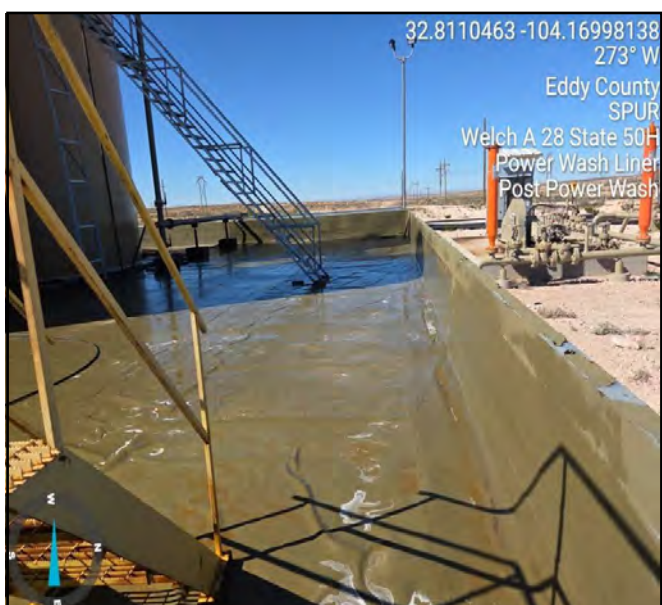
Photo of location taken post power wash facing west.

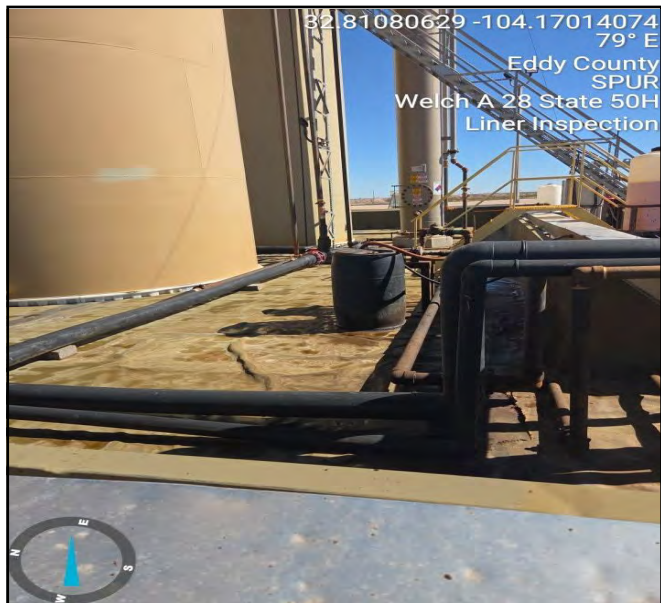
Photo of liner taken during liner inspection facing east.

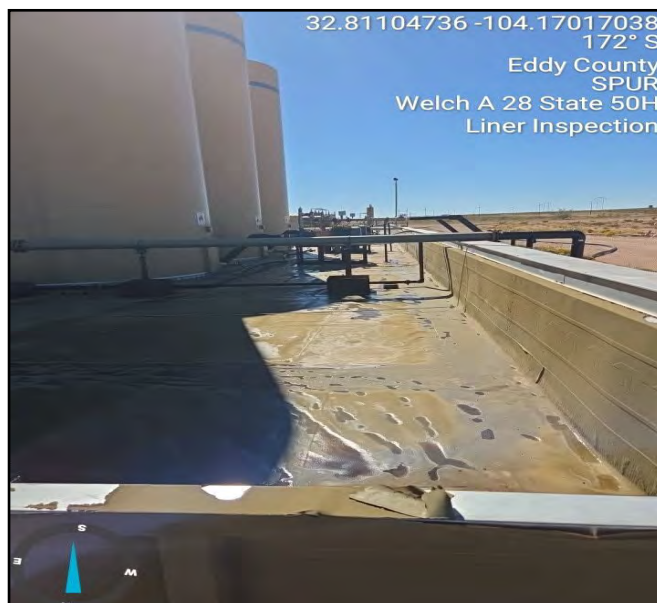
Photo of liner taken during liner inspection facing south.

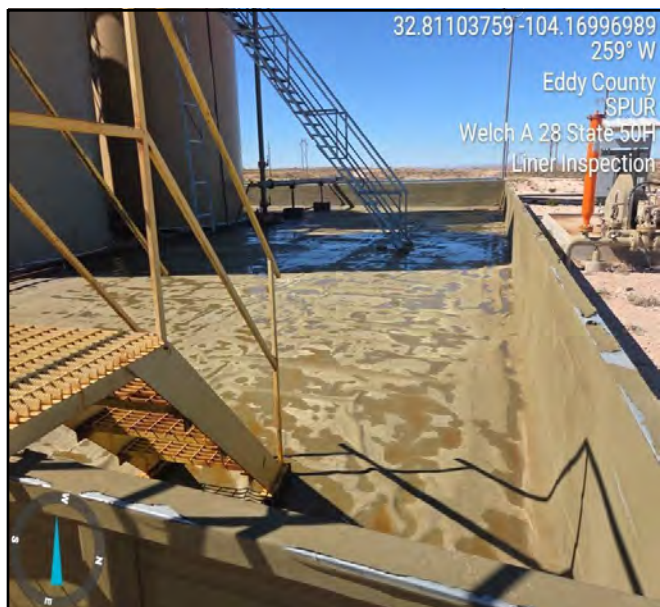
Photo of liner taken during liner inspection facing west.

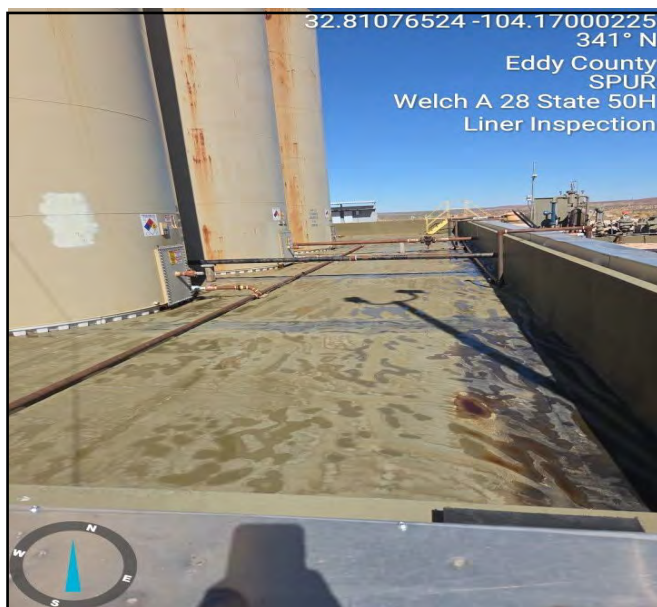
Photo of liner taken during liner inspection facing north.
