PERE MARQUETTE CTB

Incident ID nAPP2604134557

Liner Inspection and Closure Report

April 27, 2026

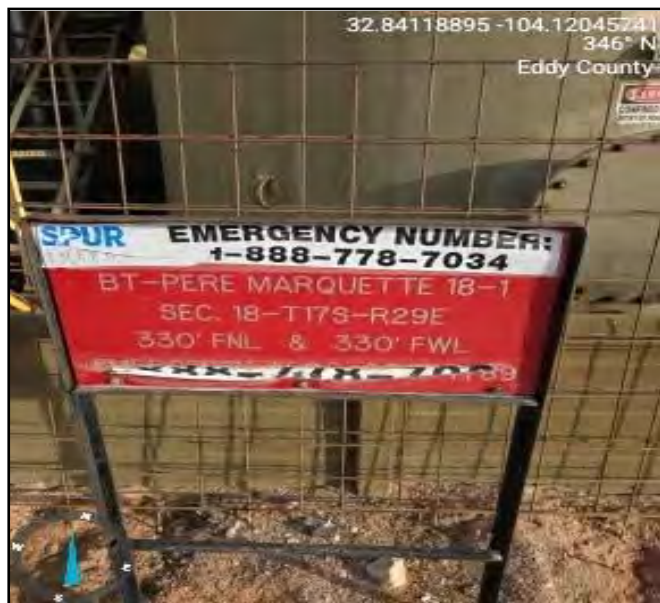
Site information sign.

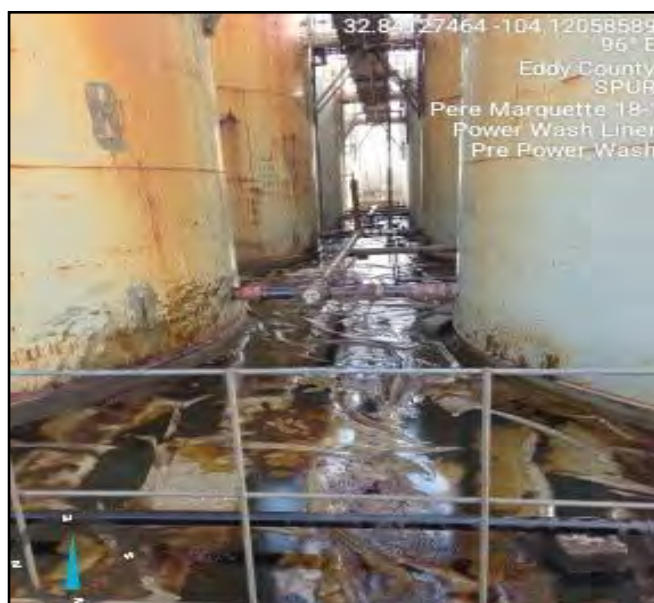
Photograph taken pre-powerwash facing east.

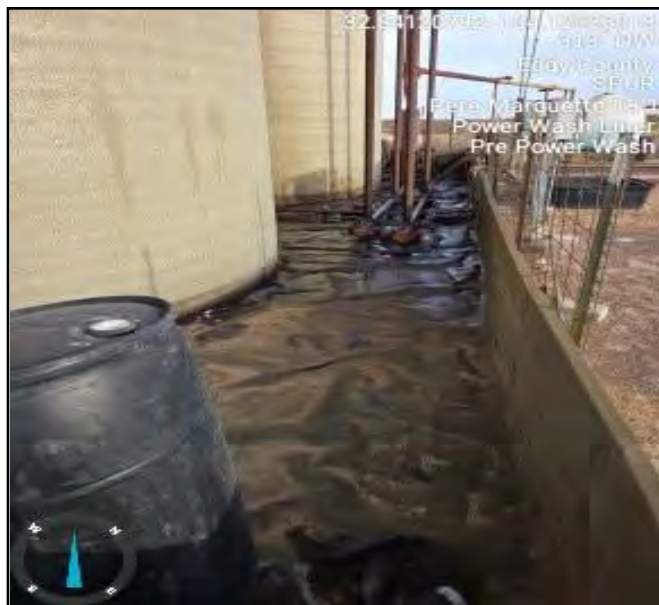
Photograph taken pre-powerwash facing northwest.

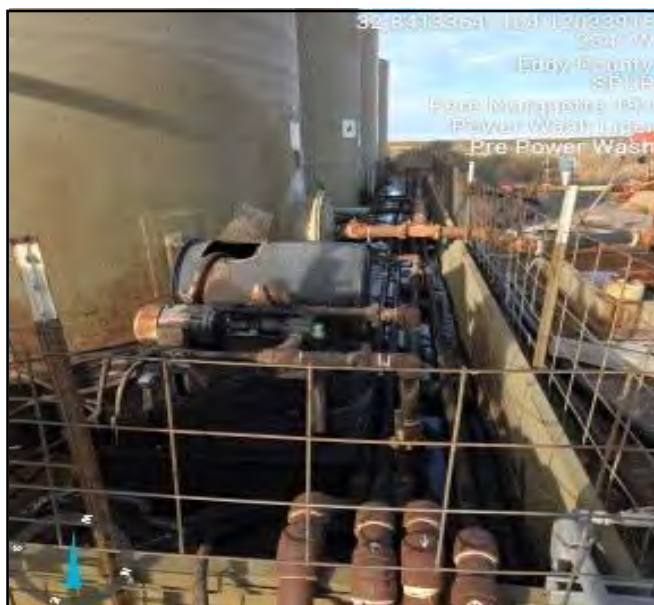
Photograph taken pre-powerwash facing west.

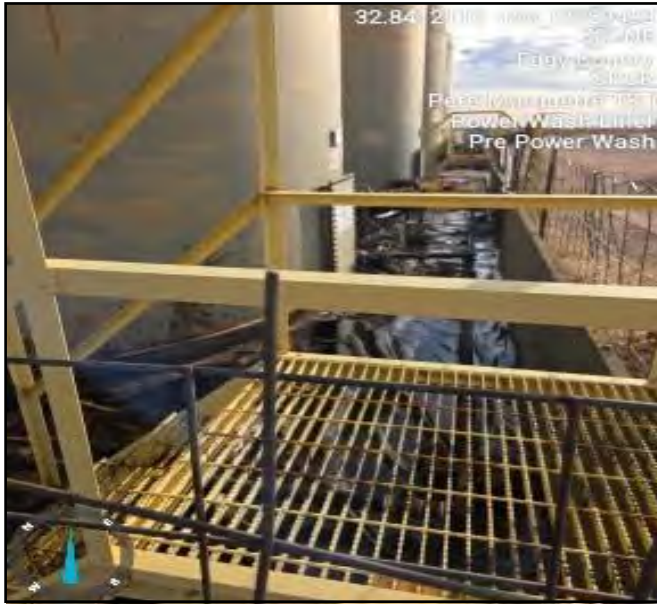
Photograph taken pre-powerwash facing northeast.

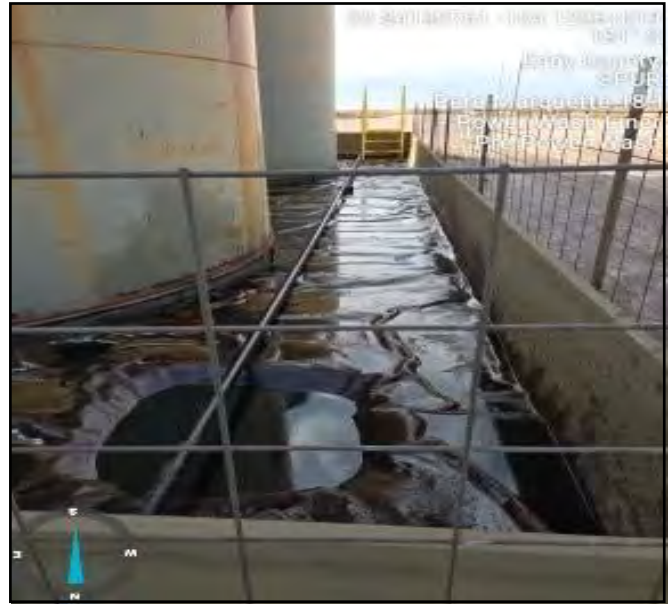
Photograph taken pre-powerwash facing south.

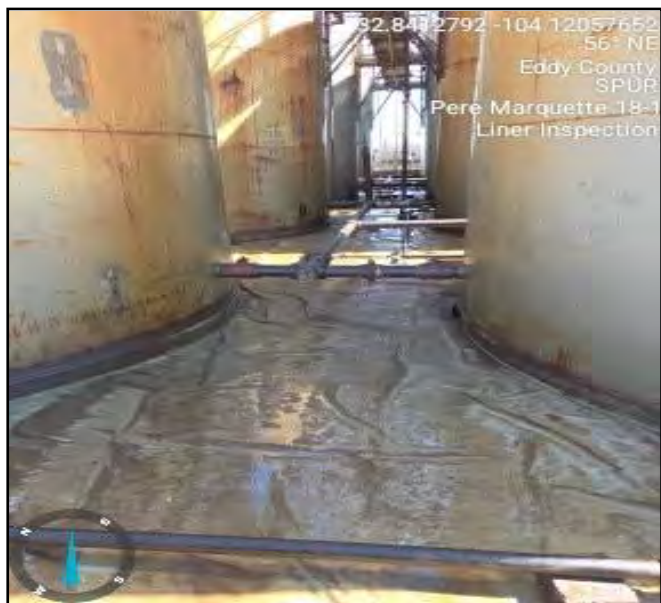
Photograph taken during liner inspection facing northeast.

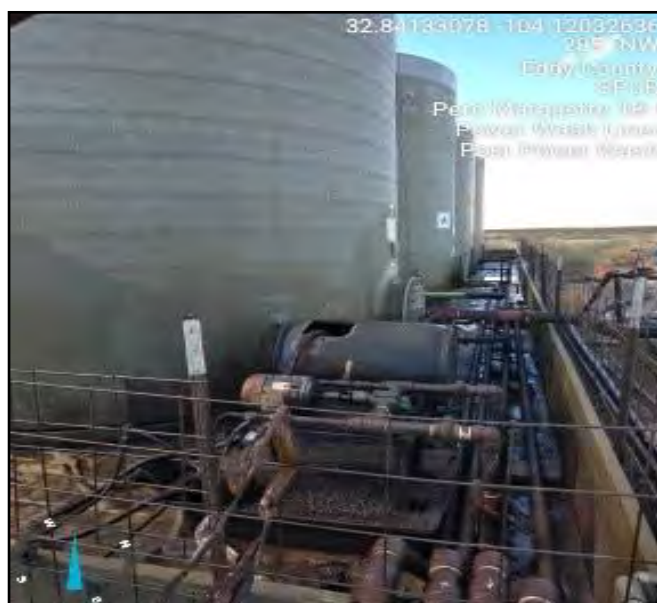
Photograph taken during liner inspection facing northwest.

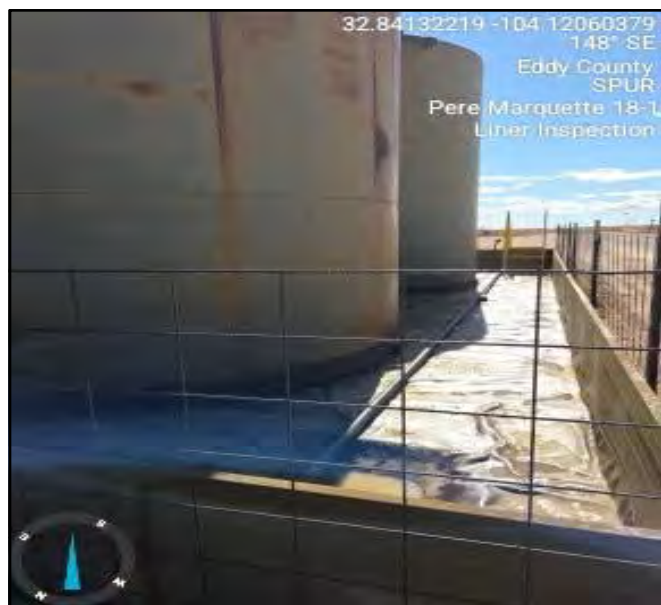
Photograph taken during liner inspection facing southeast.

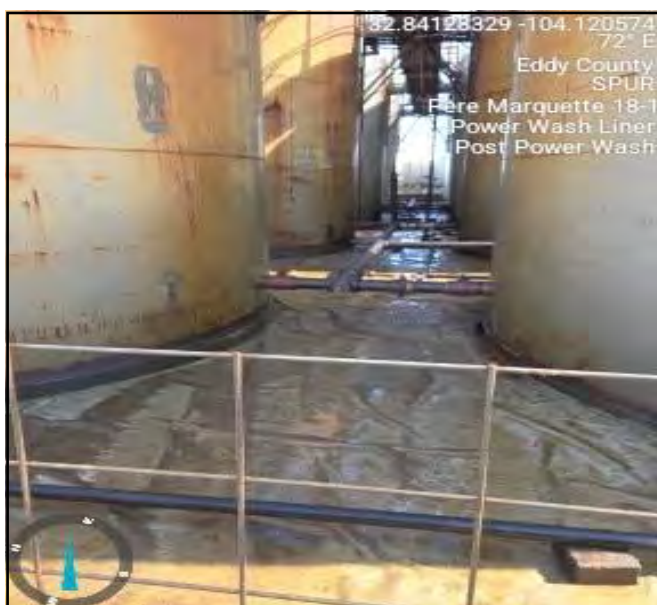
Photograph taken during liner inspection facing east.
