April 24, 2026

RE: **Mule 11 CTB 2 - Closure Request Report**

Incident Number: nAPP2602632747

ESRR Project No. VP-8747

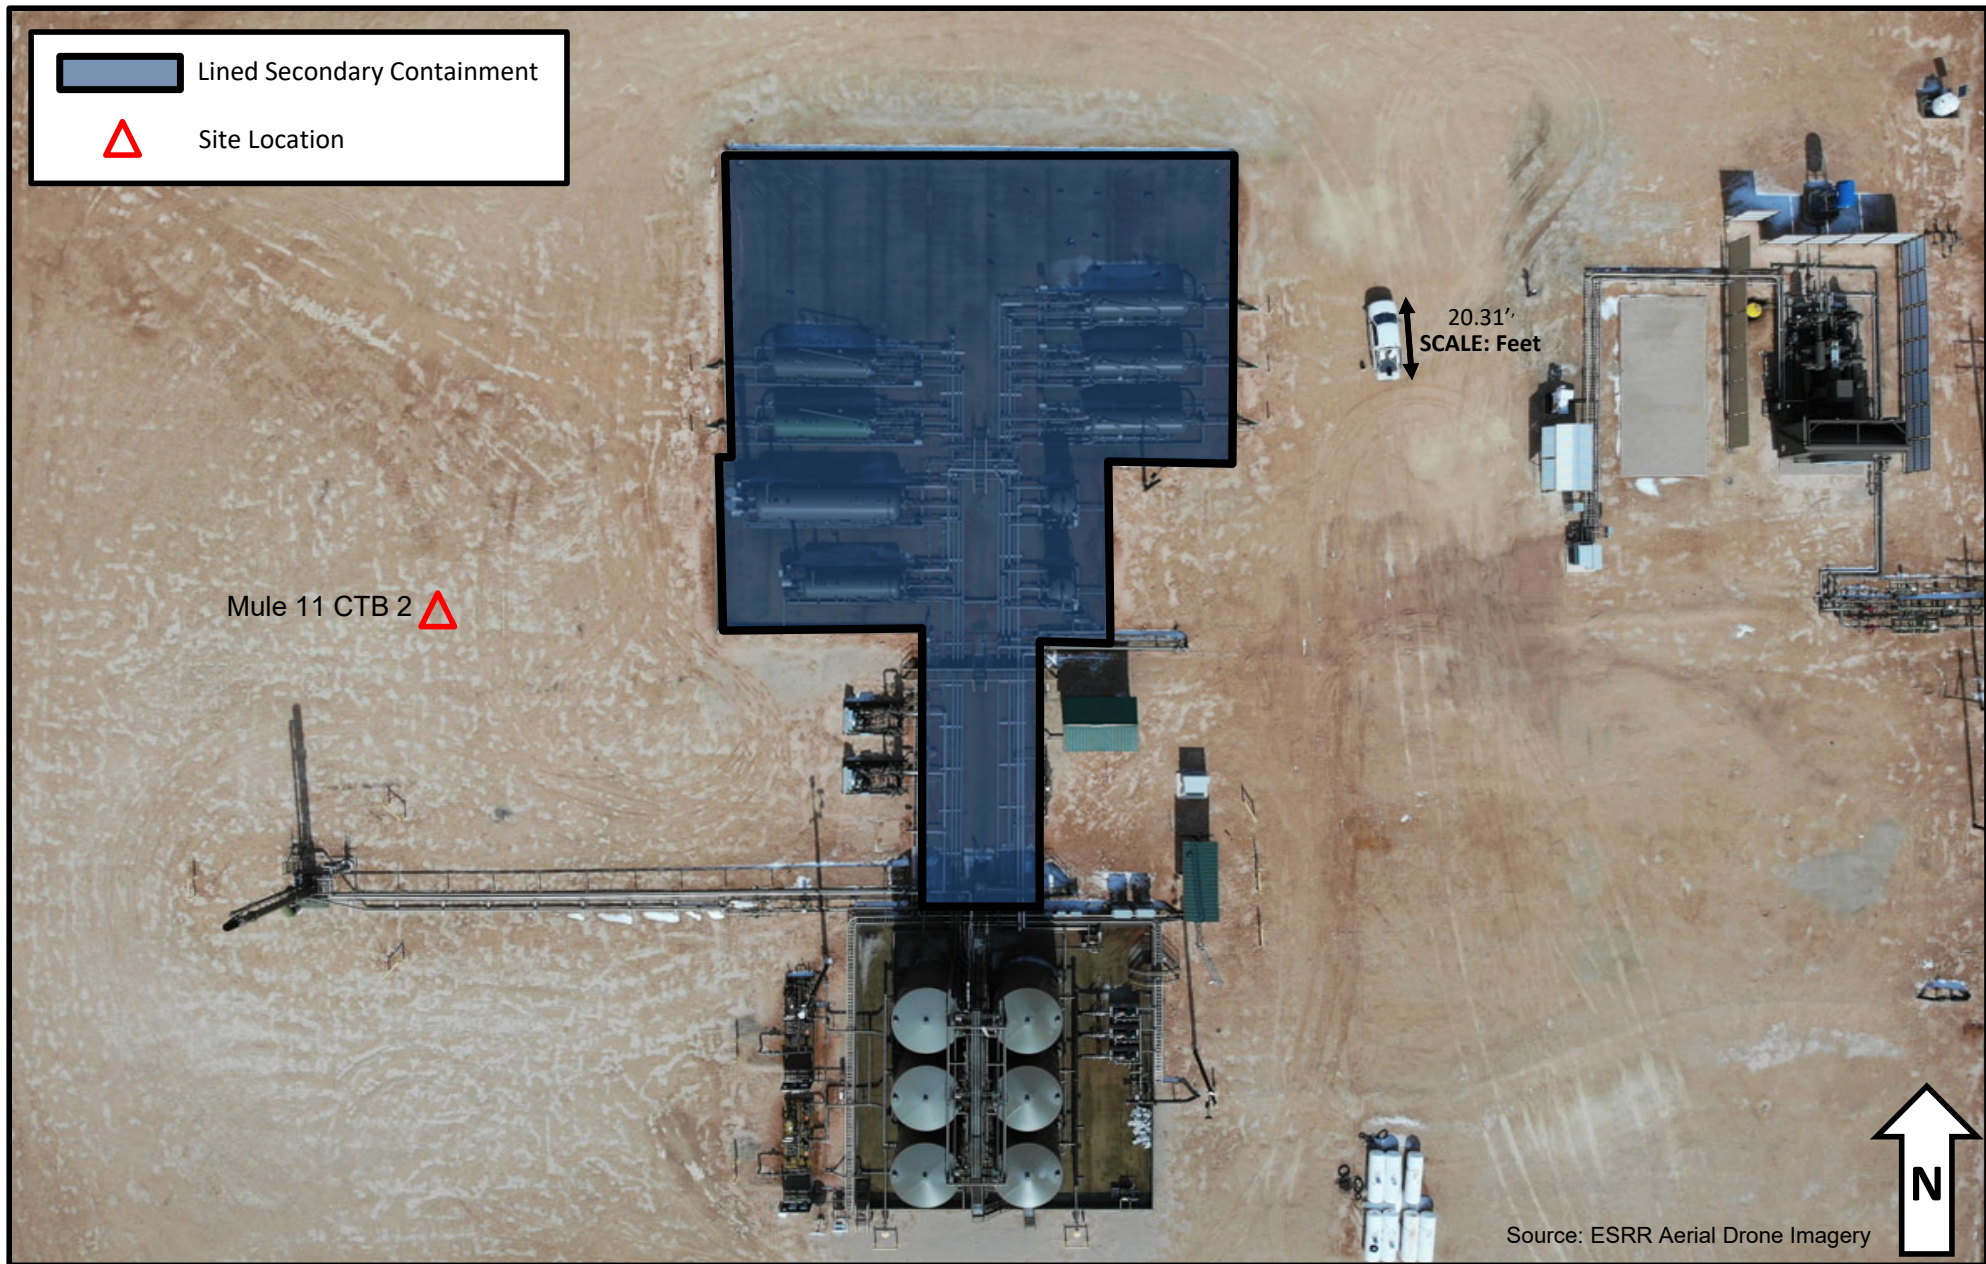
Figure 2 – Release Extent

On January 25, 2026, a valve failed on a separator, releasing approximately 97 barrels (bbls) of produced water within a LSC (**Figure 2**). The release was fully contained within the LSC with no fluids escaping to the production pad or adjacent native soils. A vacuum truck was immediately dispatched to the Site recovering the 97 bbls of produced water.

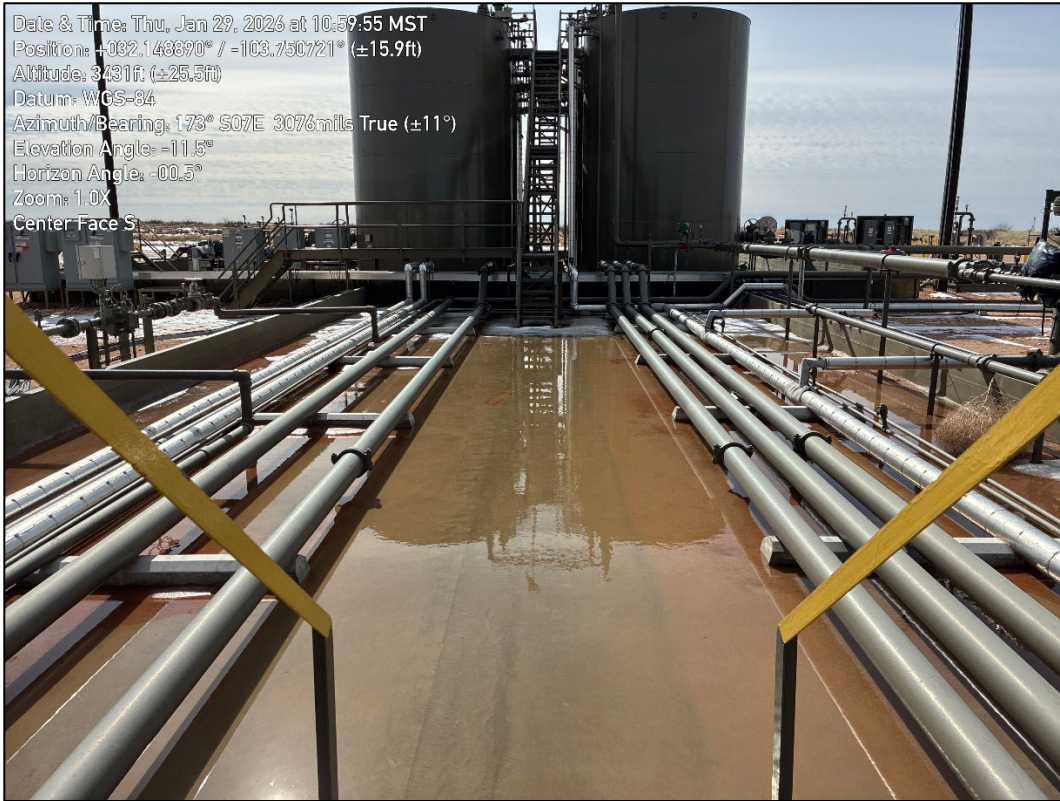
PHOTO 1: Southeastern view during initial site assessment. 1/29/2026

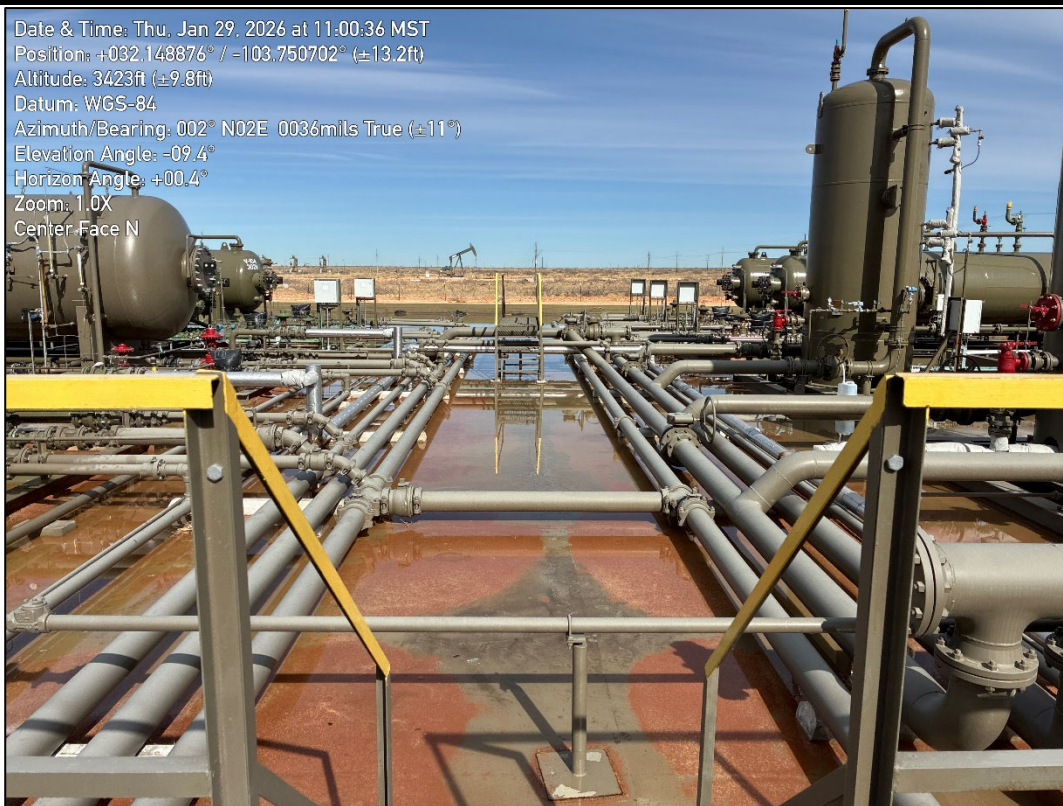
PHOTO 2: Northeastern view during initial site assessment. 1/29/2026

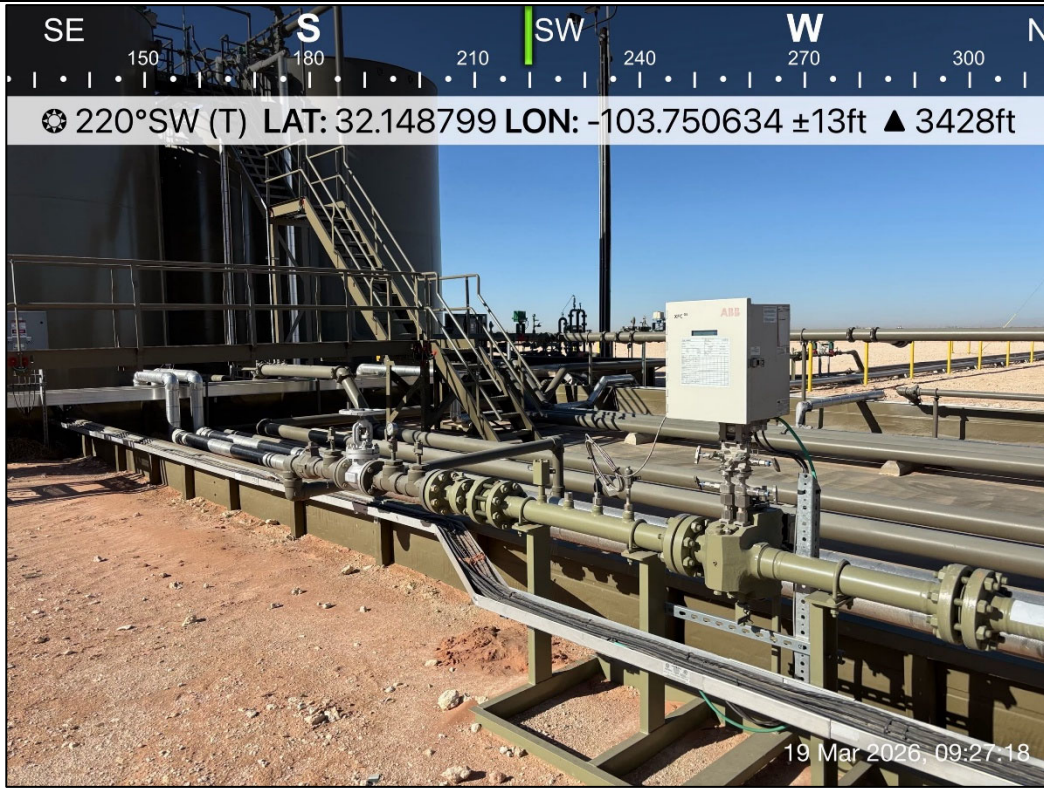
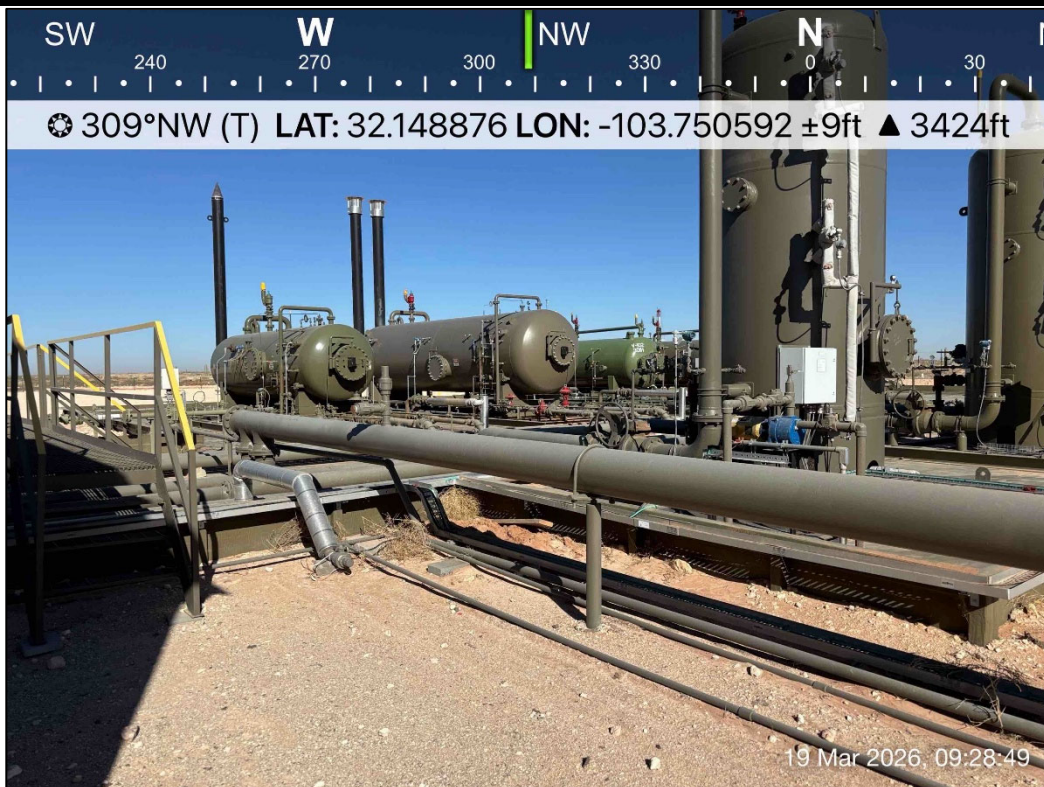
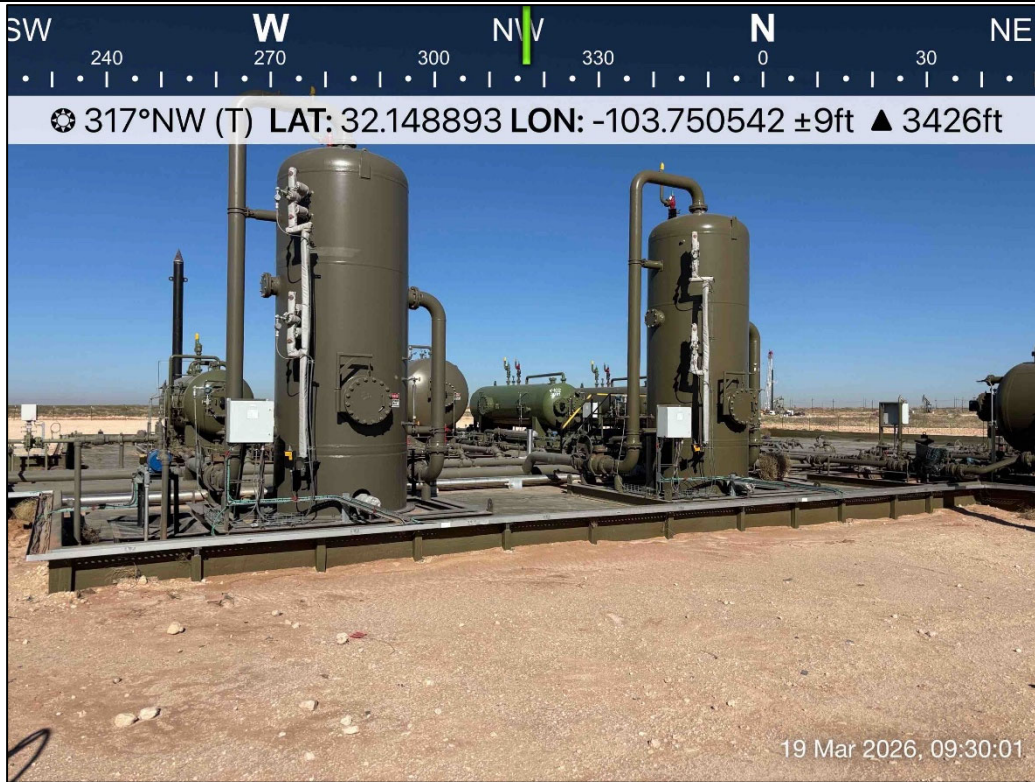
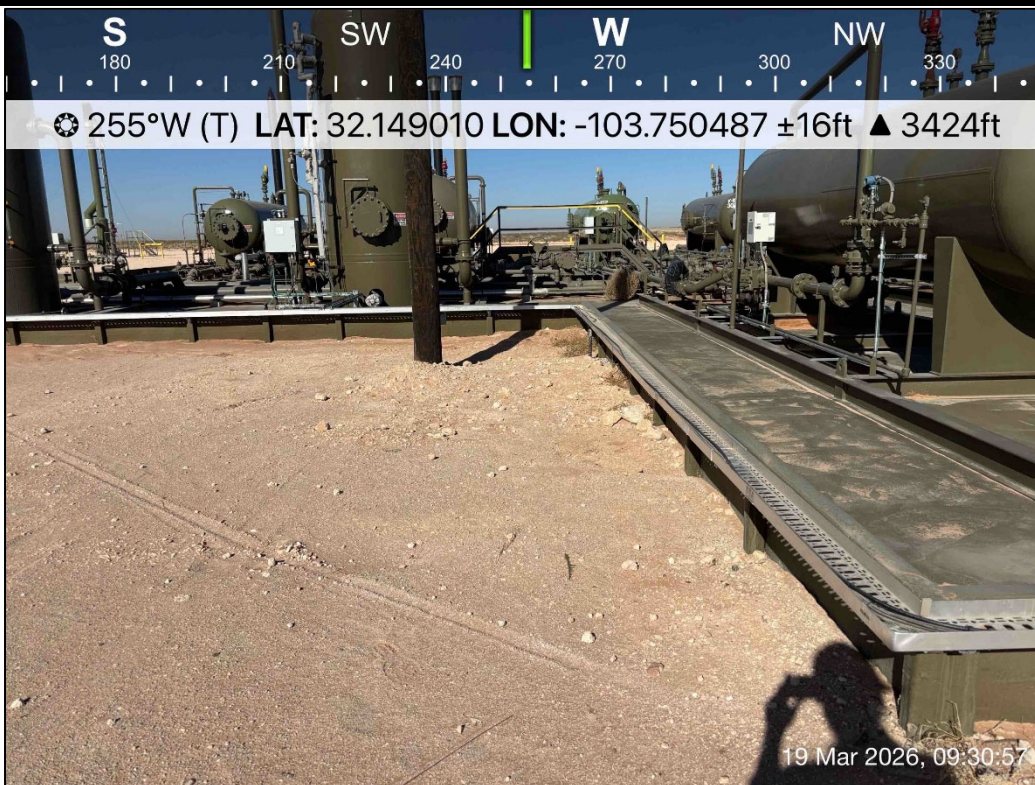
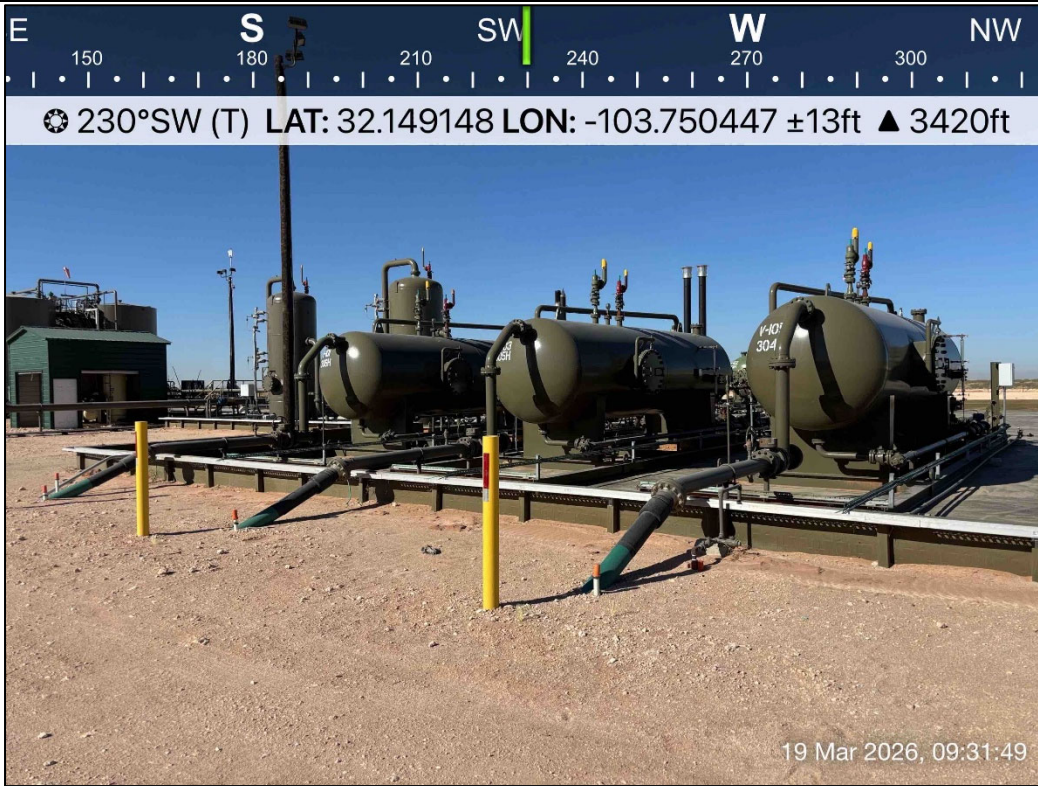
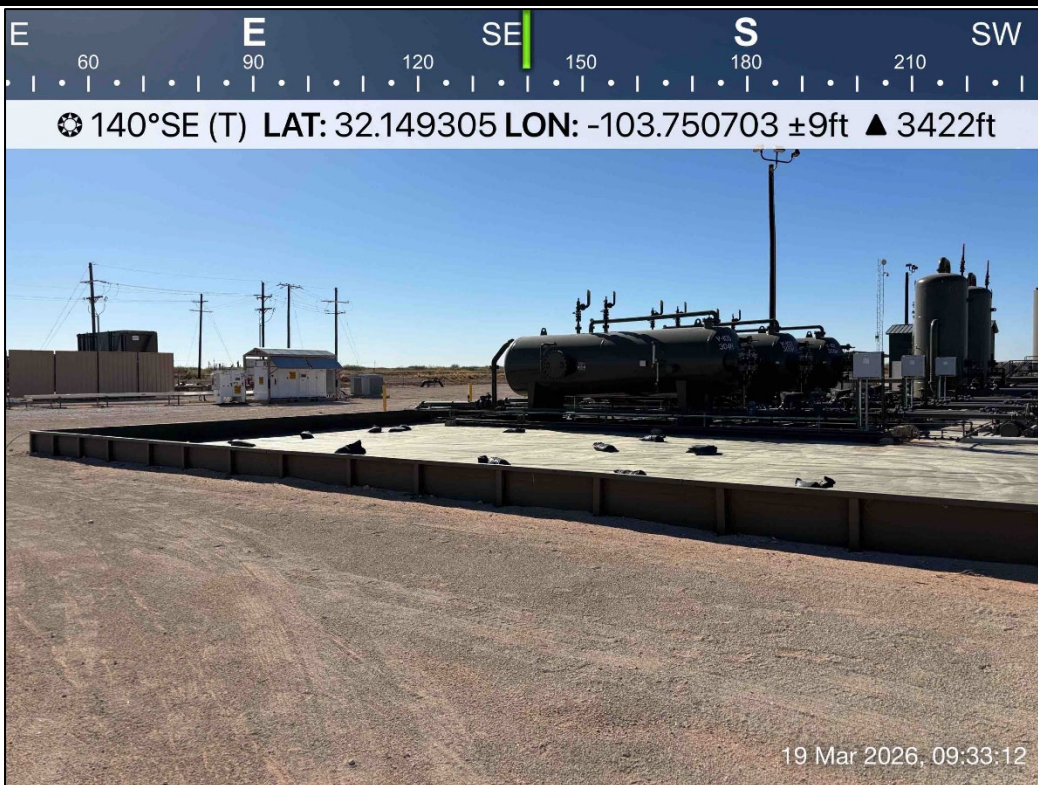
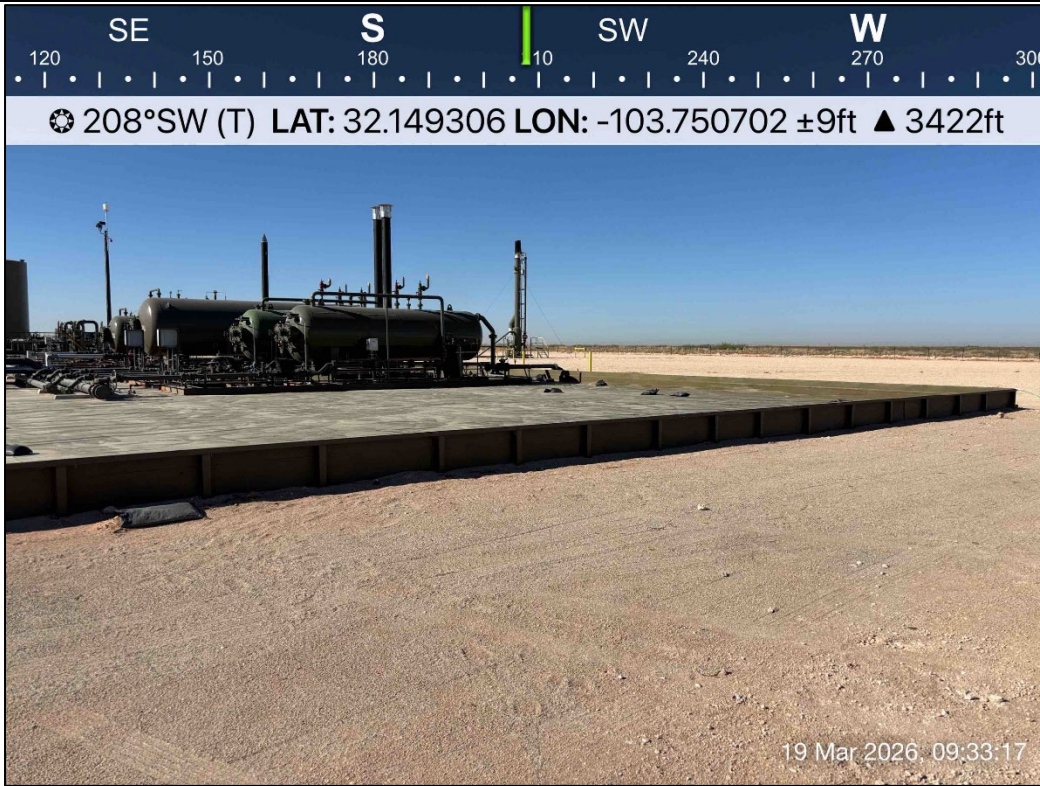
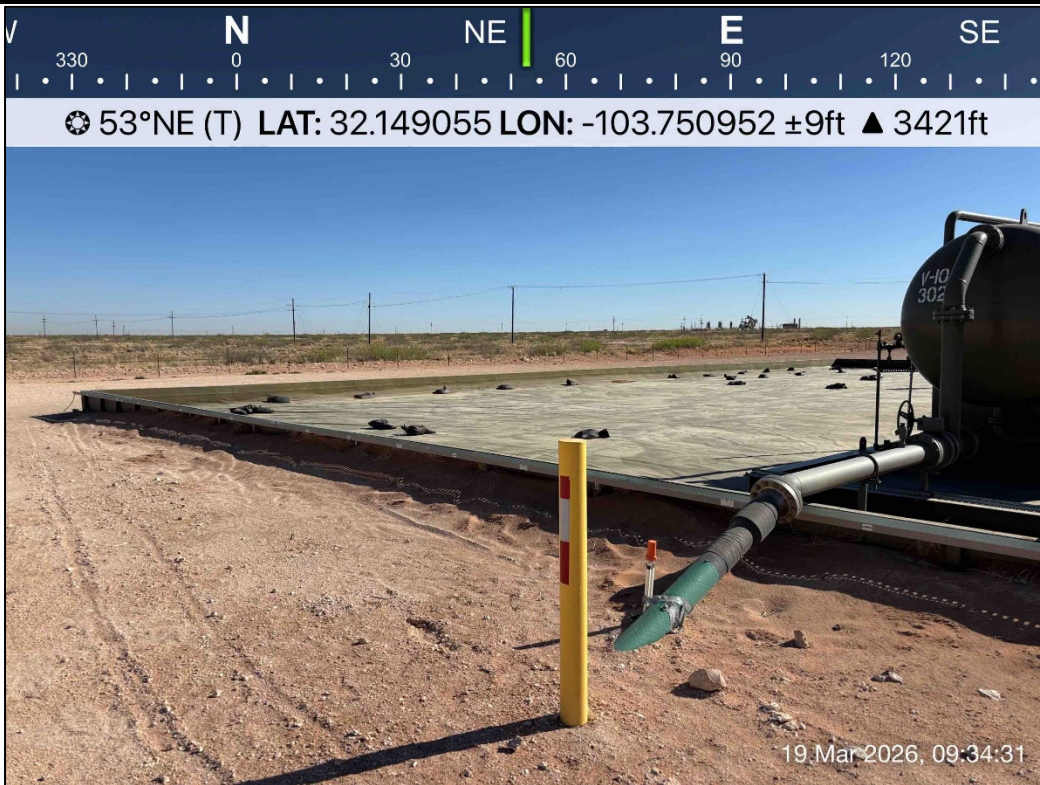
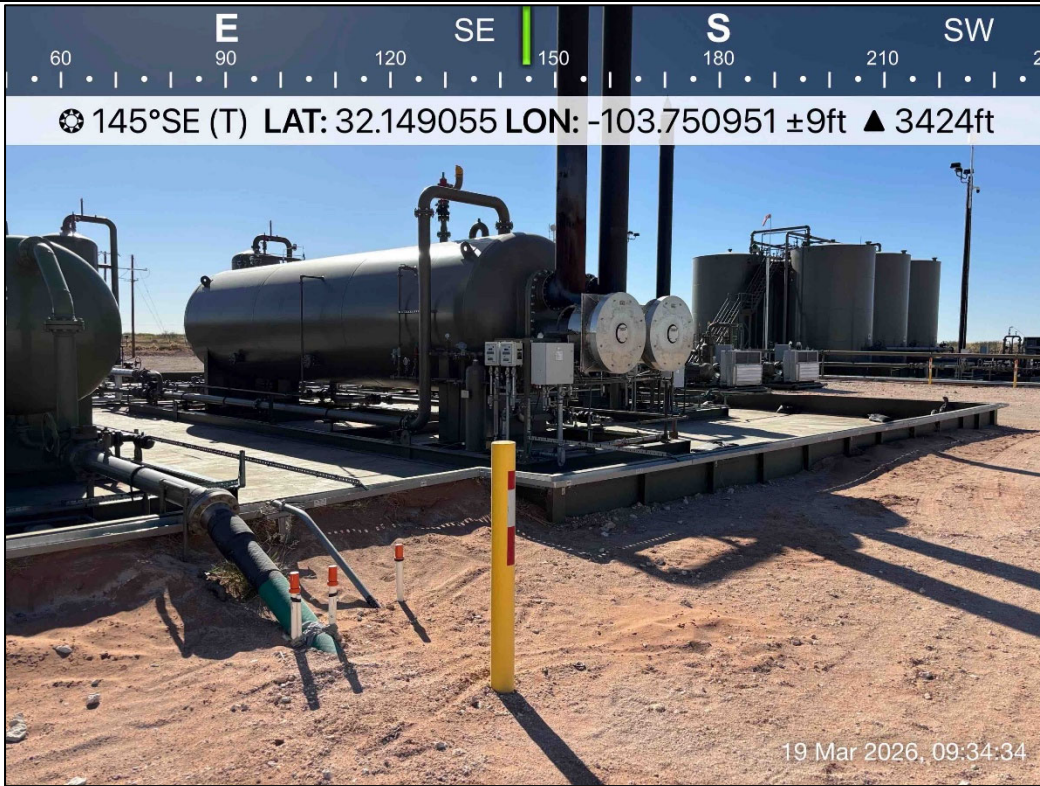
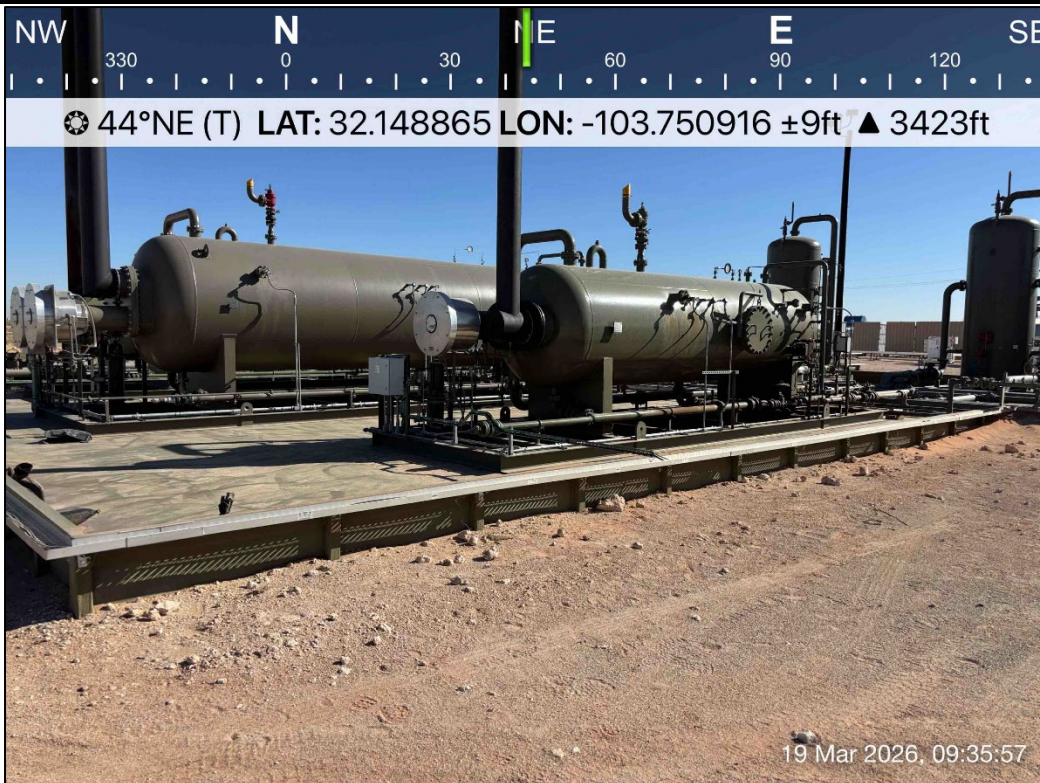
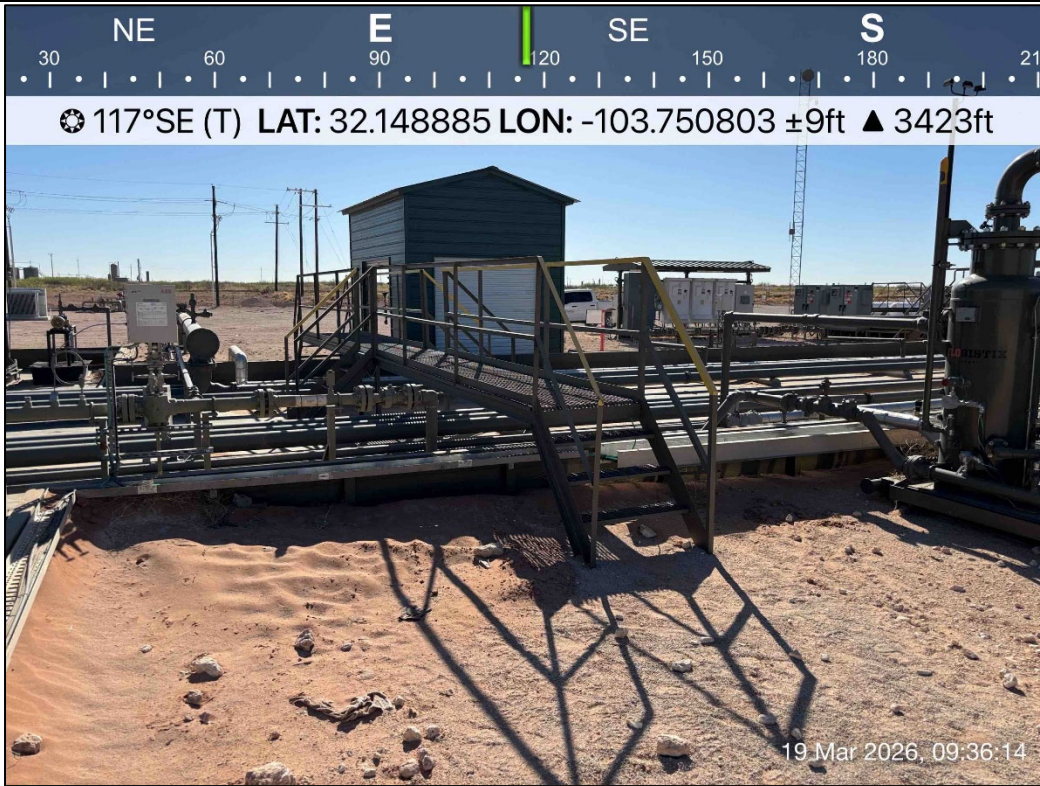
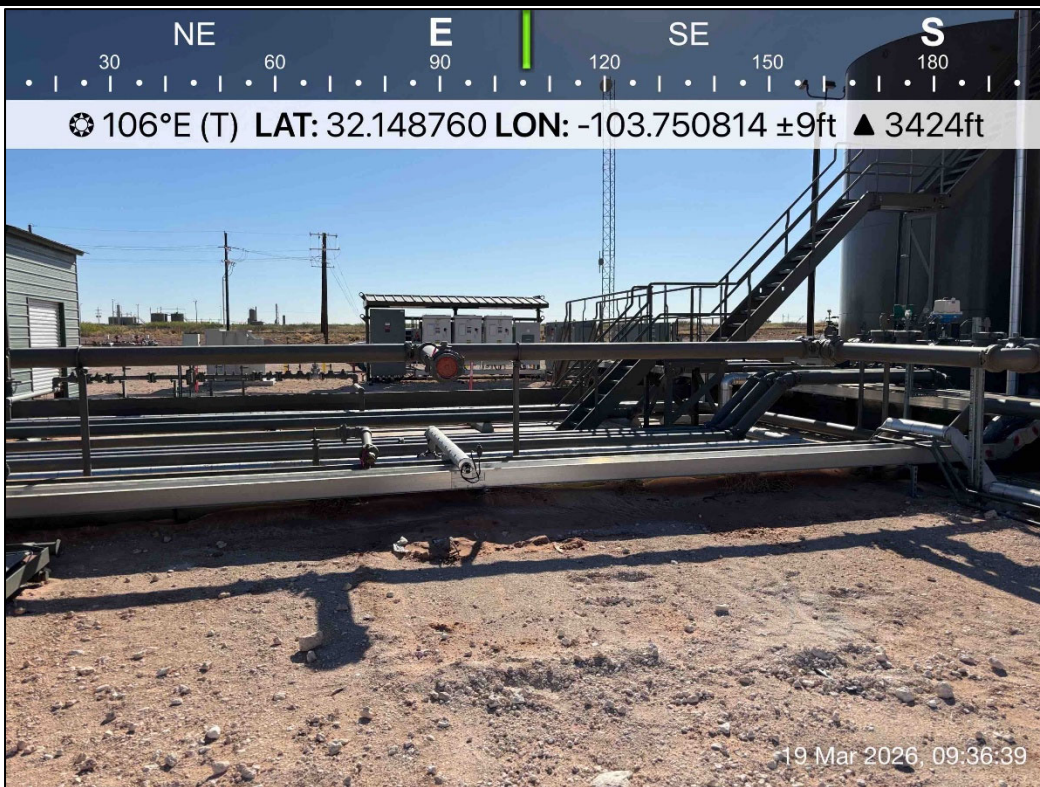
On March 19, 2026, ESRR conducted a thorough visual inspection of the LSC and found no tears, cracks, cuts, breaks, or other signs of damage, confirming no evidence of a breach to the LSC. The liner appeared to be in good condition and is performing as designed. **Photographic Documentation** of liner inspection activities is attached.
