April 24, 2026

RE: **Mule 11 CTB 2 - Closure Request Report**

Incident Number: nAPP2602632747

ESRR Project No. VP-8747

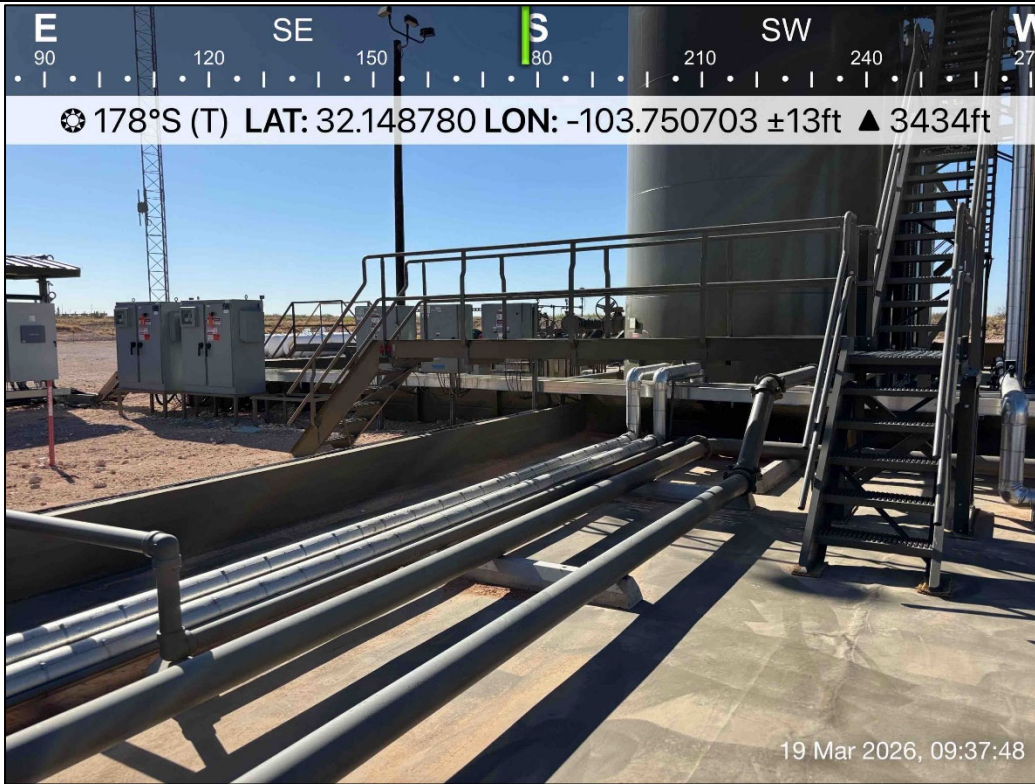
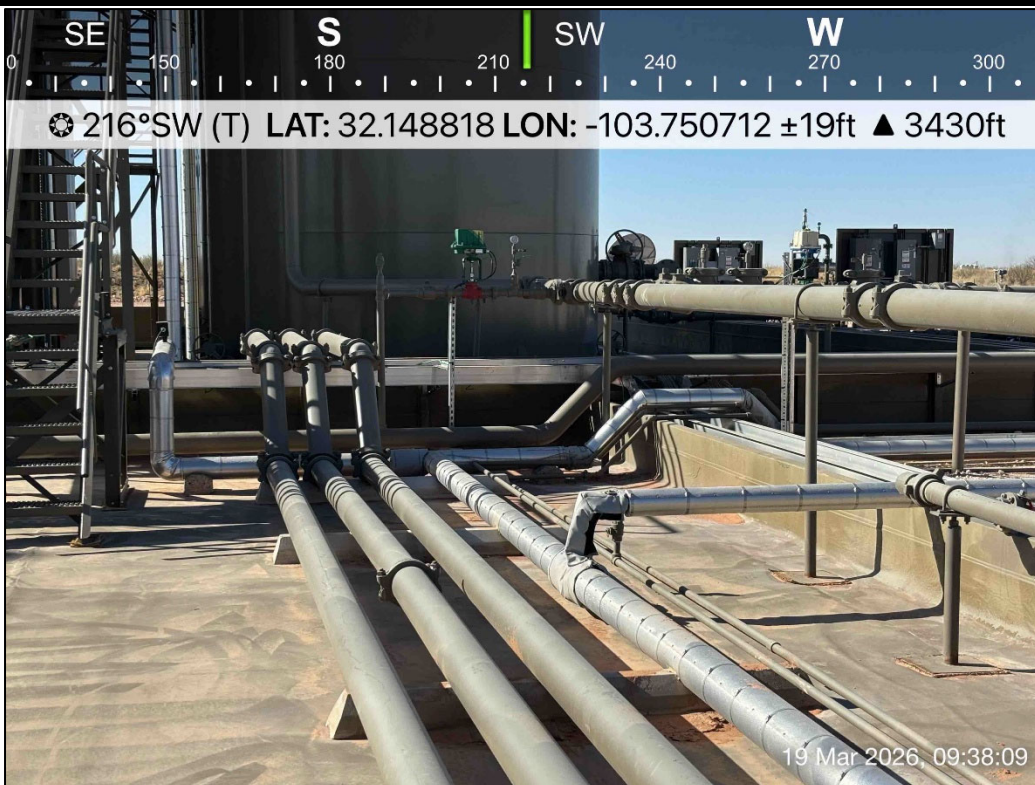
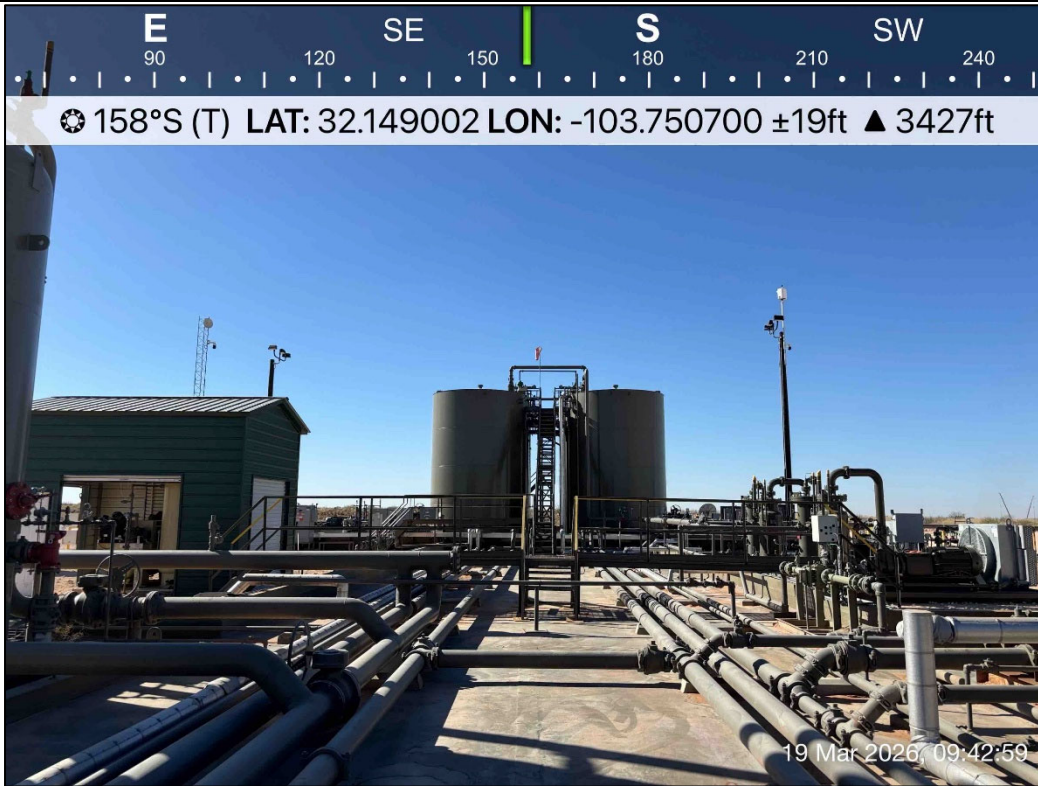
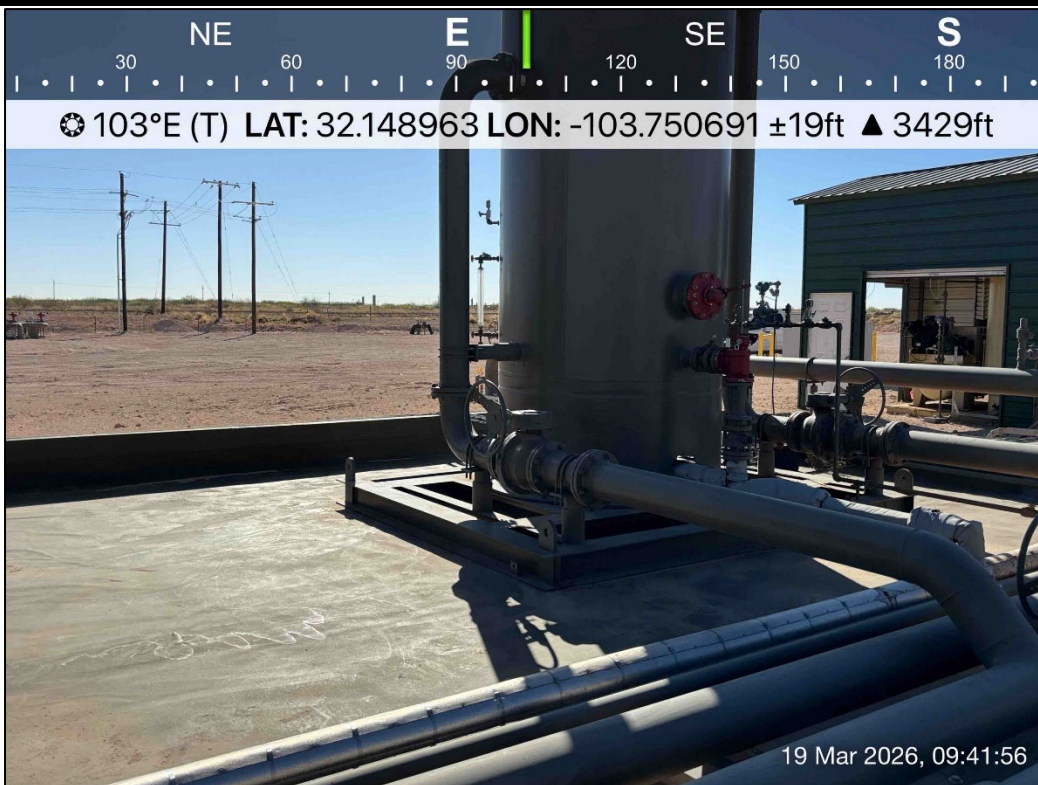
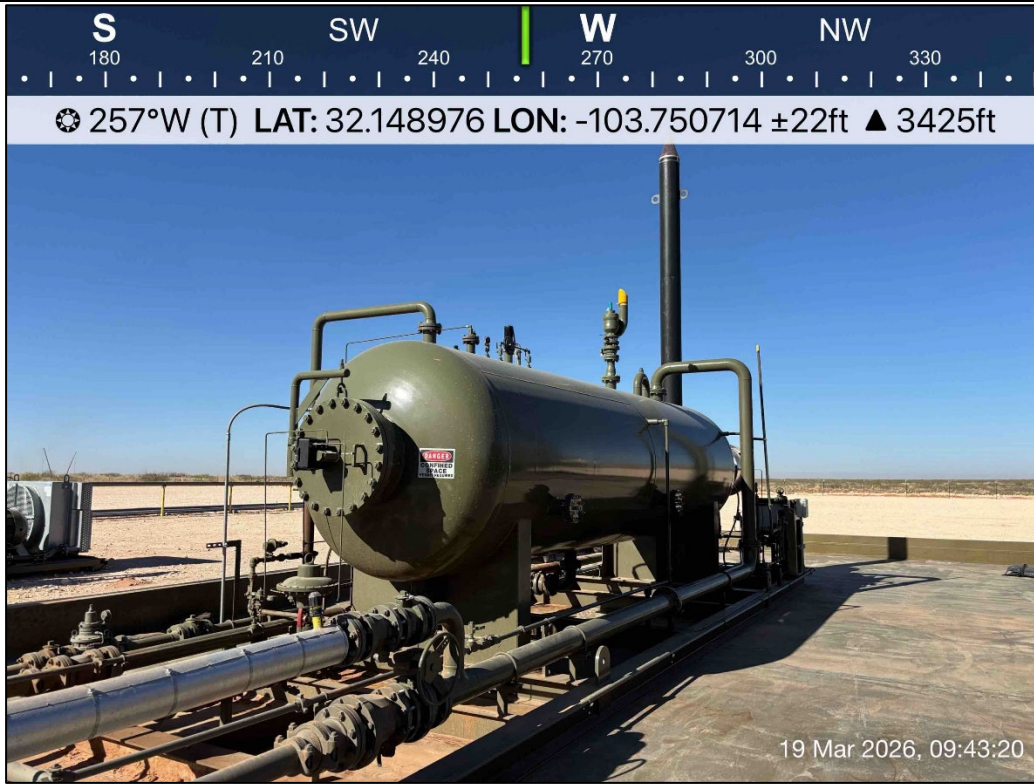
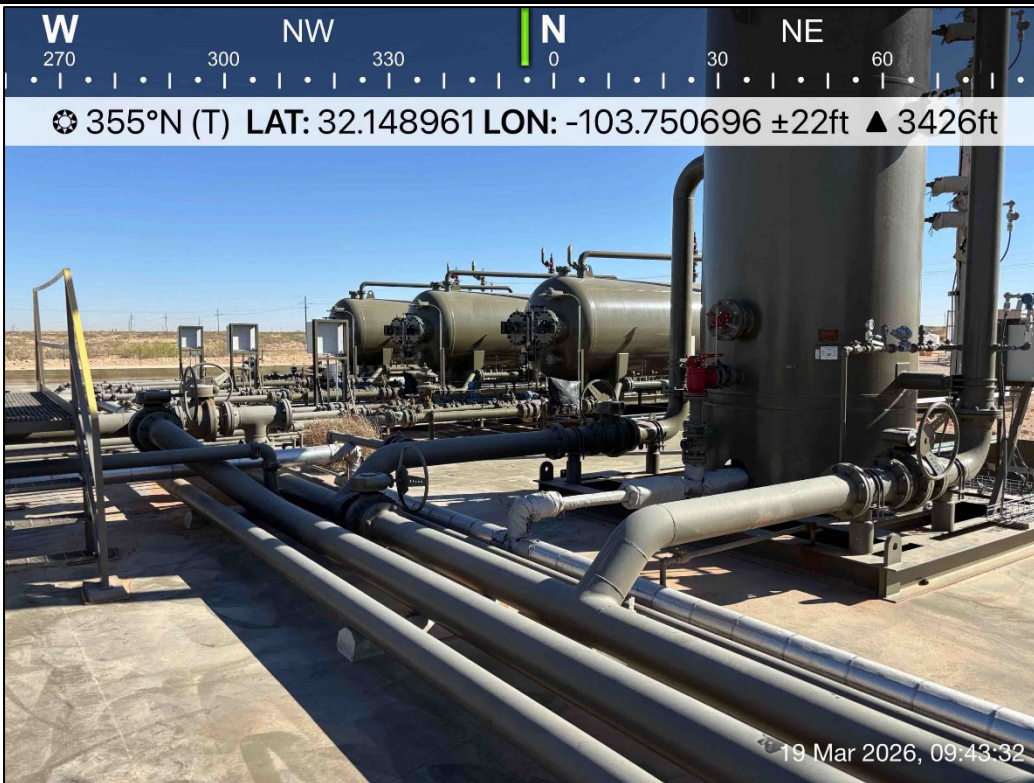
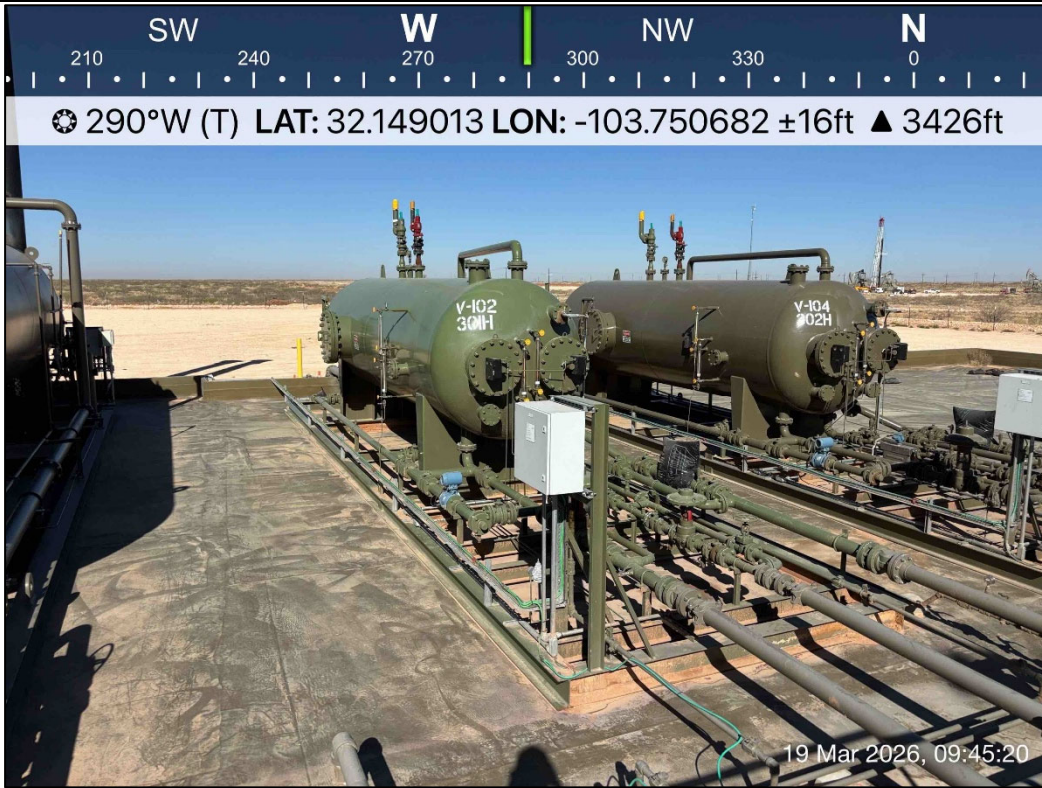
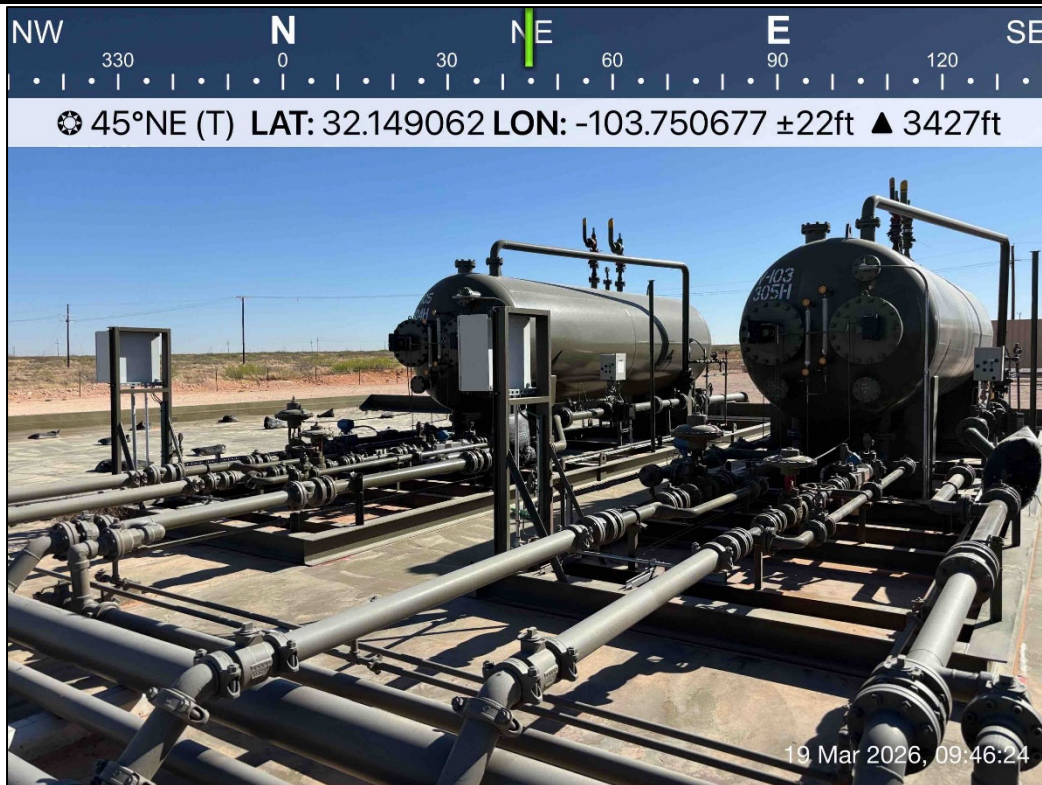
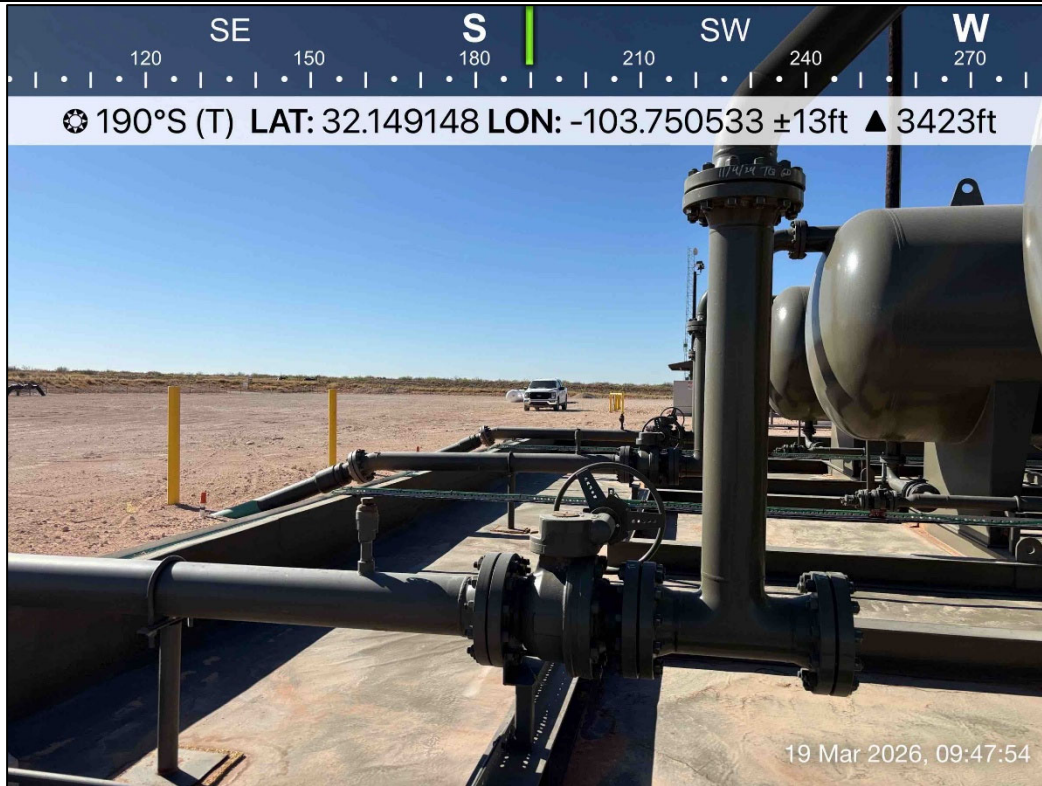
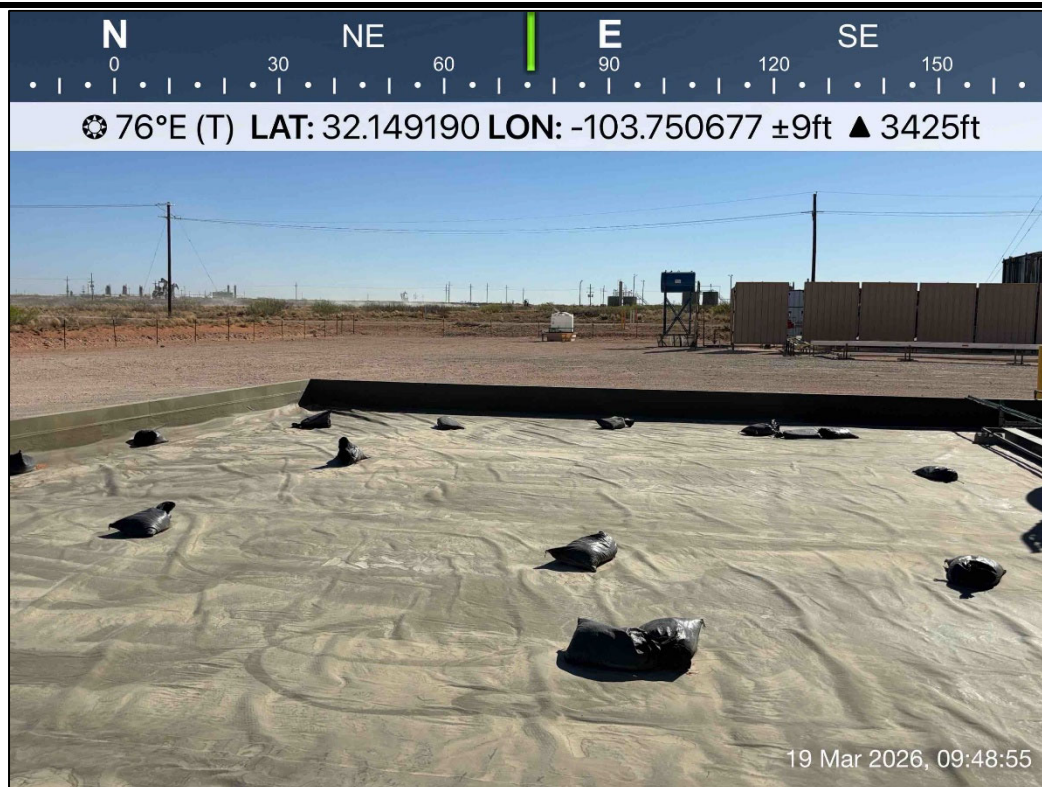
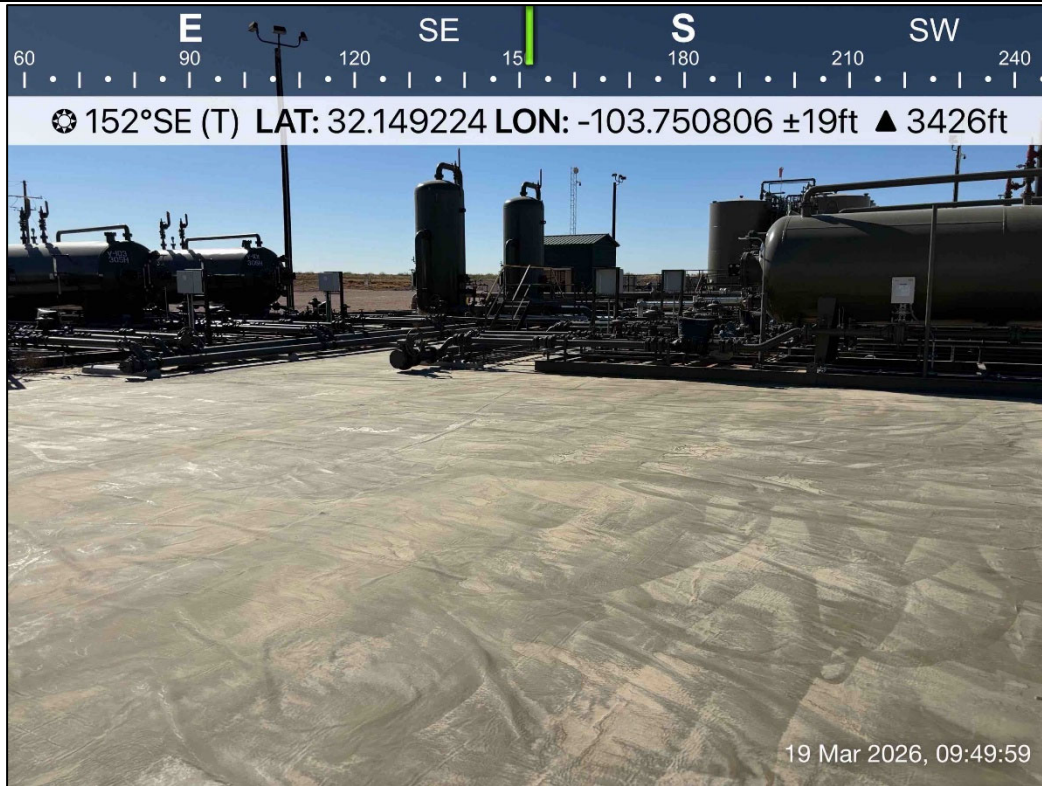
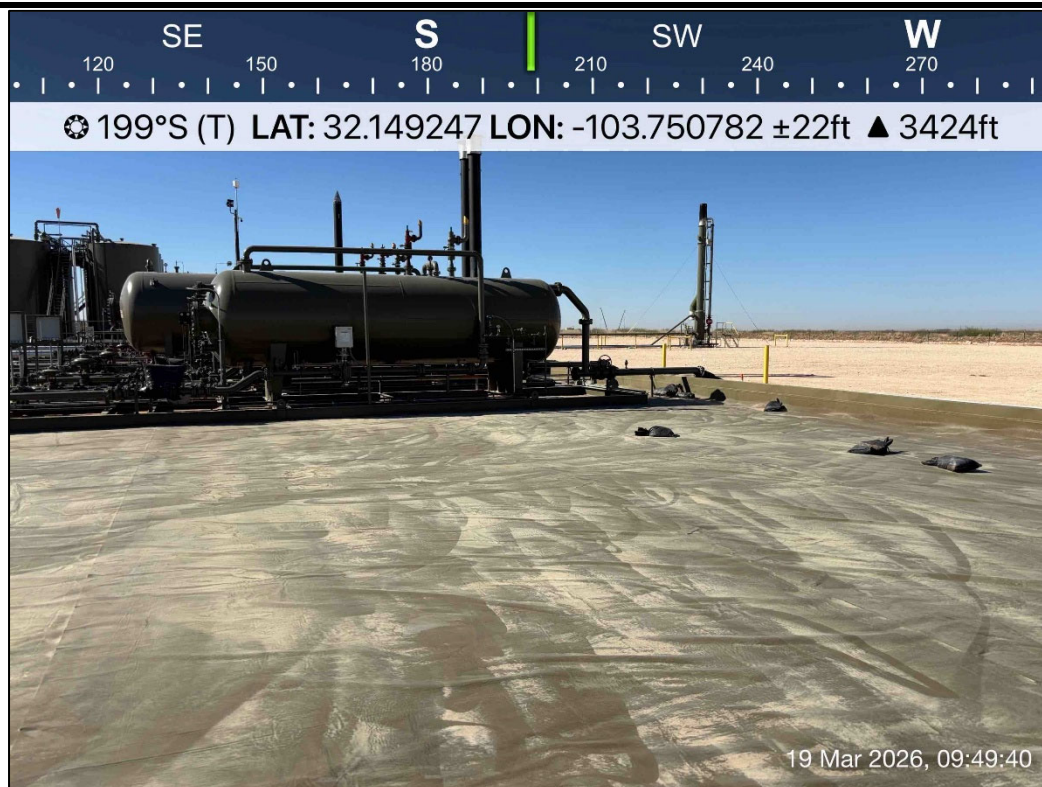
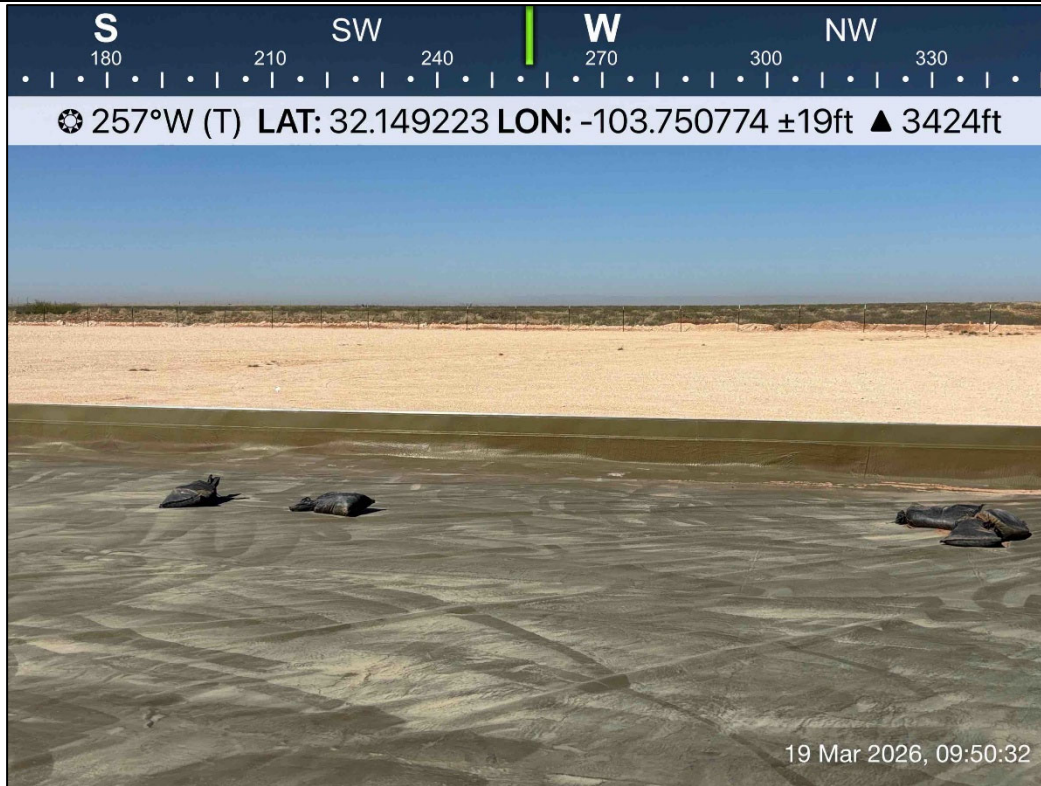
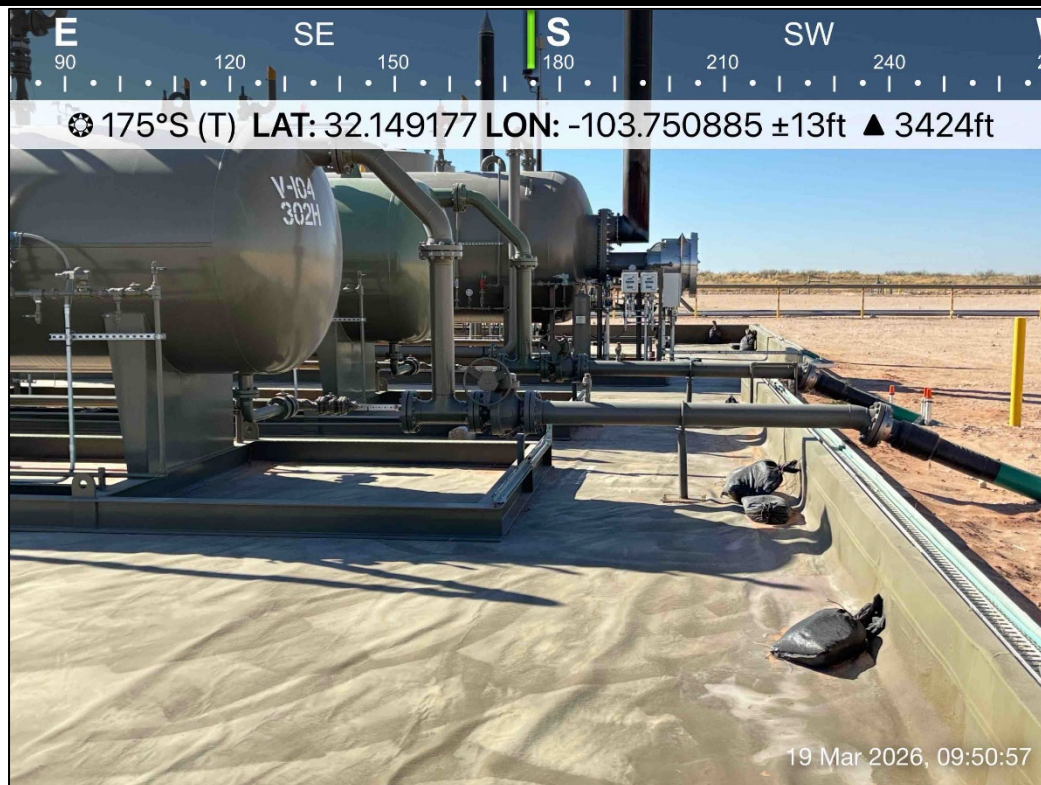
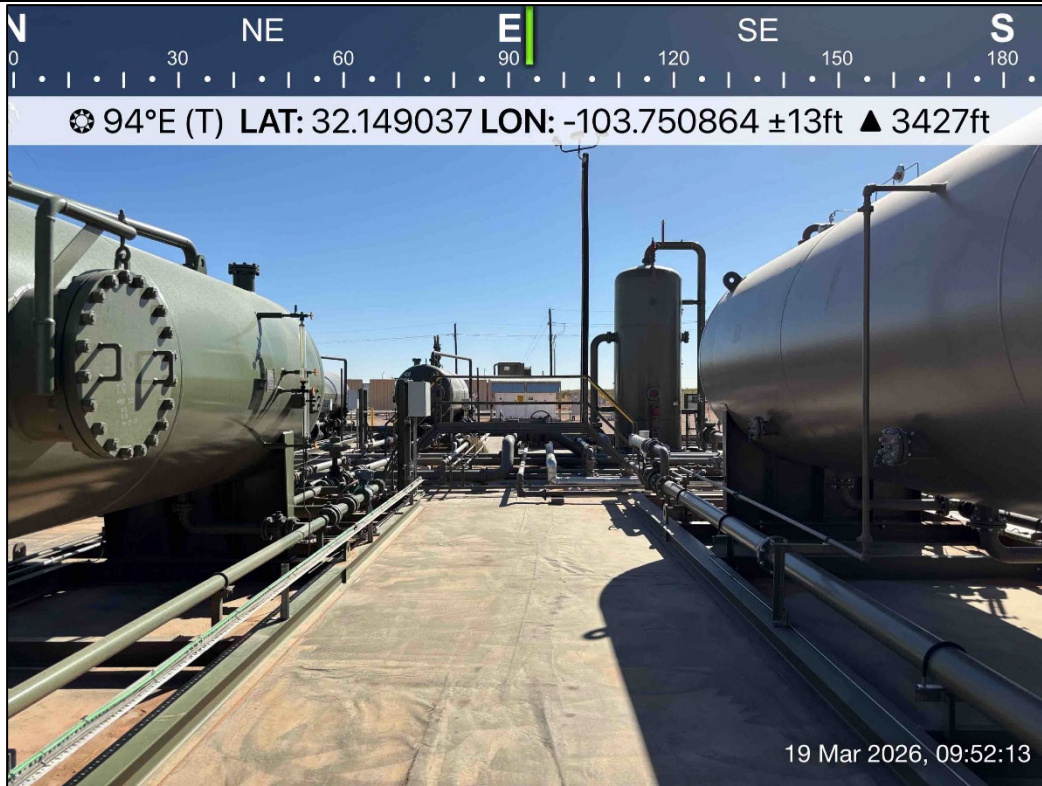
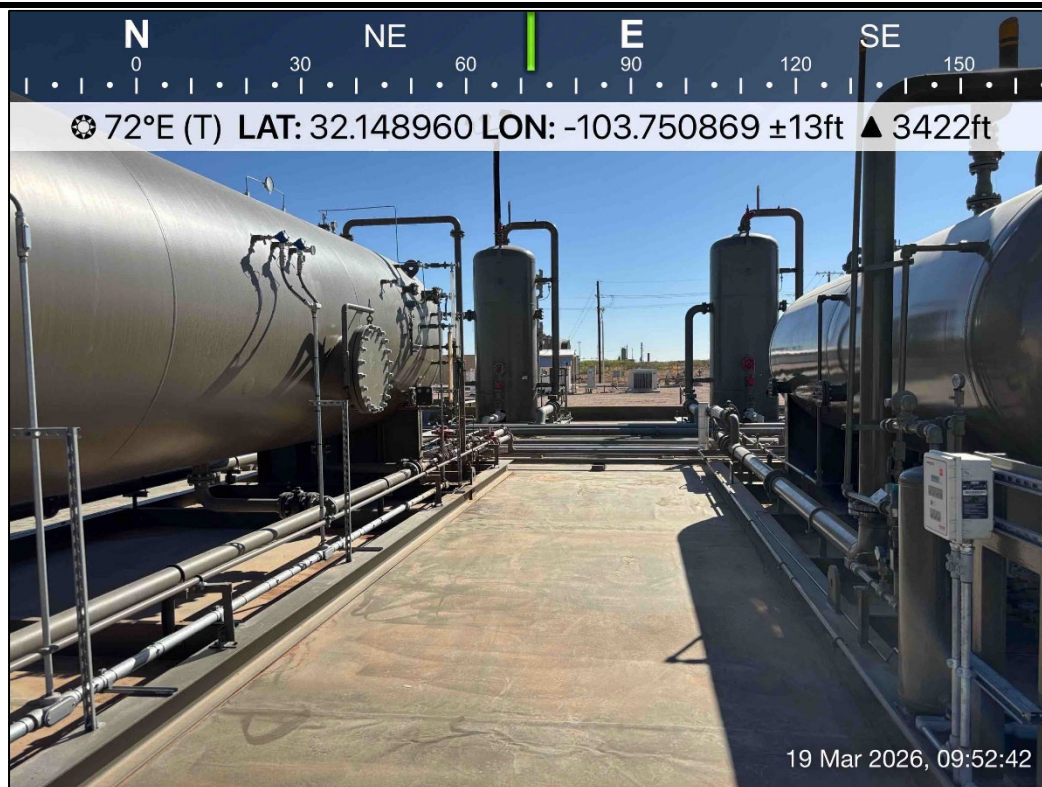
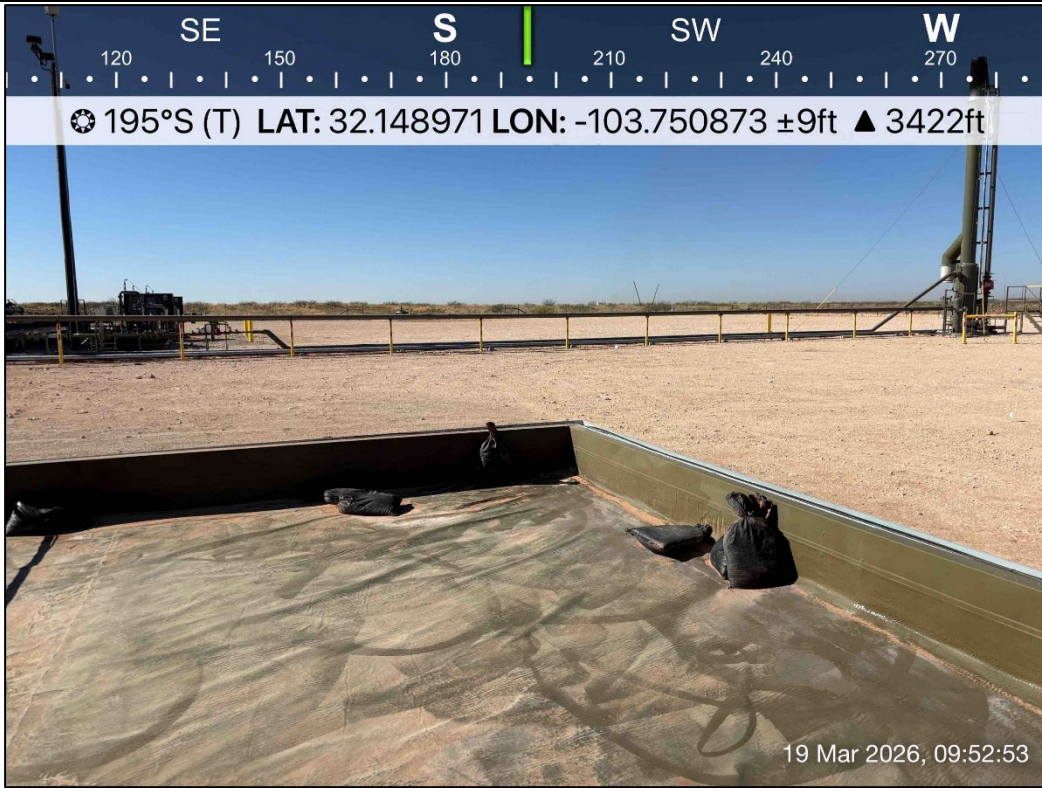
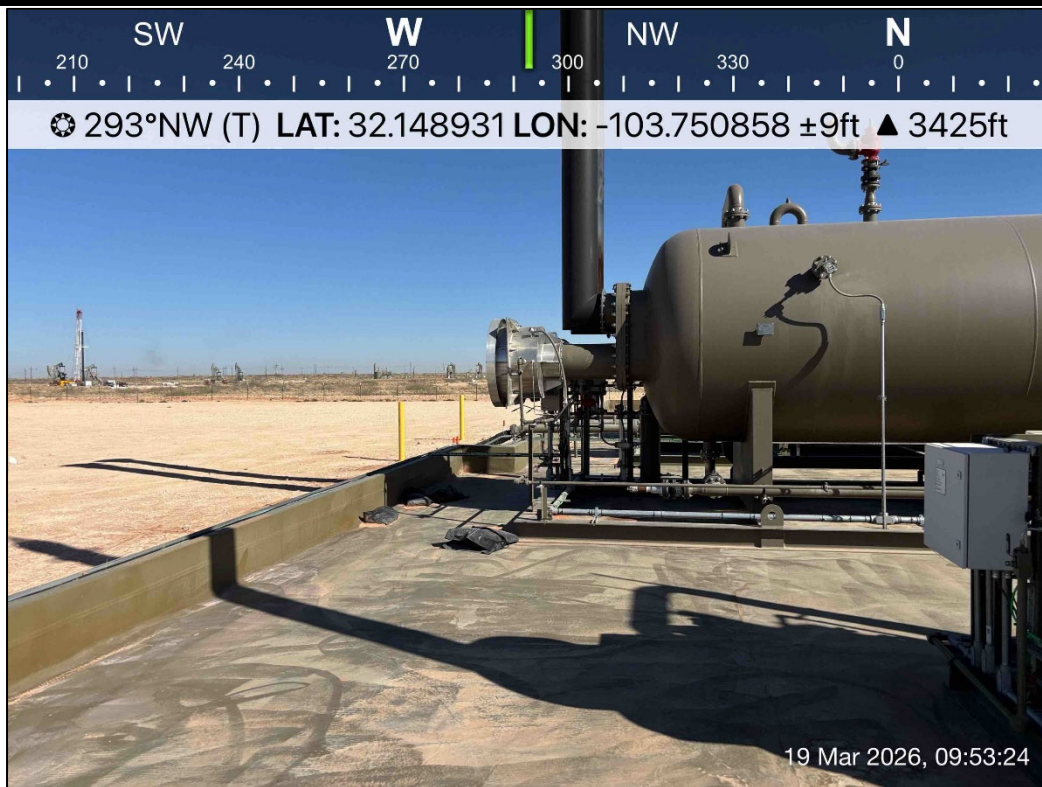
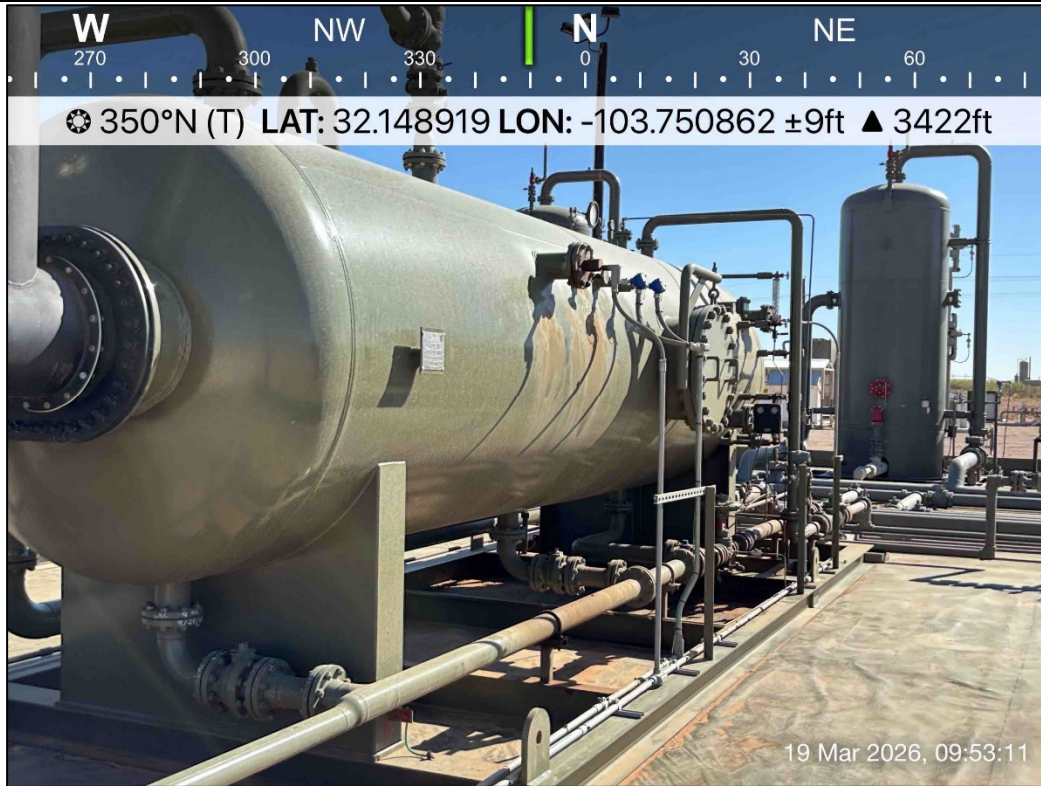
On March 19, 2026, ESRR conducted a thorough visual inspection of the LSC and found no tears, cracks, cuts, breaks, or other signs of damage, confirming no evidence of a breach to the LSC. The liner appeared to be in good condition and is performing as designed. **Photographic Documentation** of liner inspection activities is attached.
