Type of Submission: Subsequent Report

SAN JUAN 29-6 UNIT 8M

30.039.29751

INTERMEDIATE CASING REPAIR

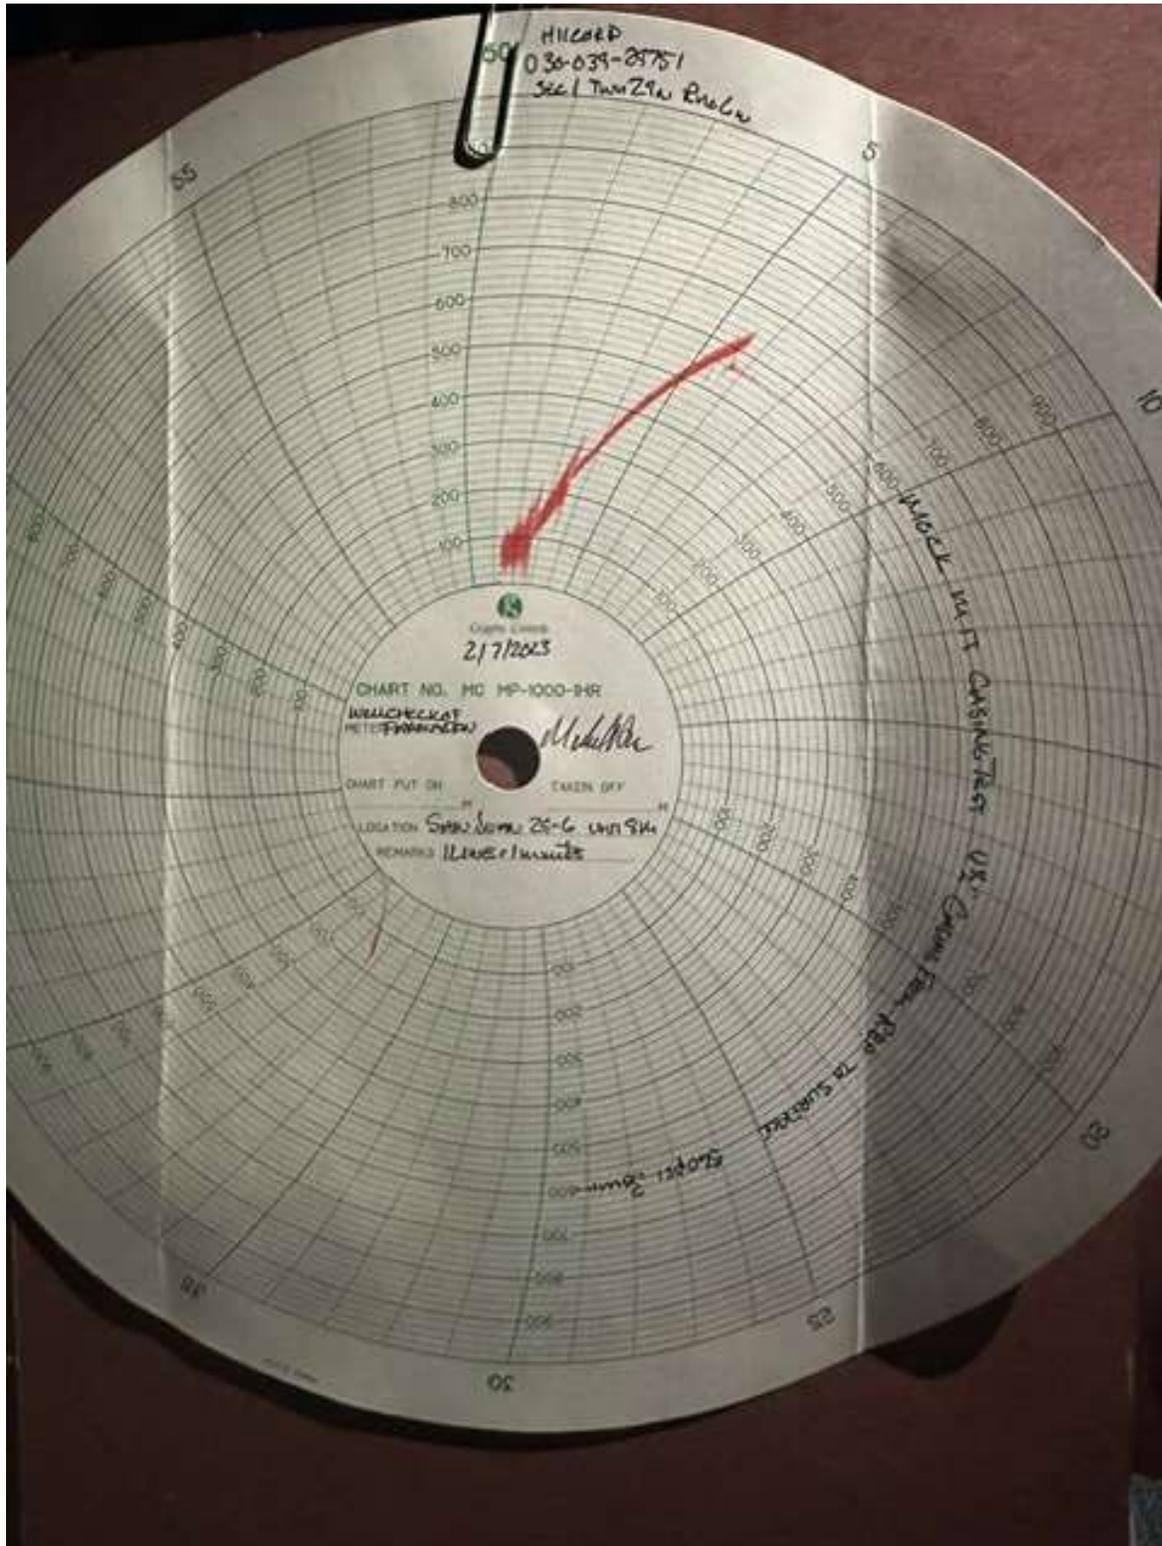
UNWITNESSED MIT CHART

2/7/2024 - CK PRESSURES. SITP-0 PSI, SICP-0 PSI, SIIC-25 PSI, SIBH-15 PSI. NO BD. RU WELLCHECK AND PERFORM UNWITNESSED MIT. PRESSURE TEST 4-1/2" PROD CSG TO 560 PSI FOR 30 MIN CHARTED TEST. NO LEAK OFF. ATTEMPT TO LOAD AND TEST WH SEALS. DUMP SAND ON RBP. TOOH. **HEC ENGINEER EMAILED MONICA KUEHLING, NMOC, PROVIDING DETAILS THAT THE DIRECT COMMUNICATION BETWEEN BH AND INT APPEARS TO BE AT THE WH. PATH FORWARD IS TO RD, EXCAVATE AROUND THE WH, REMOVE THE PC SECTION, AND REPLACE THE MANDREL-STYLE IC SECTION WITH A FLANGE-STYLE IC SECTION. RETEST.** RD FLOOR, ND BOPE, NU WH. LOAD 4-1/2" W/ WATER.

- We set a BP above the MV perfs and got a good pressure test on the 4-1/2" to 560 psi. We charted the test for 30 minutes and the 4-1/2" held like a jug
